Case study

Restoration and preservation of the reinforced concrete poles of fence at the former Auschwitz concentration and extermination camp

A. Miszczyk*, M. Szocinski, K. Darowicki

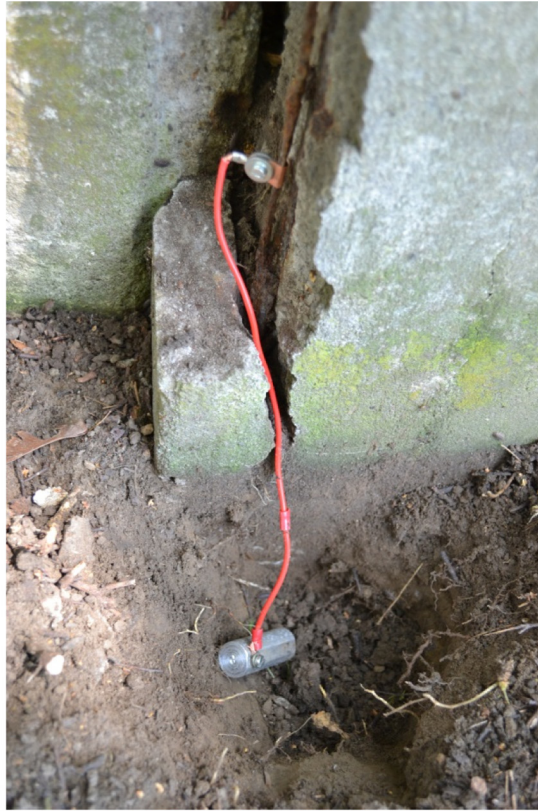
Fig. 7. Pillars located in the former Auschwitz camp protected with sacrificial anodes before applying a new repair mortar: variants with protector buried in soil (a), variant with protector placed directly on reinforcement (b).

In order to ensure effective protection of steel reinforced pillar two variants of protection are suggested. The first one consists in placing the protector in ground in vicinity of the reinforced concrete pillar as illustrated in Fig. 6a. Electrical connection between the protector and the steel reinforcement is accomplished in the underground section of the pillar, so the protection system is not visible for the potential visitors, which fulfills the requirements for conservation of historical heritage objects. The same requirement is fulfilled by the second variant of protection, which predicts positioning of the protector directly on the reinforcement (Fig. 6b). In this case the protector is typically in form of small-dimension zinc disc or wire fixed on and electrically connected with the reinforcement bar. Then missing layer of concrete is applied covering the rebar together with the protector. As long as the concrete layer is not penetrated by water, ions and the front of carbonation is away from the reinforcement, steel does not corrode and the protectors play a waiting role. The moment the aforementioned agents reach the rebar the sacrificial anodes start to provide electrochemical protection. The second variant of protection is ideally suited for the degraded pillars calling for restoration where the reinforcement is revealed and exposed to atmospheric conditions. In case of both approaches the effectiveness of applied protection as well as the time instant when the protector has to be replaced can be monitored and determined by measurements of electrochemical potential of the pillar's reinforcement. Both proposed variants of electrochemical protection have already been implemented at separate pillars present on the area of the former Auschwitz camp (Fig. 7a and b).
