Risk assessment methodologies for pedestrian crossings without traffic lights – Warsaw case study – pedestrian safety assessment

Tomasz Mackun^{1,*}, *Artur Rys*¹, and *Piotr Tomczuk*²

¹Gdansk University of Technology, Faculty of Civil and Environmental Engineering, Gdansk, Poland

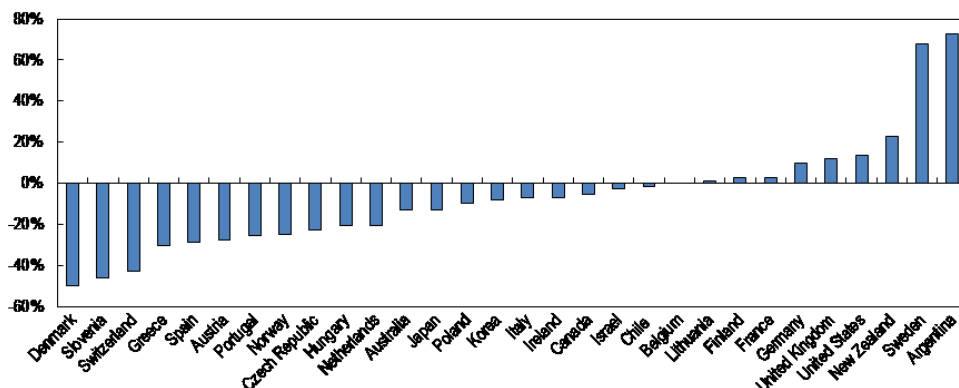
Fig. 1. Percentage change in the number of deaths among pedestrians, 2010-2014 [2].

According to the data [2], the number of pedestrian fatalities dropped by 9.7% (Fig.1) in the years 2010-2014 in Poland. The decrease in fatalities including pedestrians can be caused
