SAFETY AND FUNCTIONALITY ASSESSMENT OF TRAM LOOPS IN WROCLAW

Abstract: *The article presents the implementation of the ISFTL method proposed by the authors consisting in an indicator assessment of the safety and functionality of tram loops. Five tram loops located in Wrocław were analyzed. Each of these loops has different characteristics. The components of each assessment are described in detail and further directions for improving the proposed assessment are indicated.*

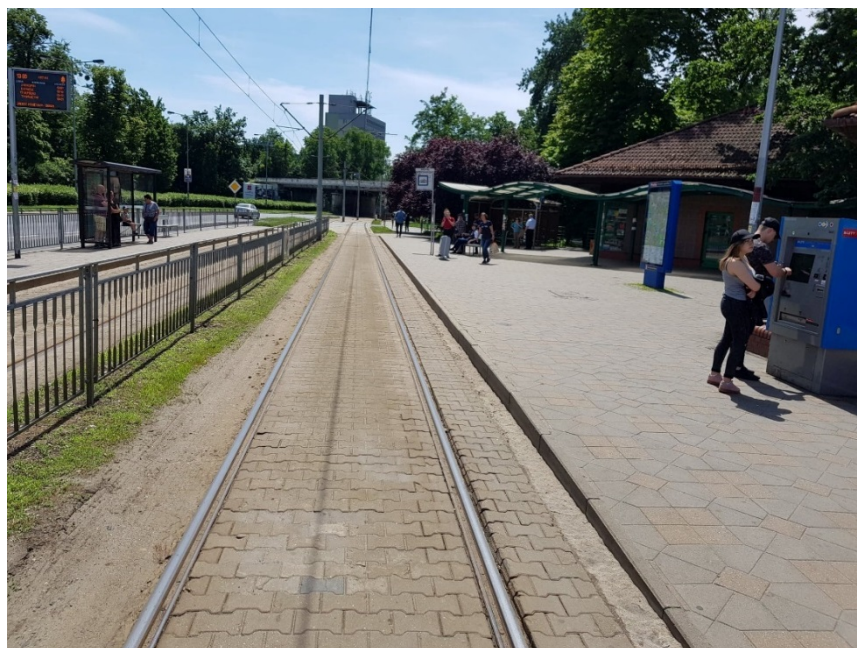
Fig. 6. Tram platform stops located in Krzyki tram loop in Wrocław (Poland)

The measurements carried out allowed for the conclusion that the Krzyki loop (fig. 6) has a low level of safety compliance. The first aspect is the condition of the pavement surface, which is not adequate. There are individual defects and unevenness. In the case of the separation of transport traces (ST), no pedestrian crossing through the tram track was identified and there was a clear problem in separating pedestrian and cyclist streams. The entire length of the stop leads as a road to the bicycle parking lot which can lead to dangerous situations in the cyclist-pedestrian relationship. The technical condition of the track is assessed as satisfactory. In terms of the functionality of the loop, the evaluation result is satisfactory.

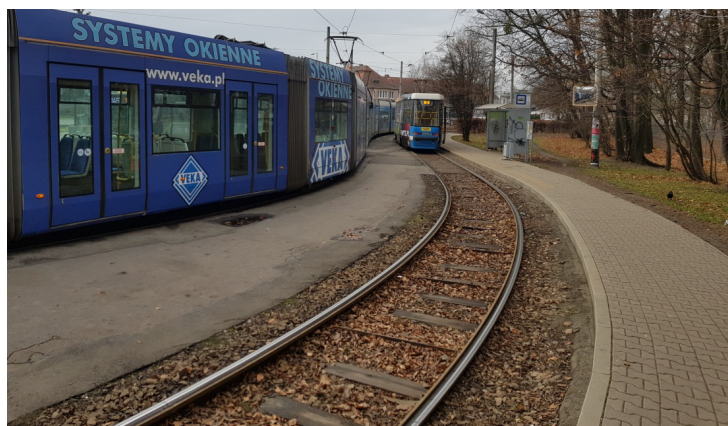
Fig. 7. Tram platform stops located in Sępolno tram loop in Wrocław (Poland)

The Sępolno loop (fig. 7) has the lowest values of ISTL and IFTL indicators. Both in the case of the safety and functionality assessment, the conducted tests showed a very bad condition of both parameters, classifying the loops at the unacceptable level in both areas of the assessment. During the audit carried out at the loop it was observed that the condition of the tram track is in poor condition. The surface of pedestrian and bicycle routes is in very poor technical condition, the pavements are uneven and have cavities. In the loop area, there are no pedestrian crossings and pavements separated from the tram track. There is also a lack of bicycle traffic separation. The Sępolno loop meets all requirements only in terms of accessibility to different forms of transport and visibility of tram trains in the area of the loop. In the case of functional indicator parameters, there is a lack of adaptation of bus platforms and infrastructure. There are no shelters, benches and dynamic passenger information boards on the loop. Platforms are not adapted for the disabled. The platform for passengers who getting on is too short. And the number of platforms for passenger who getting on is not adapted to the number of tram lines which serving loops.

The results indicate that the Sępólno loop is an example where it is necessary to carry out repair and modernization works aimed at improving the safety of users and the functionality of the facility. Analyzes indicate a significant risk of adverse events, including those threatening the health and life of users. One loop that has obtained the maximum indicator value (only in terms of security) is the Klecina loop.

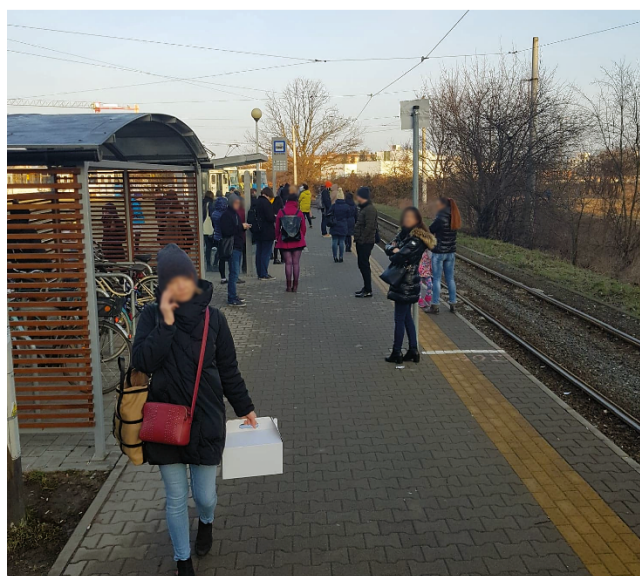
Fig. 8. Tram platform stop for getting on located in Klecina tram loop in Wrocław (Poland)

The Klecina loop (fig. 8.) is an example of a tram loop where the direction change takes place differently than on typical loops. As a standard, tramway traffic on the loop runs counter-clockwise and stops are located on the outside of the tram track. In the case of the Klecina loop, the tram traffic is clockwise and the stops are located inside the loop. The awarded point values depend on the selected parameters for: accessibility to different forms of transport (AD) - no P&R parking, the distance from the city bike station is about 80 m, bus stops located at the street adjacent to the loop at a short distance from the stop; type of stop infrastructure and facilities (TI) - no dynamic passenger information boards, service outlets and the ticket machine is located outside the tram loop.
