Article

Short and Long Term Measurements in Assessment of FRP Composite Footbridge Behavior

Figure 1. Composite footbridge designed within the FOBRIDGE project.

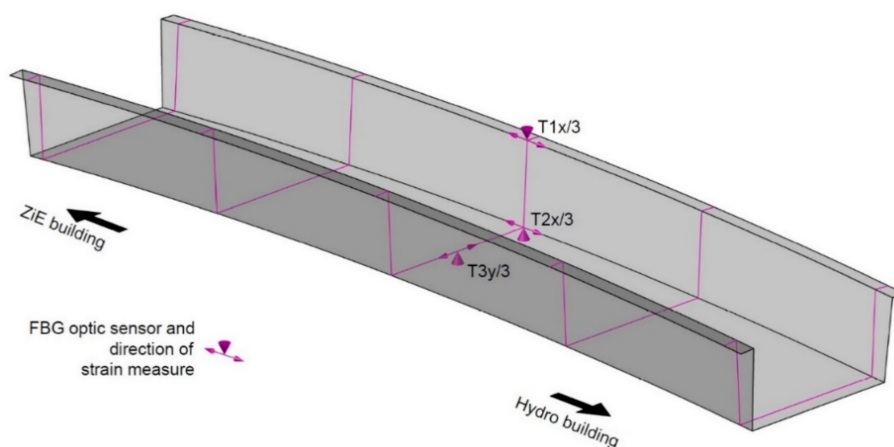
Figure 5. Location of FBG optic fiber sensors.

The fiber optic measurement system is based on two kinds of sensors. It includes three Bragg gratings to measure strain and one for temperature compensation. They form a one wire chain, ending in the SC/APC connector, see Figure 4. The following parameters characterize the Sylex (Bratislava, Slovakia) strain gauges used in measurements: 8 mm measuring length, $0.85 \mu\epsilon$ resolution, $1.7 \mu\epsilon$ accuracy, range of measure up to $5000 \mu\epsilon$. The temperature gauge parameters are: $0.1 \text{ }^\circ\text{C}$ resolution, $0.2 \text{ }^\circ\text{C}$ accuracy, in a measuring range from $-20 \text{ }^\circ\text{C}$ to $+150 \text{ }^\circ\text{C}$. The single strain gauge length is 30 mm, it was fixed to the structure by the cyano-acrylate dedicated glue. The measurements were carried out using the Sylex SCN-80 S-line Scan 800 interrogator and a computer with dedicated ILLumiSense Strain software. The locations of the sensors are shown in Figure 5, they are all placed in one cross-section at the mid-span.

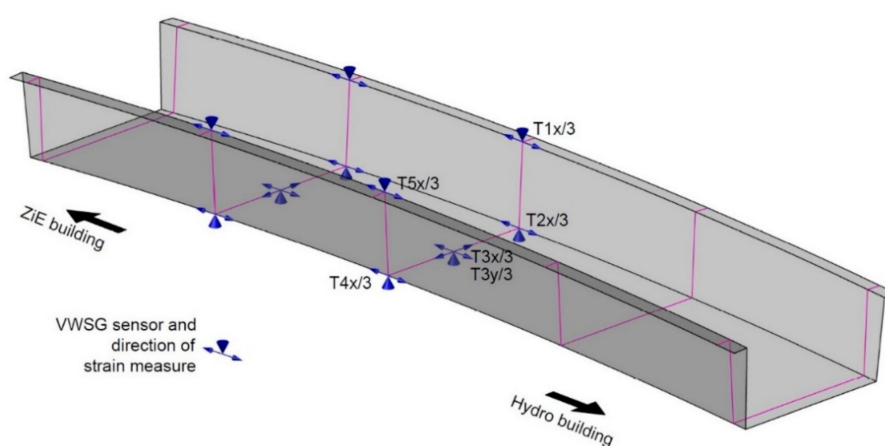
Figure 6. Location of VWSG sensors.

The VWSG measurement system is based on twelve GEOKON strain and temperature model 4000 gauges. The strain is measured on the basis of changes in the natural frequency of a string attached to anchor blocks inside a device. The system is characterized by a very good stability during long-term monitoring. The sensors are connected to the 16-channel recorder, which initiates the measurement within a given time interval. The parameters of the sensors are: measuring length of 150 mm, measuring range up to 3000 $\mu\epsilon$, resolution of 1 $\mu\epsilon$, accuracy <0.5% FS, temperature range $-20\text{ }^{\circ}\text{C}$ to $+80\text{ }^{\circ}\text{C}$, simultaneous measurement of temperature and strain. The locations of the VWSG are shown in Figure 6. The sensors are placed in two cross-sections, at quarter and mid-span. One of the sensors, being fixed to the bridge deck is presented in Figure 7.

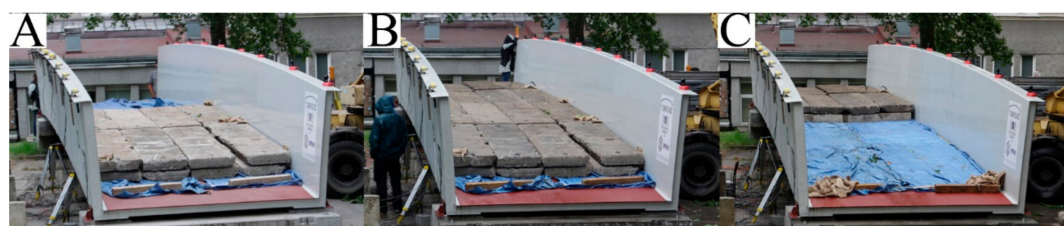
Figure 14. Loading sequence during the U3 test (from A to C).

In all static cases, the ballast was applied using concrete slabs. The total weights of the slabs during the tests were—U1: 141.2 kN, U2: 150.0 kN, and U3: 201.7 kN. The load was always put on the deck in subsequent steps. During the U1 test, the concrete slabs were placed in seven steps from A to G (each quarter of the deck) were loaded separately, see Figure 13. During U2 and U3 tests in three steps from A to C, each half of the deck loaded separately, see Figure 14. The ballast was laid on the structure in stages, asymmetrically, with respect to the longitudinal and transverse axes of the footbridge. The approach, in which so many different types of measuring points are used, was designed to identify possible irregularities in the behavior of the footbridge parts.

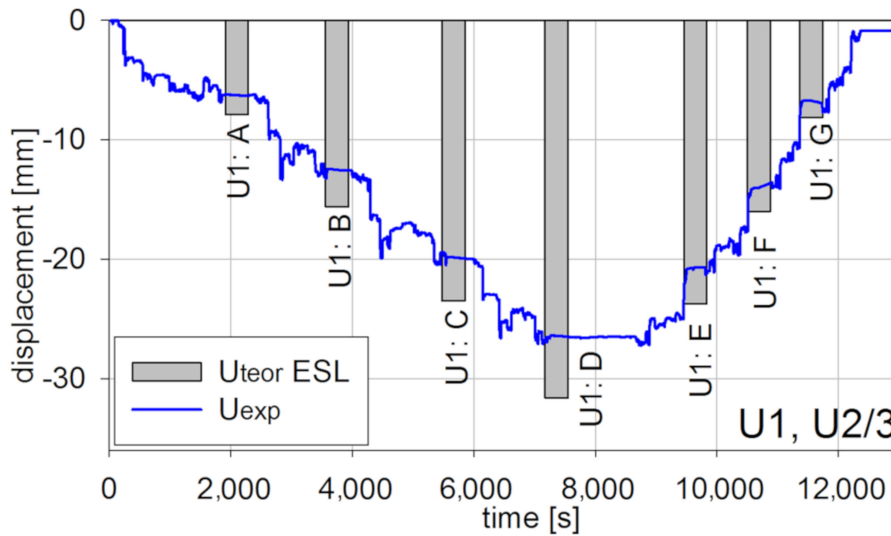
Figure 17. Vertical displacements in U2/3 for the U1 test.

Also, displacements were measured during the short-term test. The example results from inductive sensors are shown in Figures 17 and 18 correspondingly for U1 and U3 tests in U2/3 points, for which extreme values were reported (refer to Figure 11).

The displacement inductive sensors measurements were checked using geodetic precision leveling and thus assessed as precise. Therefore, they can be used to assess the behavior of the innovative bridge. Similarly as in the case of a strain measure, the in situ measure revealed a stiffness margin for the safety of the bridge.

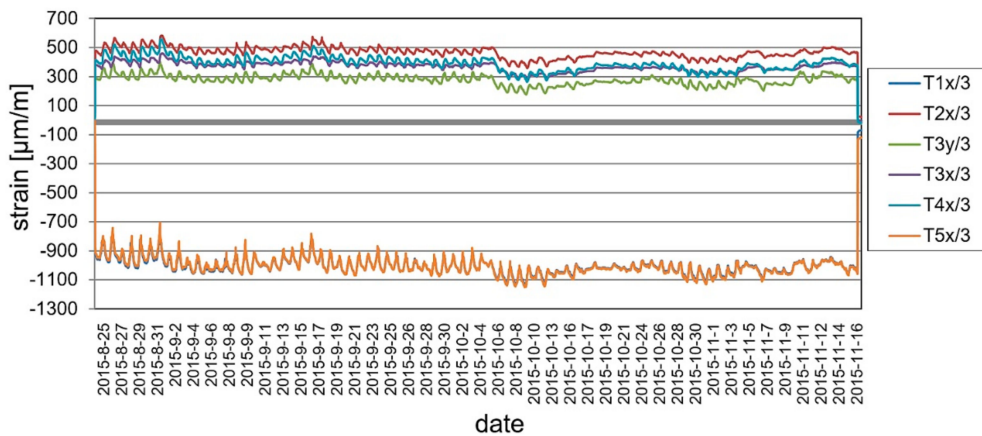
Figure 19. Strain monitoring using VWSG sensors during the long-term load test.

During the long-term load tests (U2 ballast had been left on the deck) the measurement system included VWSG sensors and vibration monitoring, as well as periodic precision leveling. The changes of the mid-span strains in time are shown in Figure 19, while the change of temperature in the same domain of time as presented for strains is shown in Figure 20. The established time intervals measurements in characteristic points of the structure by precision leveling is presented in Figure 21. For more detailed verification, regardless of whether the weight of the ballast caused rheological changes in displacements, the obtained results were normalized with respect to the deflection at start of the test. The result is shown in Figure 22.

As was predicted, only a small strain and displacement deviations are observed because of the diurnal and seasonal changes of temperature. The performance of the bridge did not change because of rheological effects and inelastic strains or permanent displacements did not occur.

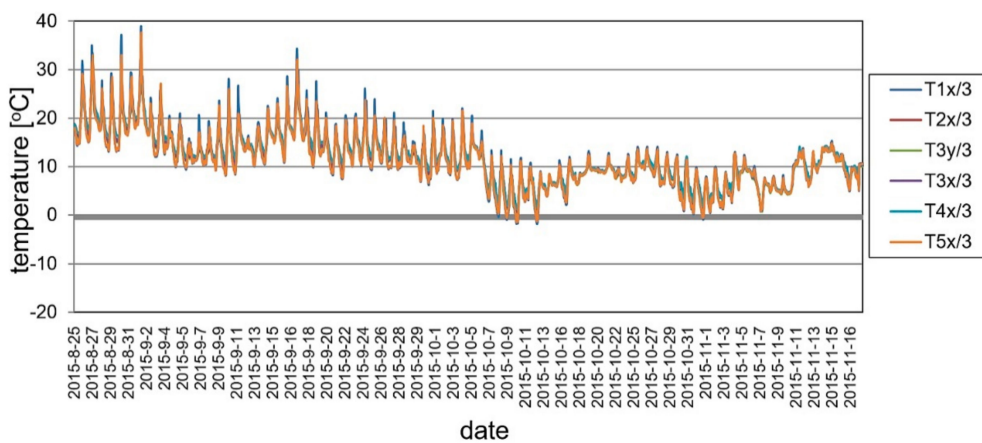
Figure 20. Temperature changes during the long-term load test.

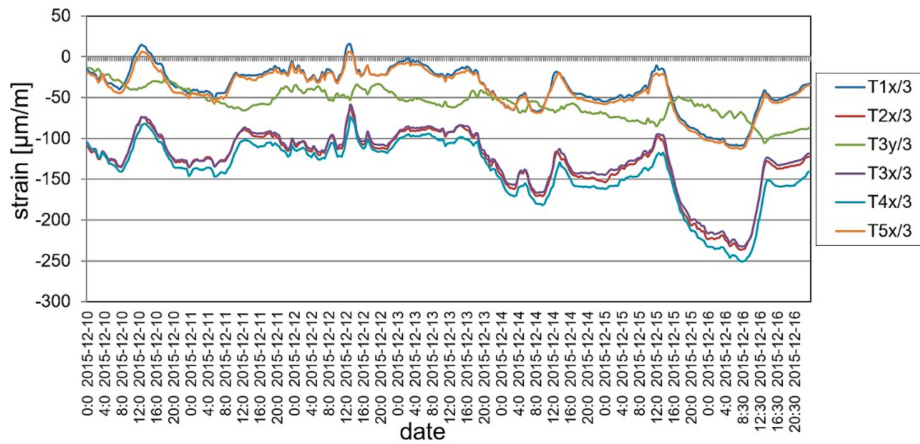
Figure 23. Strain monitoring using VWSG sensors during a one week period.

The structure was still continuously monitored by the SHM system when there were no static loads on the footbridge, between May 2015 and May 2016. In order to maintain readability of the recorded data, the presentation of results was limited to the periods of November 2015 and May 2016. The changes of the mid-span strains in time for ambient testing during a sample week period is shown in Figure 23. The temperature change in the same domain of time as presented for strains is shown in Figure 24. According to the surveillance observations and the gathered data the temperature changes and wind were the main influences affecting the footbridge. It can be observed in Figures 25 and 26, which are strains and temperature time histories throughout the six month monitoring period, that because of these effects, strains range from about -400 to 400 microstrains. Nevertheless, higher values were calculated at the stage of bridge designing. Therefore, the SHM strain measurement confirms the safe design and behavior of the bridge for environmental influences. The graphs clearly show the impact of both daily temperature changes and the ones associated with the change of seasons. The research confirmed previous observations that composite sandwich material is sensitive to thermal influences, which should definitely be taken into account when designing this type of structure.

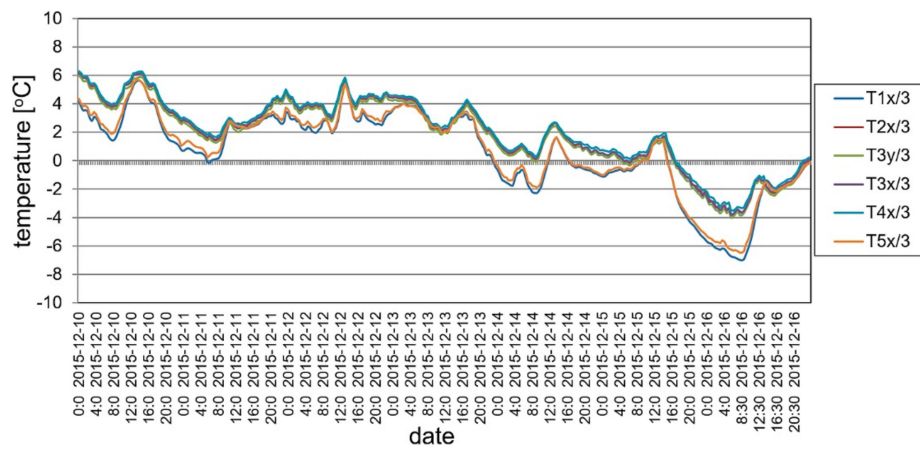
Figure 24. Temperature changes during a one week period.

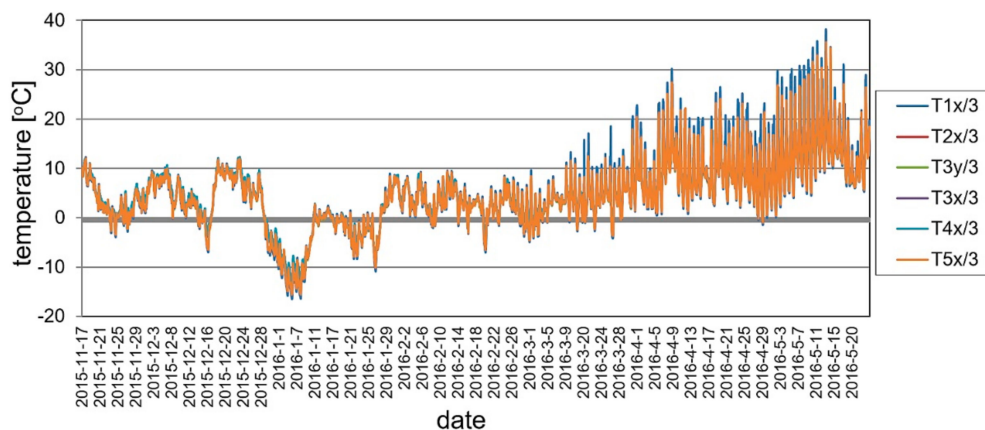
Figure 26. Temperature changes during a six month monitoring period.

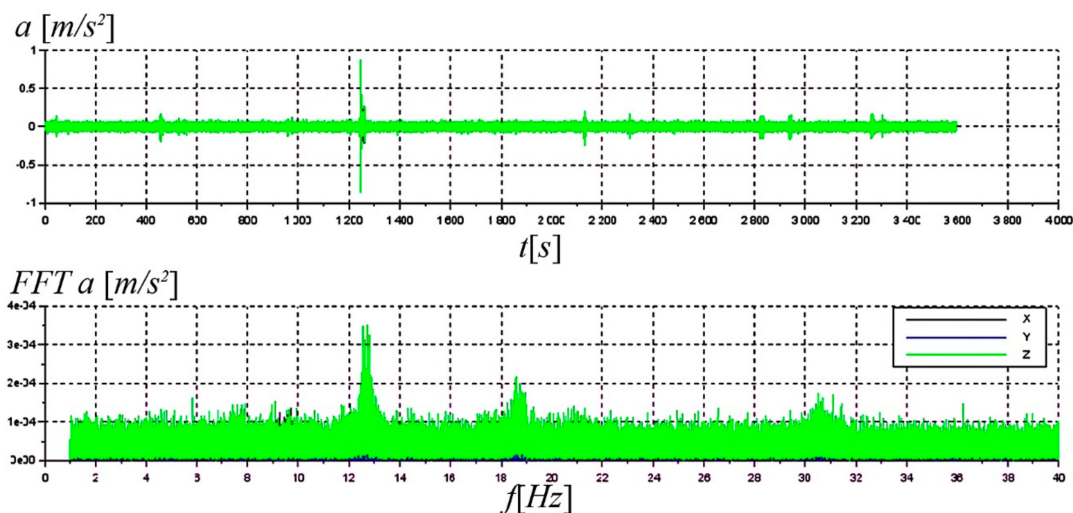
Figure 27. Example data of vibration monitoring with FFT analysis.

While performing the ambient testing, small groups of people only visited the footbridge occasionally. The object was located at the GUT campus beyond the main pedestrian traffic areas and was not used intensively. But the vibration monitoring system was still able to identify some natural frequencies of the structure. The natural frequencies analysis were limited to 40 Hz, due to numerical analysis results (see reference [34]), which showed that the basic structural characteristics fall within this range. The Fast Fourier Transform was obtained automatically with its own system continuously analyzing the recorded signal. In Figure 27 the exemplary measurement data with FFT analysis is presented. It may be observed that the values of around 12.5 Hz and 18.4 Hz are noticeable in the frequency domain. They correspond to the values of 3rd and 5th natural frequencies identified during short-term dynamic tests [34]. The values of natural frequencies did not change throughout the entire research period. On this basis, it can be concluded that the structure global stiffness did not change.
