Sustainable development requires risky decisions - problematic 300 ton overweight transport passing a bridge

Mikołaj Miśkiewicz, Andrzej Kozakiewicz, Lukasz Pyrzowski, Bartosz Sobczyk

Gdańsk University of Technology, Gdańsk, Poland

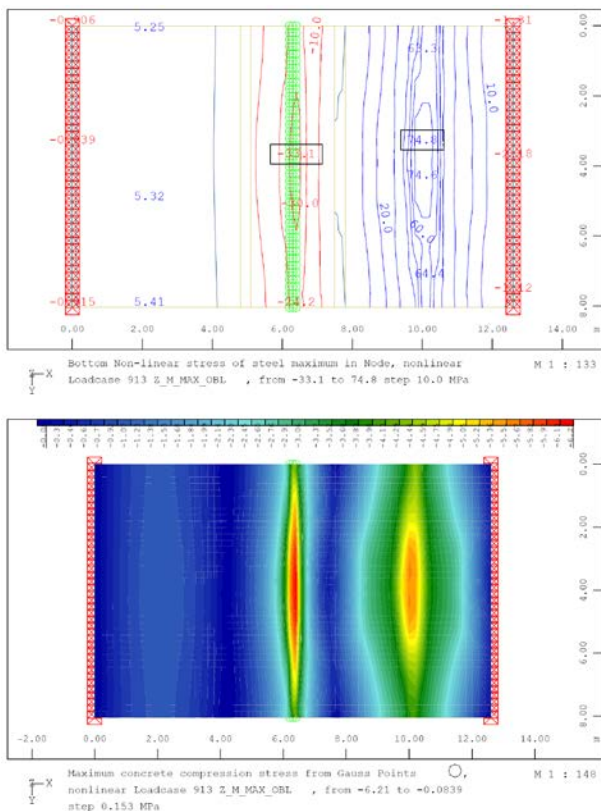
Representative stress maps determined by non-linear calculations for the passage of an oversized vehicle are shown in the Figure 9.

Figure 9. Stresses in the slab during the passage of an oversized vehicle: top (isolines) and bottom (isoarea)
