B. Świeczko-Żurek¹, M. Krzemiński²

THE DEGRADATION OF METAL IMPLANTS

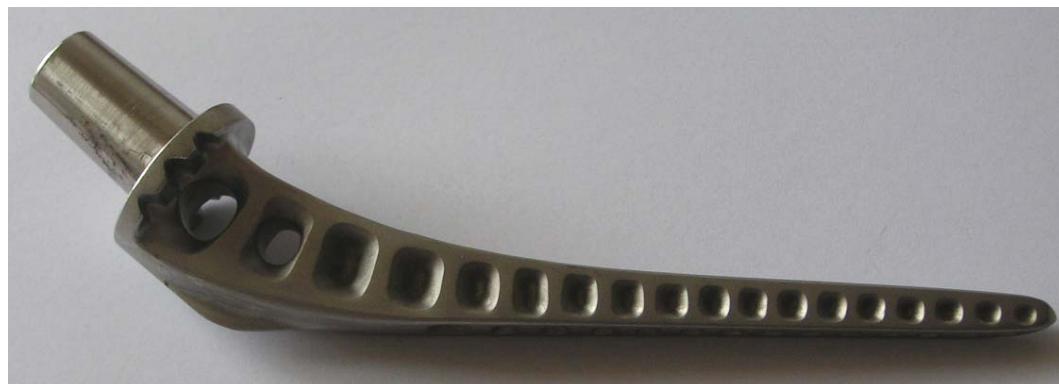
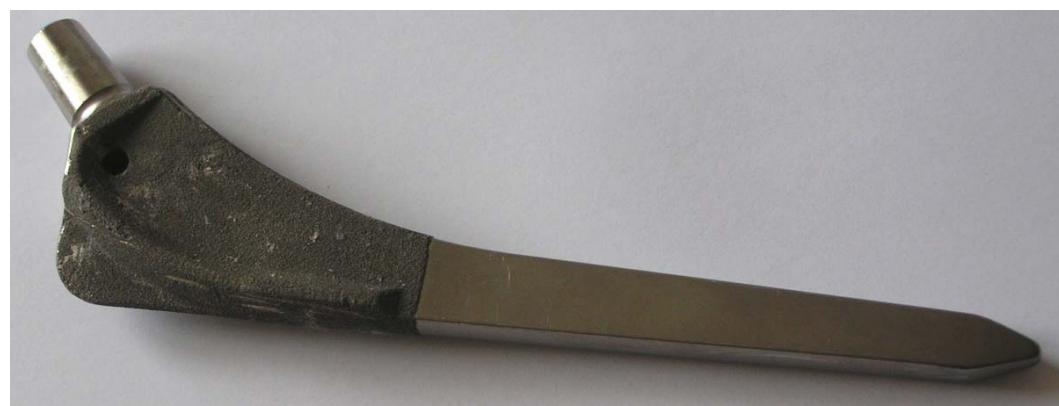
Two endoprothesis made of alloy steel - Ti6Al4V (pic.1). The chemical composition was as follows: Ti, 4,08%V, 6,39%Al, 0,17%Fe, 0,015%C, 0,185%O, 0,005%N, 0,0035%H

Pic.1. The endoprothesis made of titanium alloy (Ti-6Al-4V)

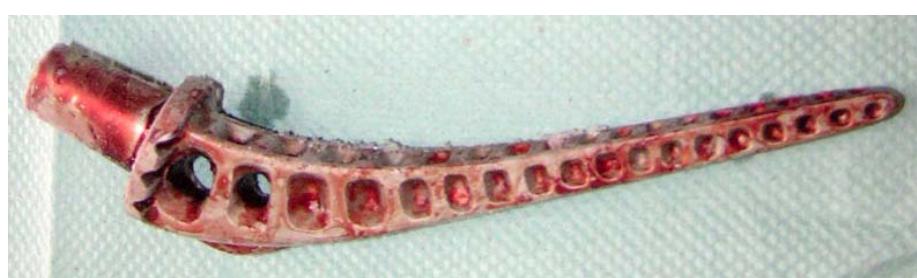
Picture 4 and 5 show degraded implants, after removed of human body.

Pic.4. The degraded implants from the first patient

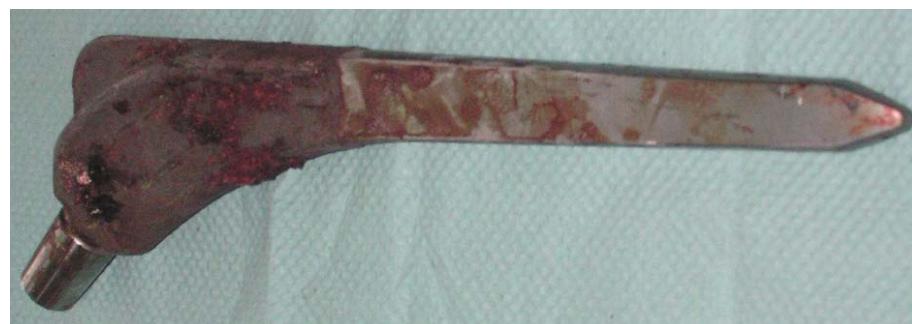
Pic.5. The degraded implants from the second patient
