The effectiveness of fault detection in common rail injectors examination methods

The article presents the effectiveness tests of fault detection in common rail injectors. 40 injectors with different wear levels were tested. Testing was made on two test benches of a completely different design. Research includes comparison of accuracy, reproducibility and testability to detect specific defects. A device was created for visualization of the fuel injector spraying steam.

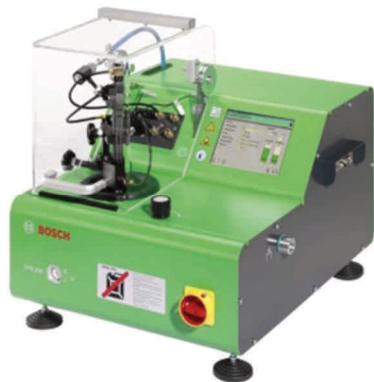
The Bosch EPS 200 (Fig. 1) is an automatic injector tester. It has a compact design but allows to test only one injector at a time. It consists of a high pressure pump Bosch CP3, which pumps the test oil to a rail. The rail is equipped with a piezoelectric pressure sensor and a pressure control valve.

Fig. 1. Bosch EPS 200

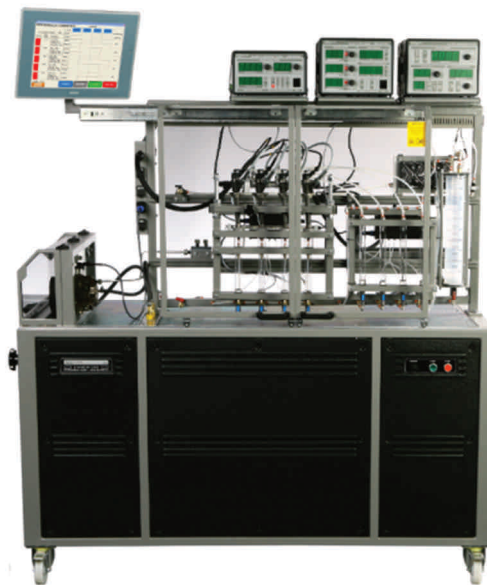
Fig. 2. STPiW 3

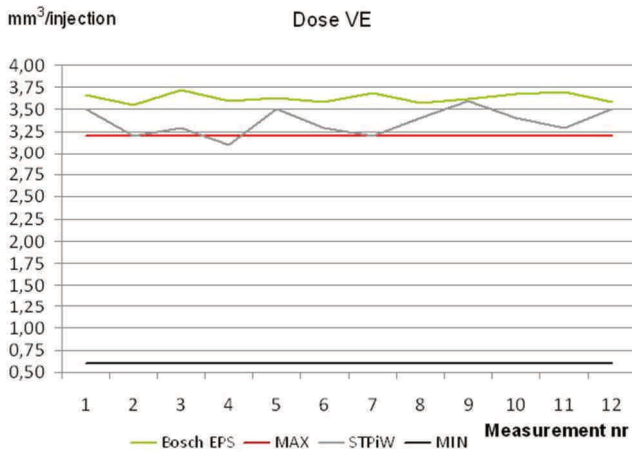
Fig. 9. VE test (actuation time 160 μ s, pressure 80 MPa)

In order to compare the accuracy and reproducibility of the measurements, a series of 12 measurements was carried out on both devices. The solenoid injector with a catalogue number 0 445 110 021 was used to carry out the tests. The following graphs (Figs 6–9) presents the results of the tests. Green lines indicate results obtained on the Bosch EPS and grey lines stand for the STPiW device. The minimum
