The influence of welding heat input on the quality and properties of high strength low-alloy dissimilar steel butt joints

Abstract: The paper presents the results of non-destructive and destructive tests of dissimilar high-strength low-alloy S460ML and S460N steel butt joints. These steels are characterized by similar mechanical properties, but their carbon equivalent C_{eqW} values are much different. The joints were made using different values of heat input for each welding bead. They were tested by non-destructive methods: visual, penetrant, radiographic and ultrasonic tests. Then, the destructive tests were made: static tensile test, bending test, impact test and Vickers HV10 hardness measurements. The results of prepared examinations showed, that welding with higher heat input has significant impact on the mechanical properties of the dissimilar steel joints – the joint welded with bigger heat input was characterized by better mechanical properties.

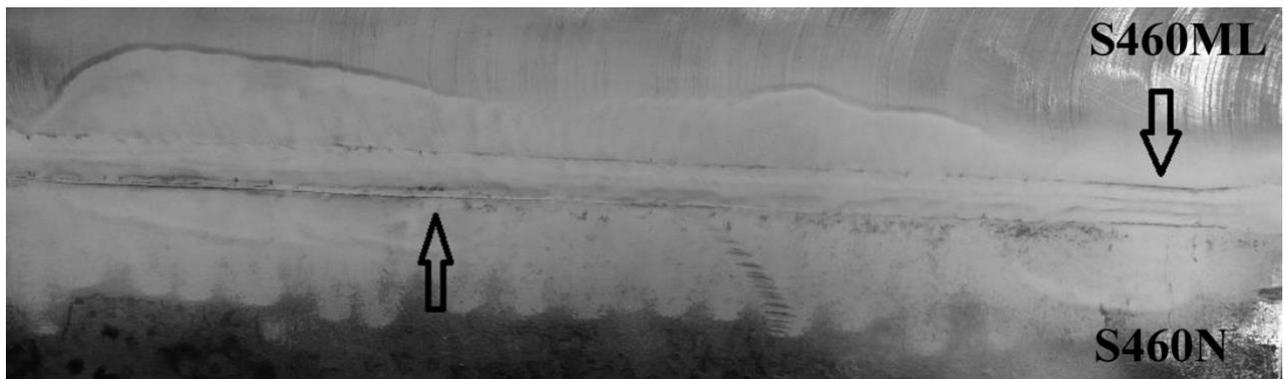
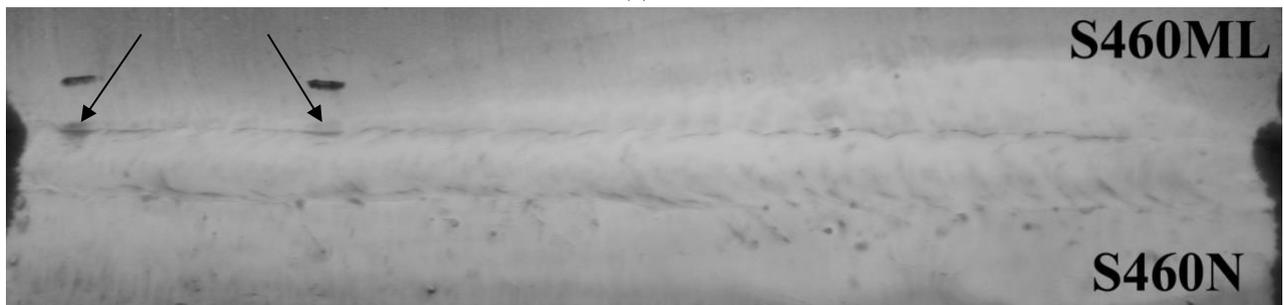
Fig. 4. Results of PT: a) Specimen 1, porosity in the middle, indication at right; b) Specimen 2, lack of fusion marked by lines

Before applying the penetrant, the surfaces were cleaned and the spatters were removed from them. A penetrant was then applied, the excess of which was removed with a cleaner after ten minutes, to then apply a developer layer. During the examination of the first sample, two indications appeared on both sides of the weld at the fusion line and a cluster of blisters at the place indicated during VT tests from the S460N steel side. Examination of a sample welded with lower heat input showed no other indications than in VT tests. The results of PT testing are presented in figure 4.
