Aleksander Piwek*, Tomasz Jażdżewski**

The room above the porte cochère of the Kwidzyn castle in the times of the Pomesanian chapter

This article presents the history of the construction of the room above the porte cochère in the northern wing of the Kwidzyn castle in the times of the Pomesanian chapter. The findings presented here were derived from the architectural and stratigraphic research and analysis of archival materials conducted in 2017. According to these findings, the room was built in the first stage of erecting the castle. In the following centuries, it underwent architectural changes corresponding to the new needs of the castle's inhabitants. The preserved traces testify that it had several successive functions from the 14th to the 16th century, so far not fully recognised and explained: a watchtower, court office or chamber, or even a chapel. Much of the knowledge about it is contained in the stratification of the walls and the reconstructions of historical transformations from the medieval period. In later times, the room was spared significant damage and still constitutes a valuable source of knowledge about the castle's history.

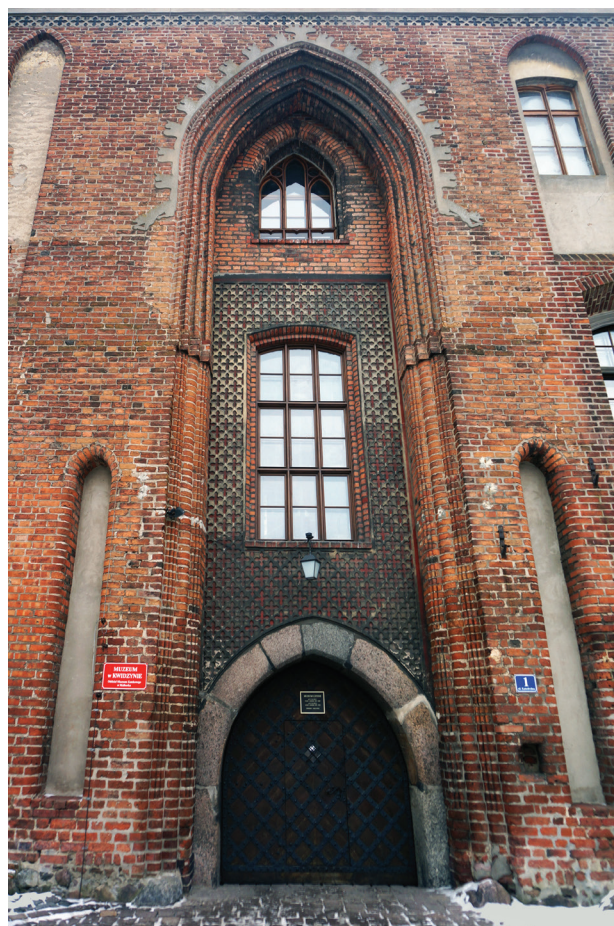
Fig. 2. View of the entrance and the rooms located above from the north (photo by A. Piwek)

one). A low porte cochère located in the northern wing led to the interior of the complex (Figs. 1, 2). Above it, there was a room whose history was connected not only with the porte cochère but also with the fate of the castle inhabitants. Their aspirations and needs significantly influenced its interior.

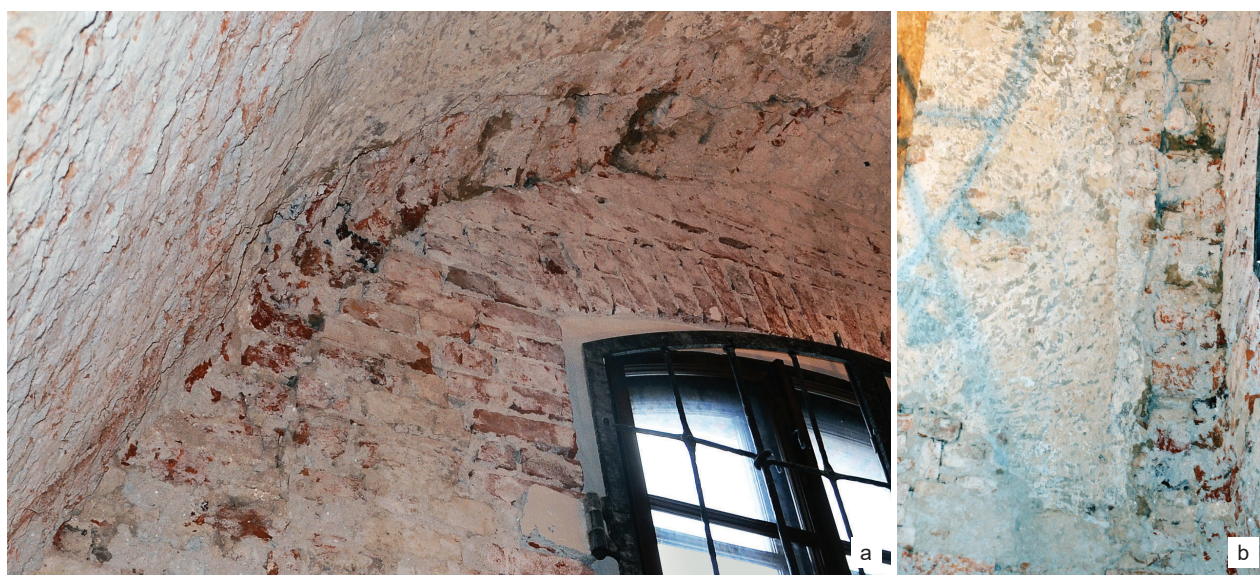
Fig. 4. Remains of the original recess in the northern wall (with a window):

- a) fragment of the arch (disappearing in the middle of the vault) at the junction with the cover of the widened recess,
 - b) part of the medieval widened recess arch with traces of the narrowing of the northern wall (strip of bricks by the window wall)
- (photo by A. Piwek)

etrating (in the middle of the recess) its lintel (Fig. 4a). The ogival arch of the recess has a strip of chipped bricks, approx. 15 cm wide, separated by a joint at the window wall (Fig. 4b).

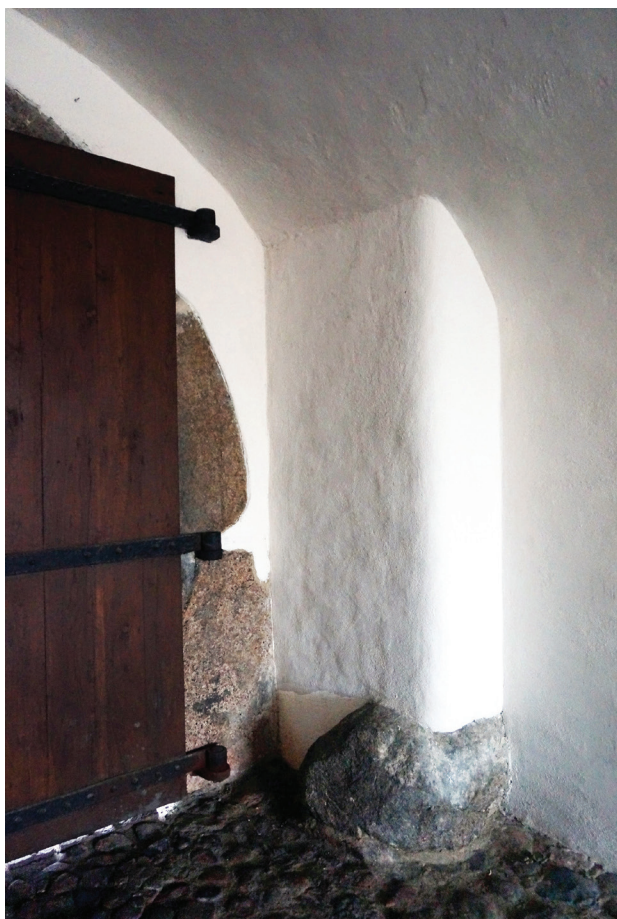
Fig. 7. The eastern fragment of the medieval entrance to the Kwidzyn castle with a late-Gothic extension (pilaster) and a modern segmental vault (photo by A. Piwek)

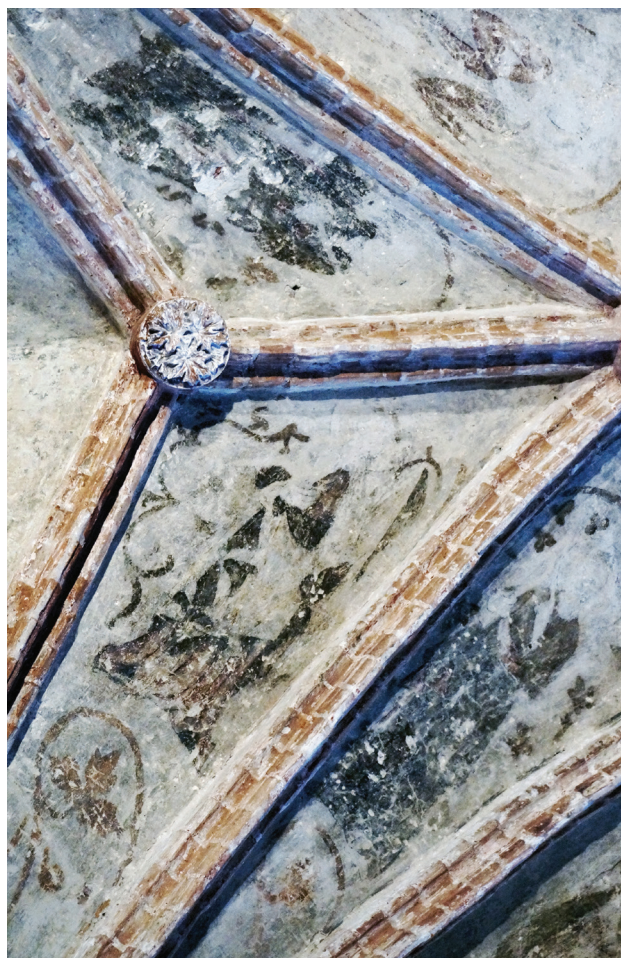
Fig. 9. Part of the northern bay vault with traces of exposed polychrome (2nd quarter of the 15th century?) (photo by A. Piwek)

The completely uncovered polychromes (Fig. 9) indicate the sacral function of the room and the time of its creation. It is assumed that they were made between 1400 and 1450 [10, pp. 8, 9], although this is not the only possibility¹³. Their sacral content (figures of saints) corresponds with the new use of the hall. Their appearance only on the vaulting of the northern bay has not been explained yet. The suggested reason is the start of the war in 1409 [9, p. 8] and its consequences. There is also another explanation. When a wooden partition is placed in the middle of the interior, it separates parts intended for users of different status – the clergy and the castle servants.
