Aleksander Piwek*, Tomasz Jażdżewski**

The room above the porte cochère of the Kwidzyn castle in the times of the Pomesanian chapter

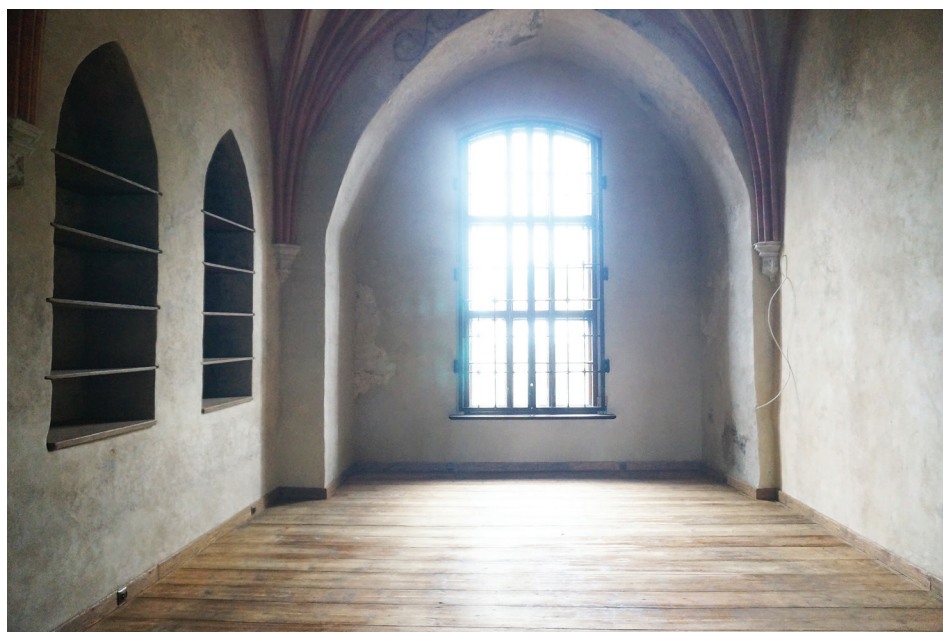
Fig. 10. Northward view of the interior of the room above the porte cochère at the end of conservation work (September 2017) (photo by A. Piwek)
