Travelling Architecture: Vanishing heritage of Gypsy caravans in Poland

Lucyna Nyka, & Jakub Szczepański
Gdańsk University of Technology,
Faculty of Architecture,
Poland.

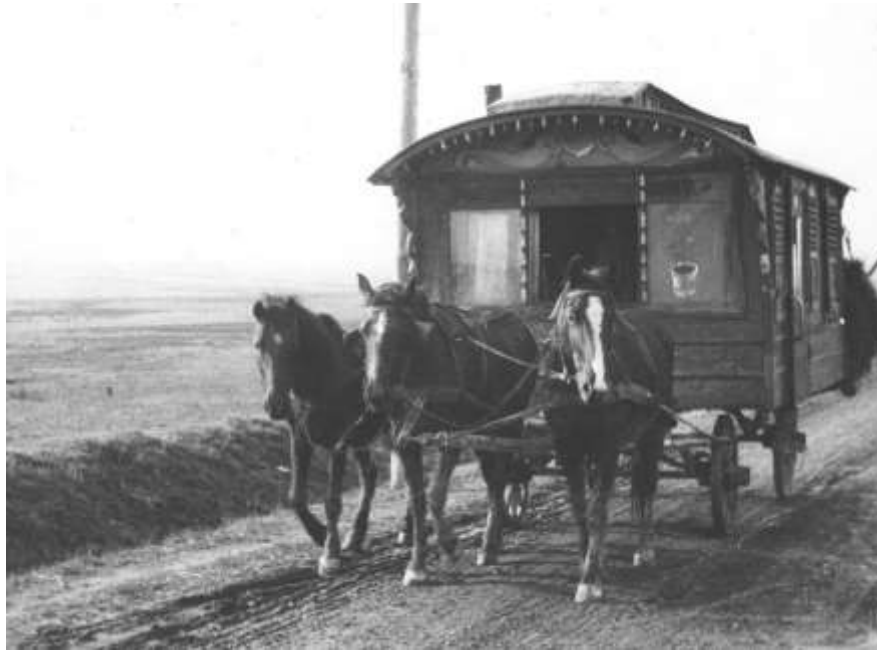
Fig. 1: Gypsy wagon dated about 1930

photographs were imported to the AutoCAD programme, which allowed the authors to build 3D models and establish the approximate dimensions and proportions of the photographed wagons and their details. Results confirmed that this method of digital restitution is reliable since the received dimensions were the same as the dimensions of the existing measured wagons; the differences were less than 5%. This allowed for preparing a hypothetical reconstruction drawing for one exemplary non-existent wagon illustrated in the archive photograph from the first decades of the twentieth century (Fig. 1).
