Types of wear and tear of biomaterials used in orthopaedic surgery

ABSTRACT

Purpose: Purpose of this paper is presentation of observations on different kinds of wear and tear of biomaterials used in contemporary orthopaedic surgery.

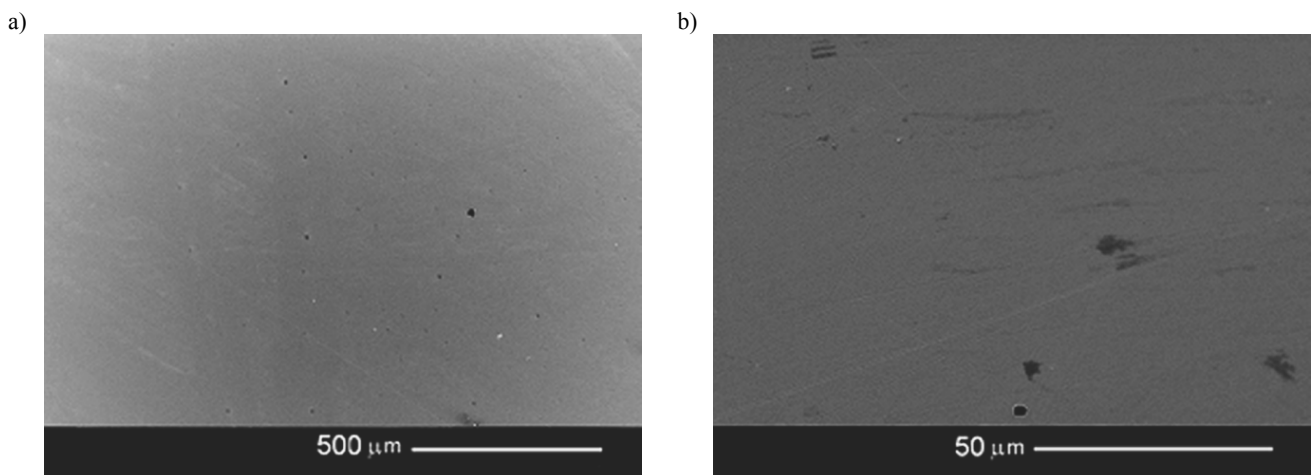
Fig. 1. The surface of a new socket - images at different magnifications

As the photographs show, the nature of wear of an implant sockets is highly varied. Compared to new sockets, whose surface is very smooth (Figs. 1 a, b), the surface of used sockets is in much worse condition. The most common type of wear observed in the sockets under examination was damage caused by biological corrosion (Figs. 2 a, b). This indicates insufficient resistance to that type of corrosion of the materials used for the implants. Despite using hard PE to make prostheses sockets, sometimes the material is seen to flow (Figs. 3 a, b).

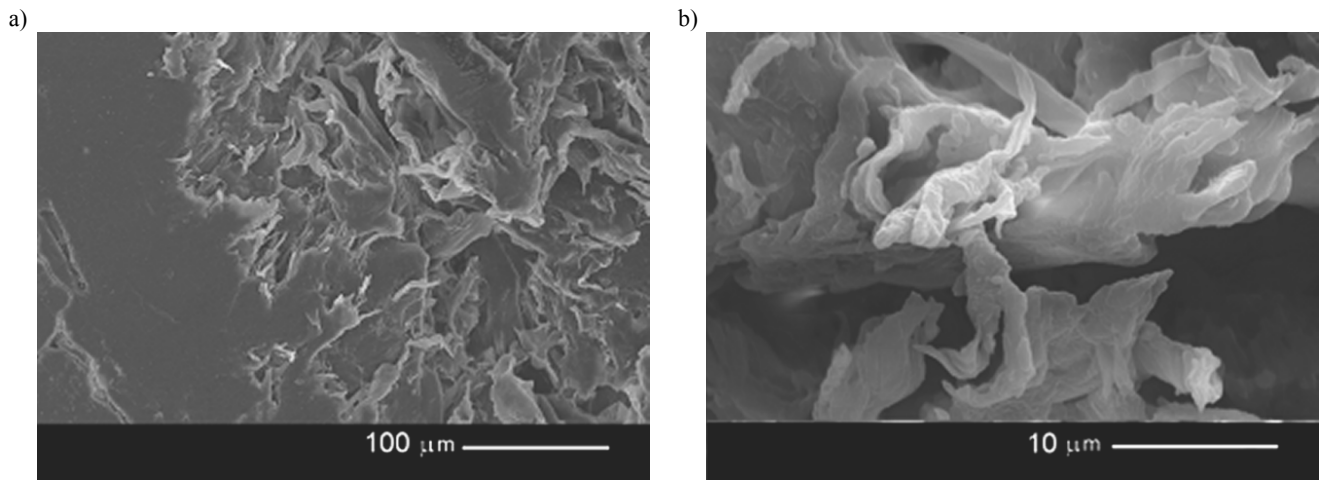
Fig. 2. The surface of a socket damaged as a result of biological corrosion

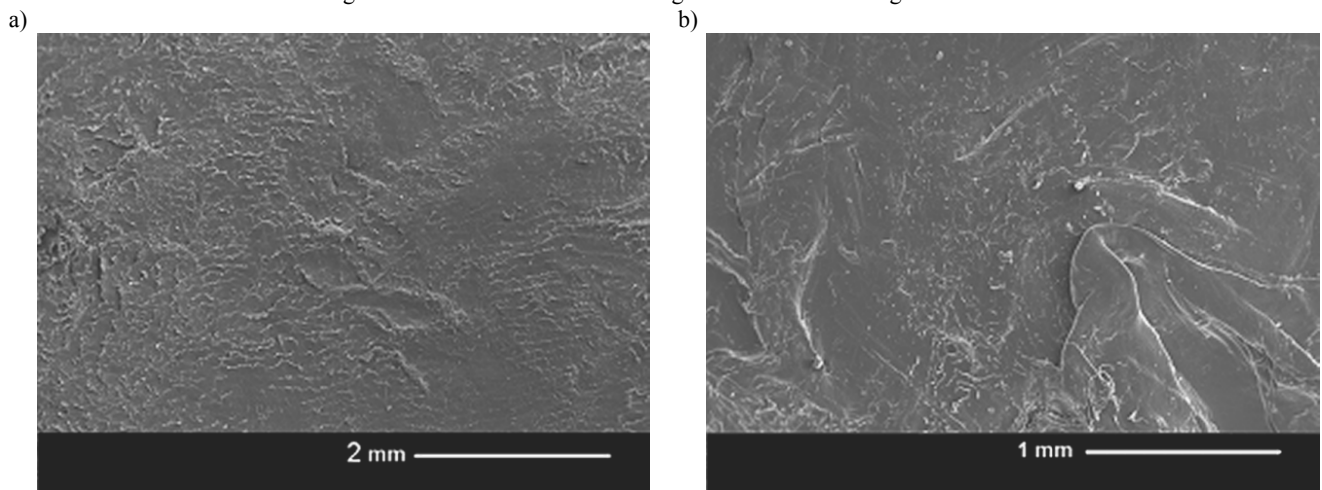
Fig. 3. Plastic flow of the socket material

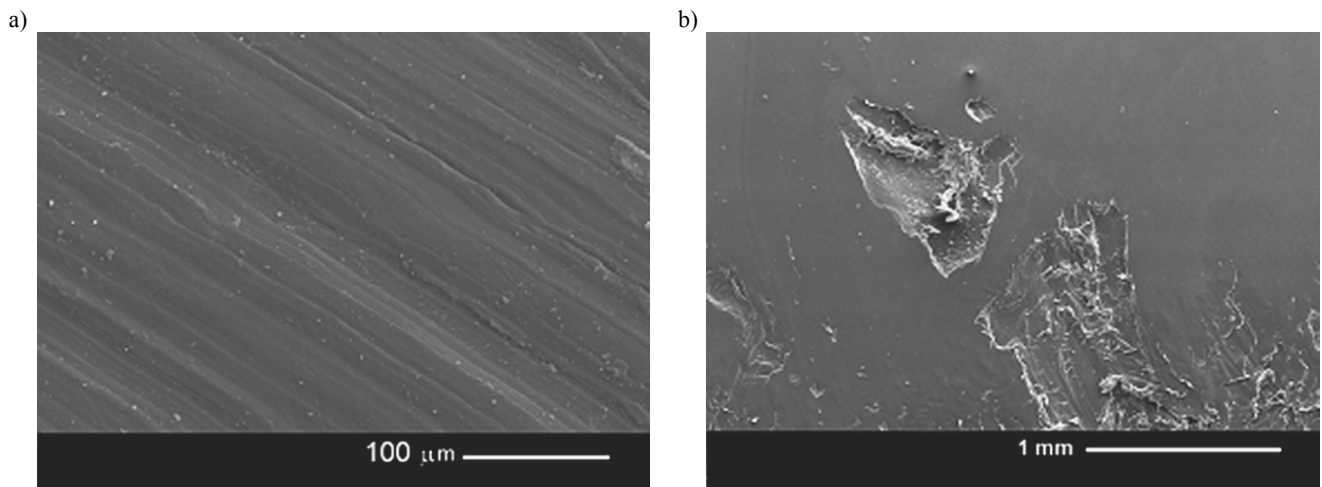
Fig. 4. Examples of different types of wear of hip joint prostheses sockets: a) abrasive wear, b) chipping the sockets material

Some socket surface has been seen to crack (Fig. 5a). However, abrasive wear has been the most common type of damage to their surface (Figs. 4 a, b). This may have been caused by elements of the socket material which have chipped off during the joint use (Fig. 4) or foreign bodies (Fig. 5 b) which entered the "prosthesis socket - head" contact zone. This has been confirmed by authors of other publications [2,35], whose studies have shown that parts of prostheses made of hard metals, which are in contact with polyethylene, do not show signs of significant wear even after more than ten years of use. Only hard products of wear, e.g. chips of bone cement, which enter the friction zone, can scratch the smooth surface of the metal element.

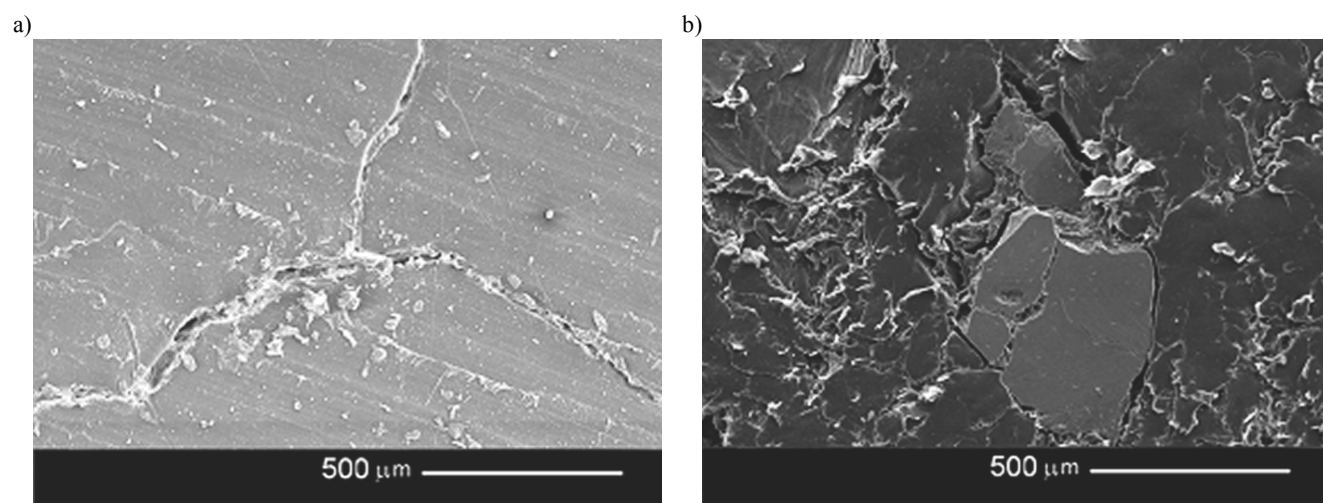
Fig. 5. Examples of different types of wear of hip joint prosthesis sockets (continued): a) socket cracking, b) denting by foreign material

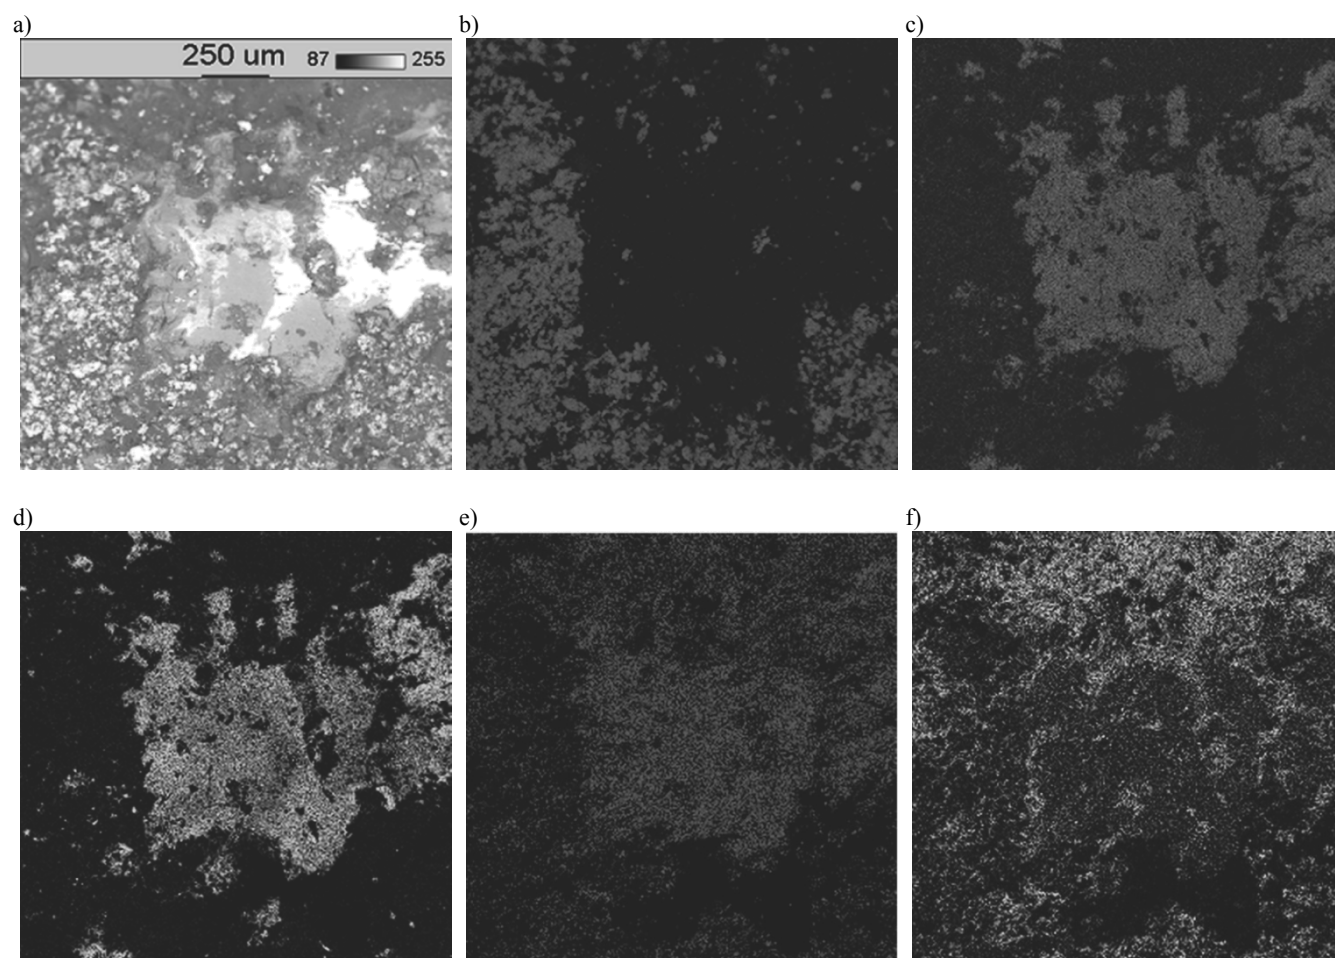
Fig. 6. Intrusions in titanium socket: a) image of the intrusion, b), c), d), e), f) distributions of titanium, phosphorus, calcium, oxygen and carbon

Some elements have been observed on the sockets surface which may have come from the patient's body. As is seen on the maps of surface element distribution, the intrusion shown in Fig. 6 contains mainly calcium, phosphorus and oxygen. Those elements are found in hydroxyapatites, which are the main components of bones. This allows one to conclude that the element entered between the head and the socket during the prosthesis implanting procedure.

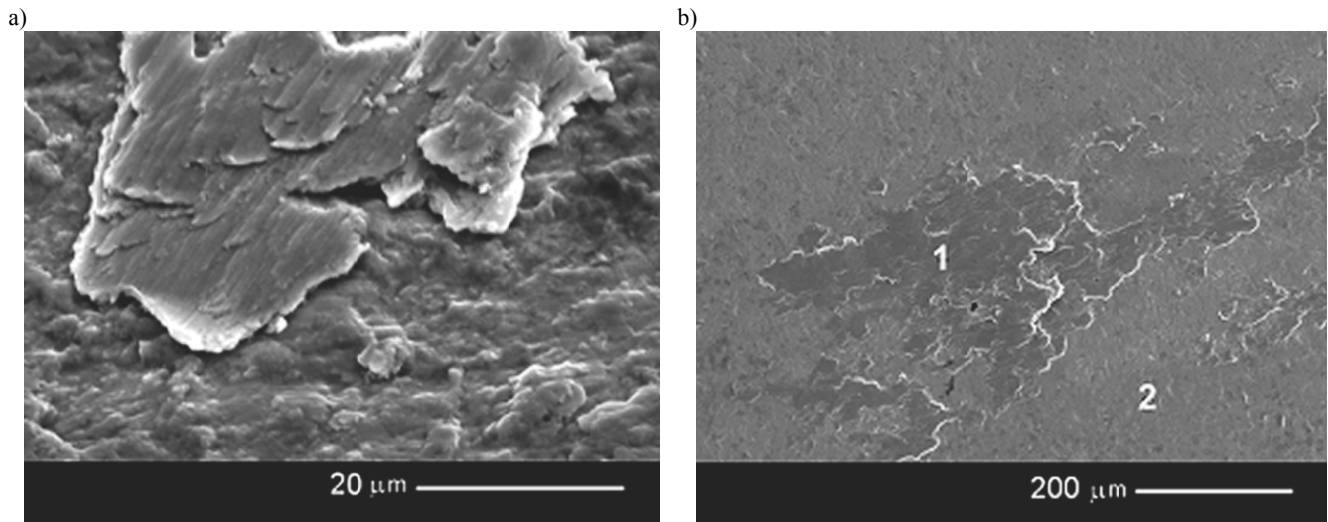
Despite being made of harder materials (metal alloys, ceramic materials), heads of hip joint wear out more quickly than sockets. Intrusions of foreign material are also observed on their surface, as shown in Fig. 7 and Fig. 8. Due to stochastic aspects related to formation, migration and characteristics of those hard foreign bodies, it is difficult to anticipate the disadvantageous positions of the head, as is the moment at which a disadvantageous change in roughness occurs. Therefore, it needs to be stated clearly that the knowledge of the mechanism of scratching the head of the femoral bone is not complete.

Fig. 7. Foreign material on the surface of hip joint prostheses heads a, b) different size of intrusions

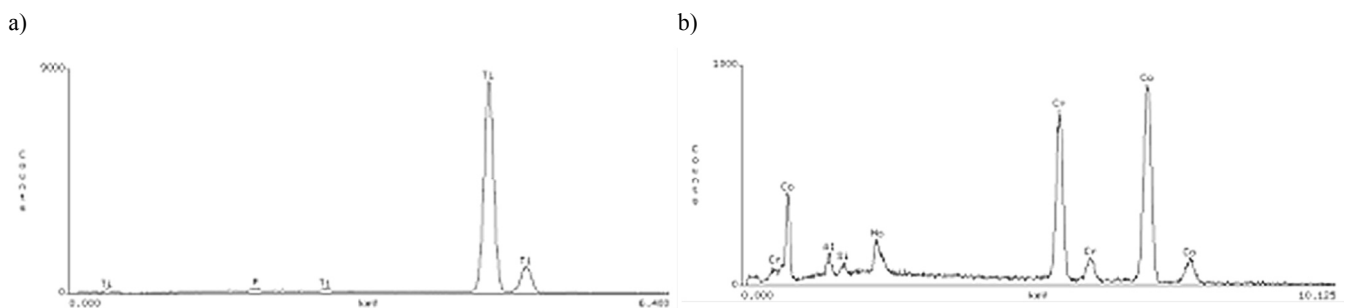
Fig. 8. Foreign material on the surface of hip joint prostheses heads from Fig. 7: a) EDS spectrogram from point 1, b) EDS spectrogram from point 2

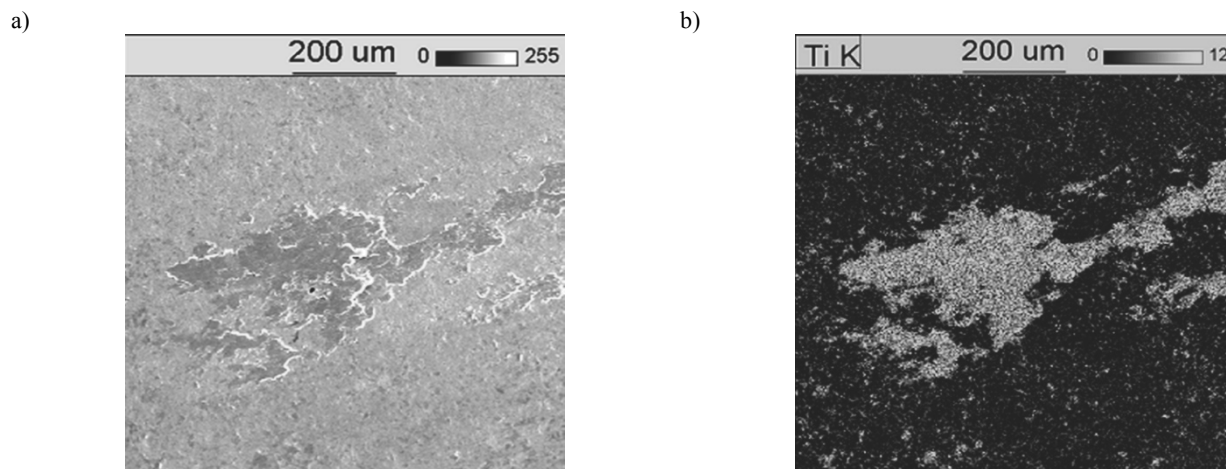
An analysis of the chemical composition has shown that certain titanium elements appeared on the prosthesis head, made of Co-Cr-Mo alloy (Vitalium). As the map of titanium distribution (Fig. 9) shows, its presence exactly coincides with the eruption. Titanium is not as hard as the Vitalium alloy, so those are not particles stuck into the surface; rather they are spread on the surface. Therefore, its presence here has different reasons. As the socket casing was made of titanium, the eruption on the surface may originate from it. This indicates that apart from typical wear processes by friction, a process of dissolving titanium by body fluids and transporting it to other places takes place.

Fig. 9. Foreign material on the surface of the head of a hip joint prosthesis: a) image of the intrusion, b) surface distribution of titanium.

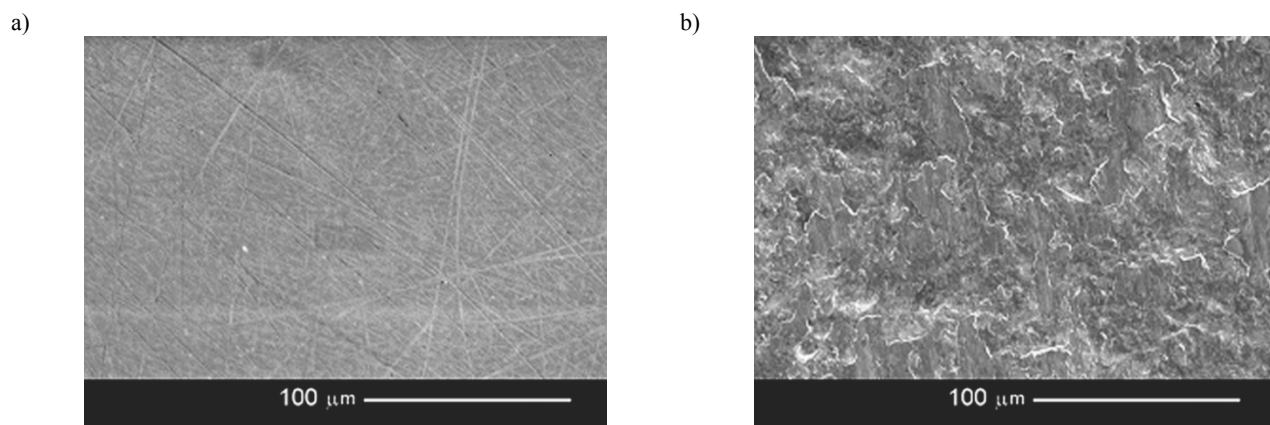
Apart from intrusions, there are also other types of wear observed on the surface of a prosthesis head. The surface of a non-worn head, shown in Fig. 10, is relatively smooth and there are only scratches on it caused by mechanical processing. A worn prosthesis head looks completely different (Fig. 10b). This is typical wear observed in cutting elements. Material defects and traces of its plastic flow are visible.

Fig. 10. Examples of different types of wear of heads of hip joint prostheses: a) non-worn surface, b) surface worn by friction
