Excavation induced cast iron pipeline failure – a numerical study

Dr inż. Krzysztof Szarf, dr inż. Rafał Ossowski

Gdańsk University of Technology, Faculty of Civil and Environmental Engineering

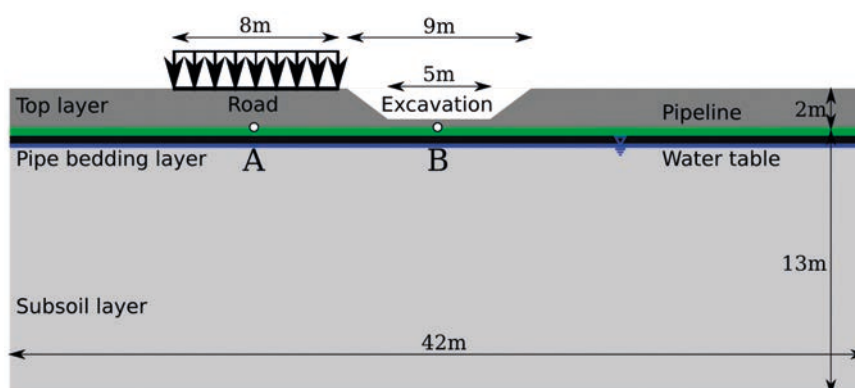
Figure 1. 2D geometry of the problem. Two points of interest, below the centerline of the road and the excavation centerline, were denoted A and B. The largest soil deformations occurred around these points

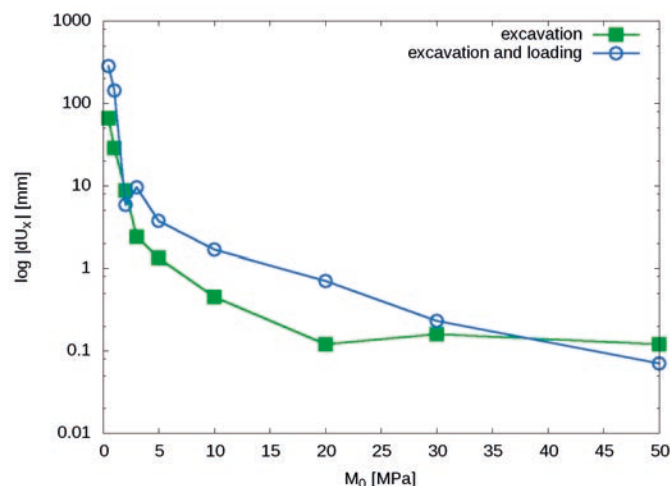
Figure 2. Upper-bound case (pipe with no stiffness) horizontal differential displacements $| U_x^A - U_x^B |$ plotted against subsoil oedometric modulus

These simulations lead to a conclusion that the soils with oedometric modulus $M_0 \leq 5$ MPa could cause differential settlements greater than 100 mm. Such values of displacements acting on rigid pipe elements could damage bell and spigot pipe joints. Therefore the second group of simulations was focused on these types of soils.

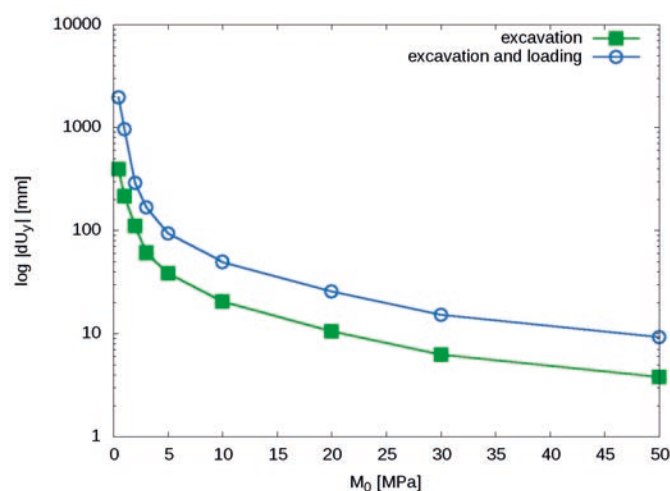
Figure 3. Upper-bound case (pipe with no stiffness) vertical differential displacements $| U_y^A - U_y^B |$ plotted against subsoil oedometric modulus

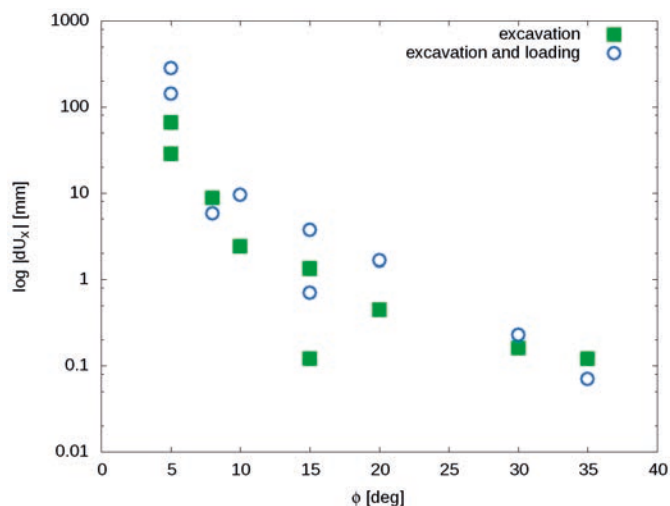
As expected, the analysis indicated the oedometric modulus M_0 is the most important parameter for soil settlements. Moreover, its value is correlated to values of the other mechanical parameters. As an example, in Figure 4 and Figure 5 the differential displacements are plotted as a function of the internal friction angle and show a similar trend (it is clear however that lower values of friction angle are correlated to lower oedometric modulus, which determines soil deformations).

Figure 4. Upper-bound case (pipe with no stiffness) horizontal differential displacements $| U_x^A - U_x^B |$ plotted against subsoil internal friction angle

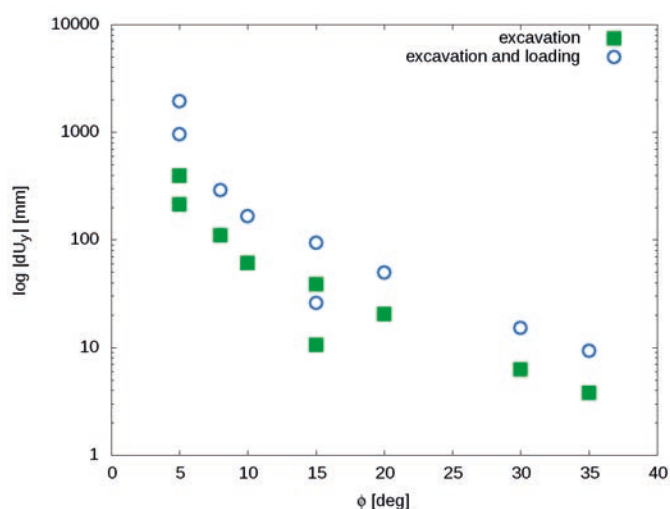
Figure 5. Upper-bound case (pipe with no stiffness) vertical differential displacements $| U_y^A - U_y^B |$ plotted against subsoil internal friction angle

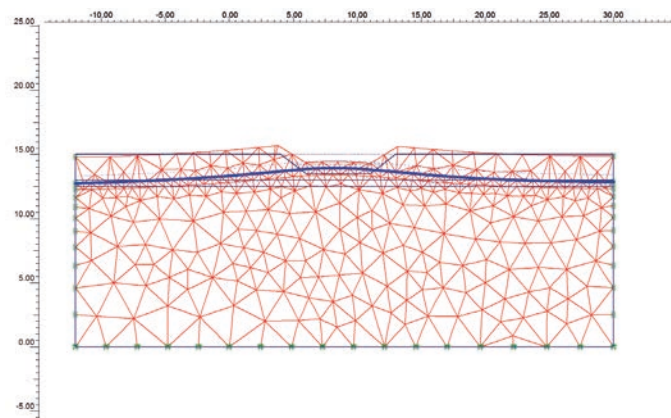
Figure 6. Deformed mesh after excavation (scaled up 10 times)

tion, but without traffic loading. Figure 6 depicts a deformed mesh with indicated uplift caused by unloading the trench. Figure 7 and Figure 8 show detailed displacement fields divided into horizontal and vertical components.

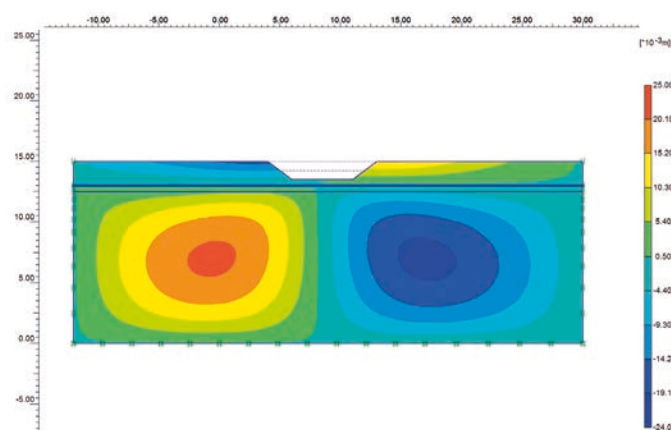
Figure 7. Horizontal soil displacements map (excavation unloading)

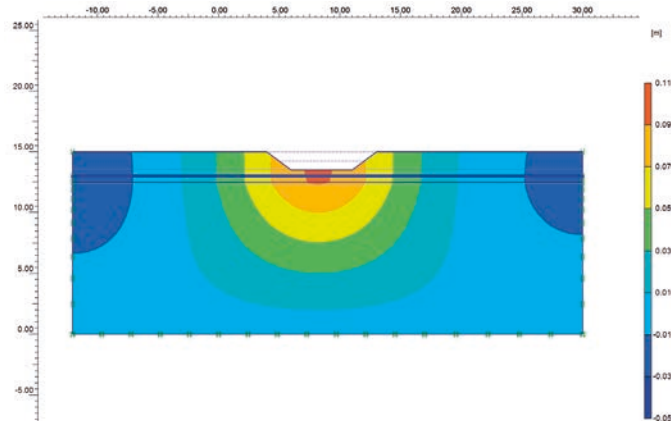
Figure 8. Vertical soil displacements map (excavation unloading)
Subsoil type: Or – Compacted mud ($M_0 = 2$ MPa).

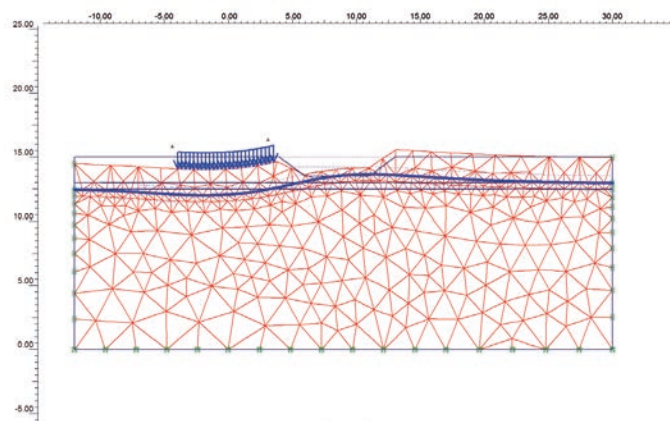
The second failure phase – after applying the loading acting on the road, are presented in Figures 9 ÷ 11. Figure 9 presents a deformed mesh with clearly visible pipe deformation as a result of traffic load. Figure 10 and Figure 11 show detailed displacement fields divided into horizontal and vertical components.

Figure 9. Deformed mesh after traffic loading (scaled up 10 times)

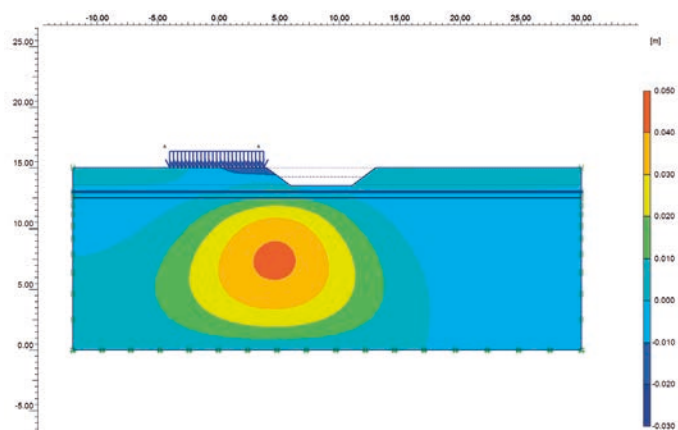
As stated previously, there is a difference in the direction of vertical displacements below the road and below the excavation, see Figure 11. Soil settlements exceed 90 mm below the road centreline, are close to 0 mm at the edge of the excavation near to the road and finally reach 60 mm of uplift on the other side of the excavation. Such differences occurring around points placed less than 15 m from each other could lead either to stress increase in the pipe joint material and possibly fracturing of the bell, or to disjoining of the pipe elements through rotation. Conversely, in Figure 10 we observe smaller horizontal displacements of the soil, in the range of 10 mm. Horizontal soil

displacements around the pipe theoretically could lead to pipe joint failure by disjoining of the pipe elements, even though soil displacements are not identical with pipe displacements. Nevertheless, that kind of failure was reported in Gdańsk in 2013 [7].

Figure 10. Horizontal soil displacements map (after traffic loading)

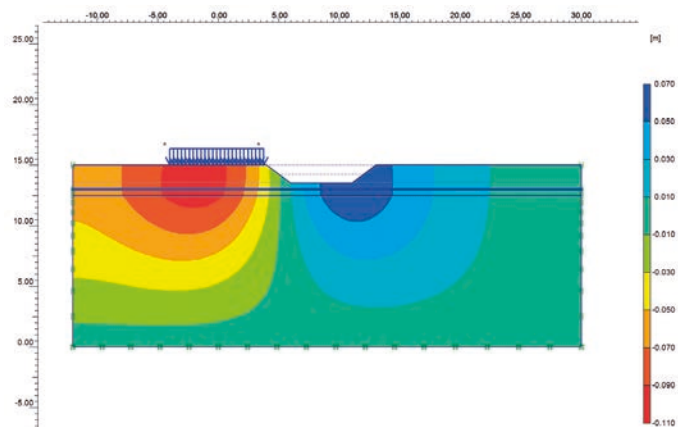
Figure 11: Vertical soil displacements map (after traffic loading)
Subsoil type: Or – Compacted mud ($M_0 = 2$ MPa)
