PROTECTION OF BRIDGES AGAINST STRAY CURRENT CORROSION

Abstract. A case study of Siennicki Bridge stray current corrosion hazard is presented. A corrosion risk was caused by incorrectly designed tram line traction which goes over the bridge. No dielectric insulation between running rails and bridge steel construction was used. A variety of protection methods against stray currents are described. Characteristics of the endangered bridge were described. Impressed current cathodic protection system against stray currents was proposed and designed at the Department of Electrochemistry, Corrosion and Materials Engineering, Gdansk University of Technology. Coupon technique measurements and potential measurements were performed to verify the effectiveness of the protection system.

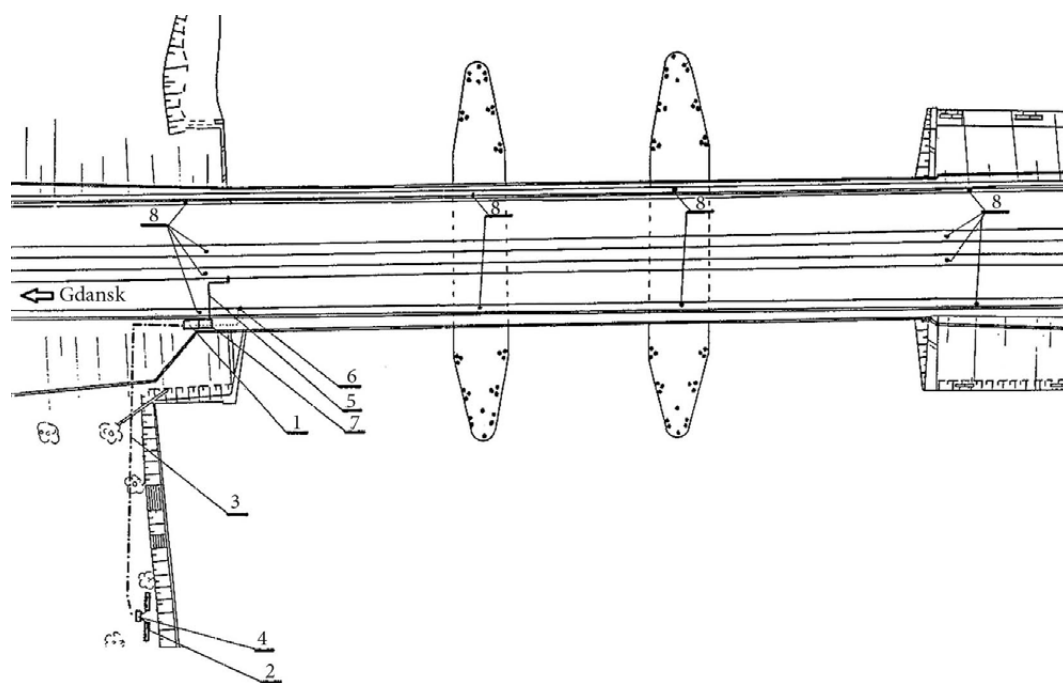
was found that a satisfying stray current protection was reached with one CP station. Anodes were placed at the riverside. The protection current demand was approx 20 A. Cathodic protection system circuit consisted of: cathodic protection station, electrical power supply line, multi-anode groundbed, anode cap and cable, cathode cap and cable. Test and verification circuit consisted of: permanent zinc reference electrodes, pilot $Cu/CuSO_4$ electrode, potential cap and cable, remote control system, anode test station. A simplified scheme of the protection system and its elements placement is shown in Fig. 2. Orientation of the bridge in Figs 1–2 are complaint.

Fig. 2. Simplified scheme of Siennicki Bridge: 1 – cathodic protection station; 2 – multi-anode groundbed; 3 – anode cable; 4 – anode test station; 5 – cathode cable; 6 – potential cap; 7 – remote control system; 8 – permanent zinc reference electrodes

The cathodic protection installation was placed on the left side of the bridge (from Fig. 1 point of view). Parameters of the cathodic protection station were as follows: adjustable current intensity up to 30 A at the maximum output voltage of 40 V. The cathodic protection system was supplied from the bridge electric lighting system. The groundbed was designed as a group of four anodes ϕ50×2000 mm made of high silicon cast iron. Anodes were buried and placed in a graphite-coke backfill in order to lower the current spread resistance. The groundbed was localized approx 50 m away from the bridge. The anode spread resistance equalled 2.15 Ω. Cable YKOXs 1×16 mm² (shipboard power cable with cross-linked polyethylene insulation and PVC sheath) connecting CP station to anodes was buried in soil. The cathode cap was made by connecting the cable (YKOXs 1×16 mm²) from CP station to the steel span of the bridge. Pilot electrode – saturated $Cu/CuSO_4$ electrode of a cylindrical shape (110 mm×250 mm) was connected to the CP station with a buried cable (YKOXs 1×4 mm²).

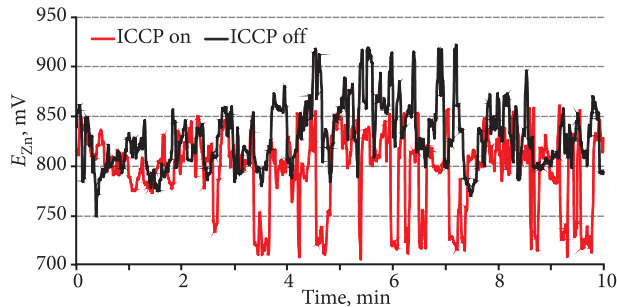
Exemplary registers fragment of bridge potential E_{zn} measured against one of the zinc reference electrodes,

which was placed near the left bridgehead, is presented in Fig. 3. There are plots where protection current is turned on and off. Quick potential shifts are typical for the interaction of dynamic stray currents which originate from the tram traction (Zakowski, Darowicki 2003). When the cathodic protection current was switched on the bridge average daily potential was lowered by about 80 mV. This fact indirectly indicates that the corrosion rate of bridge metal elements was hindered.

**Fig. 3.** An example of bridge potential changes

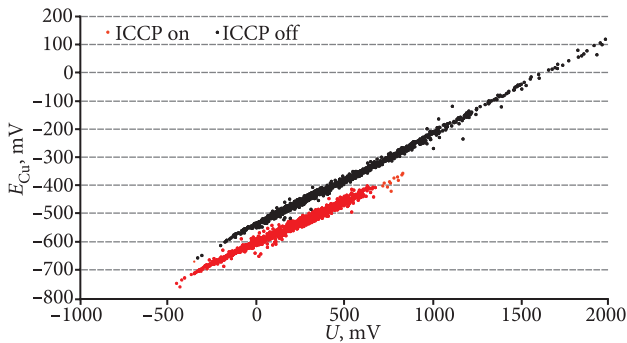
Fig. 4. Potential–voltage correlation spectra measured at the left bridgehead

Furthermore, a correlation plot has been plotted for a relationship between the stray current electric field vector in soil and the bridge potential (Fig. 4). The electric field vector U was measured between two zinc electrodes, the bridge potential E_{Cu} was measured against a portable saturated copper reference electrode. The upper spectra in Fig. 4 corresponds to the ICCP turned off, the lower spectra to the ICCP turned on. The protection effect is visible as the downward shift of the spectra.

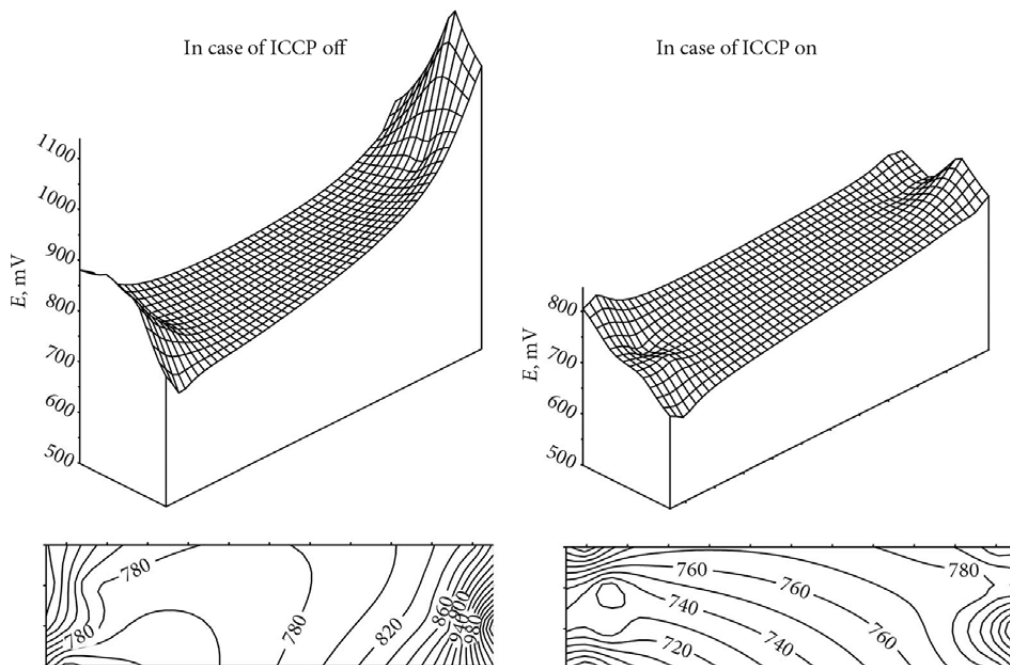
The left diagram in the Fig. 5 indicates that without the cathodic protection the bridge potential was higher at the right bridgehead. It implies that the anodic polarization of the structure was greater there. This phenomenon was caused by greater stray current density outflow from

Fig. 5. Potential distributions of the bridge

the bridge metal parts to the environment. Thus the stray current corrosion hazard was graver at the region of the right bridgehead. Such a potential distribution was caused by the tram substation location. It was located few kilometres away to the right from the bridge. Stray currents flowing out from the bridge tend to flow in the substation direction. When the cathodic protection station was turned on the steepness of the potential distribution surface lowered and the average potential value was also lowered.

Thus, the effect of the ICCP system was the lower value of the bridge potential. The left and the right bridgehead potential were lowered by approx 80 mV and 200 mV, respectively. The protection effect was satisfying. Almost the whole bridge construction met the 100 mV polarization criterion requirement which is given in the European standards *EN-12696:2000 Cathodic Protection of Steel in Concrete* and *EN-14505:2005 Cathodic Protection of Complex Structures*. The magnitude of the potential shift indicates that the cathodic current of greater intensity flew through the right bridgehead. It also indirectly indicates that the spread resistance at the right bridgehead is lower compared to the left bridgehead.
