Assessment of Wooden Beams from Historical Buildings Using Ultrasonic Transmission Tomography

The main goal of this study was non-destructive evaluation of wooden elements using ultrasonic waves. The inspection was carried out on wooden beams from a historical object. Elastic wave signals were processed by ultrasonic transmission tomography to obtain imaging of the internal structure of tested elements without disturbing their state and integrity. The focus was on the influence of wood anisotropy on the propagation of ultrasonic waves. A novel method of determining the position of the cross-section pith was proposed. The study presented that the proposed imaging approach was capable to assess the technical condition of historic wooden beams by determining the degree of wood damage and the location of discontinuities, scratches or fibrosis in the tested cross-section.

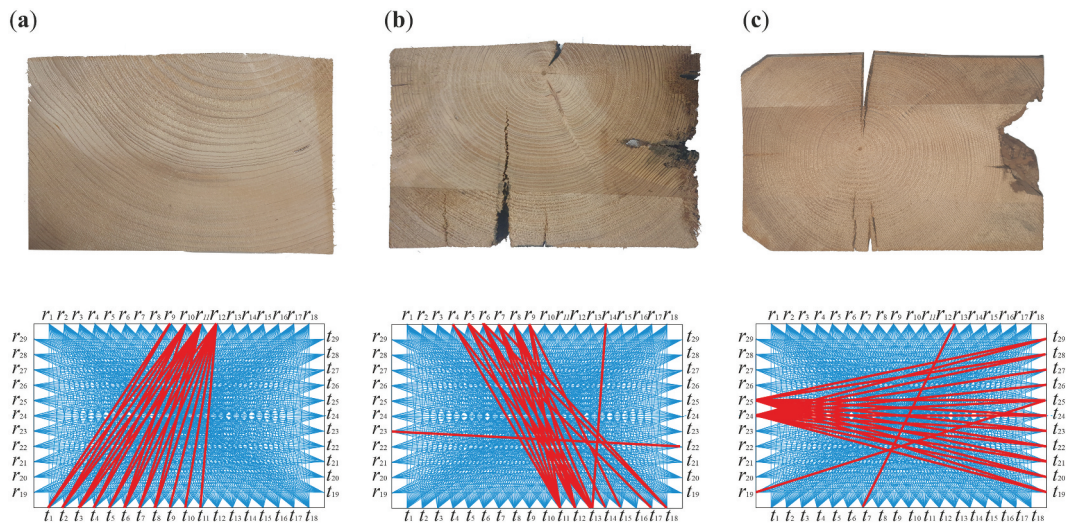
Figure 11. Rays of performed measurements with the 5% fastest waves marked in red.

maps. In general, the wood pith may be within or outside the cross-sectional area for which the measurements are made. In the proposed approach, it was based on 5% of the fastest paths among the collected measurement data. These paths, marked in red in Figure 11, were selected in order to determine the location of the pith for each of the beams. If the fastest paths appear between a pair of opposite edges, it is an indication that the pith lies outside the examined area.
