# Causes of damage and methods of repairing floor made on polystyrene concrete

**Abstract.** The paper describes damages, tests and repair of the floor made on existing ceiling and expanded polystyrene concrete underlay. The floor was built on a reinforced concrete ceiling with an area of about 1050 m<sup>2</sup>. Significant damage in the form of cracks, detachments and unevenness was found in the floor. In order to determine the causes of damage, in situ tests and laboratory tests were carried out. It was found that the damage was caused by numerous performance errors. A test repair of the damage (4.7x6.0 m) was carried out, and then the repair method was applied on the entire floor surface.

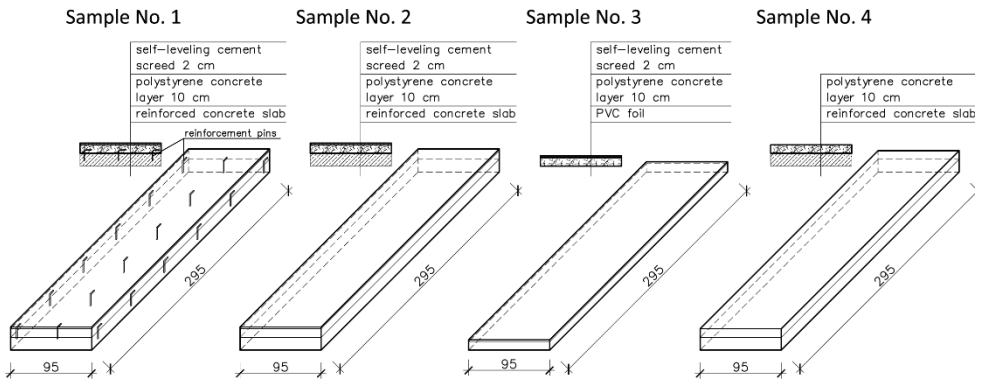
In order to determine the possible interaction between individual layers of the floor, four test specimen were prepared. Three of them were made on a 95x295 cm reinforced concrete slab, the last one on a PVC foil (Fig. 7). The first sample was reinforced with steel 12 mm pins, with 10 cm of a 30/50 EPSC overlay and 2 cm of self-leveling screed. The model reflected the existing floor. Sample no. 2, was identical to the first one with exclusion of reinforcement pins which were not installed. The model, in comparison to the first one, was used to determine the effect of the pins. In sample no. 3, a 30/50 EPSC was cast on a PVC foil and finished with a 2 cm layer of self-levelling screed. The model was used to determine the possible influence of slip membrane laid under the EPSC. The last sample, a 10 cm layer of 30/50 EPSC cast over a reinforced concrete slab. was made in order to determine the possible shrinkage. The specimen was left uncured and uncovered, untypically to standard practices. The samples are shown in Fig. 8 and Fig. 9.

**Fig. 7.** Comparative test samples.

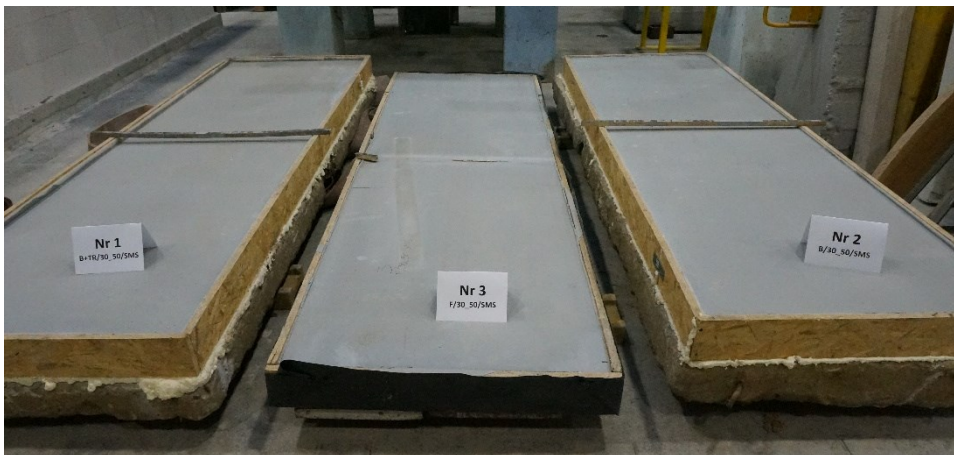
**Fig. 8.** Samples no. 1, 2 and 3.

The visual evaluation of the samples was being conducted for over 2 months. The observations lasted over 2,5 times longer than the time in which the cracks occurred in analyzed floor. After 49 days first three samples did not exhibit any signs of cracking. The last sample exhibited small shrinkage cracks. Local width of the crack reached between  $0.1 \div 0.5$  mm. The cracks on the surface of the EPSC occurred after two weeks due to lack of curing. The cracks are shown in Fig. 10.
