# Causes of damage and methods of repairing floor made on polystyrene concrete

**Abstract.** The paper describes damages, tests and repair of the floor made on existing ceiling and expanded polystyrene concrete underlay. The floor was built on a reinforced concrete ceiling with an area of about 1050 m<sup>2</sup>. Significant damage in the form of cracks, detachments and unevenness was found in the floor. In order to determine the causes of damage, in situ tests and laboratory tests were carried out. It was found that the damage was caused by numerous performance errors. A test repair of the damage (4.7x6.0 m) was carried out, and then the repair method was applied on the entire floor surface.

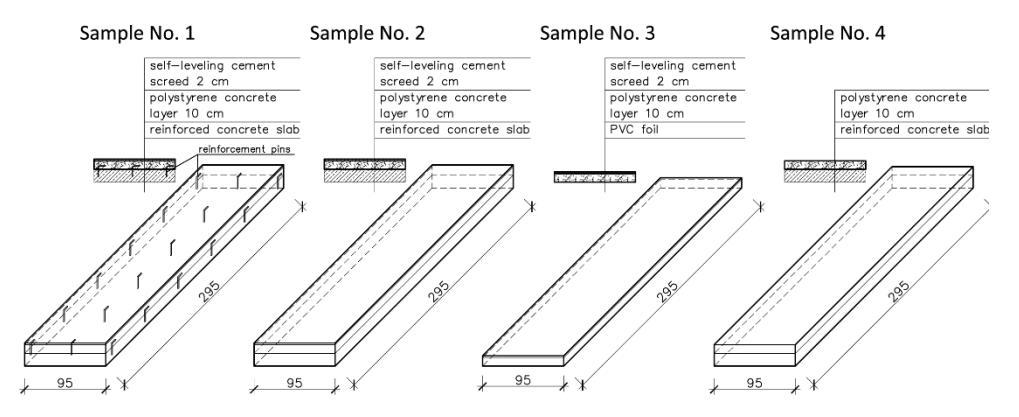
Fig. 7. Comparative test samples.

In order to determine the possible interaction between individual layers of the floor, four test specimen were prepared. Three of them were made on a 95x295 cm reinforced concrete slab, the last one on a PVC foil (Fig. 7). The first sample was reinforced with steel 12 mm pins, with 10 cm of a 30/50 EPSC overlay and 2 cm of self-leveling screed. The model reflected the existing floor. Sample no. 2, was identical to the first one with exclusion of reinforcement pins which were not installed. The model, in comparison to the first one, was used to determine the effect of the pins. In sample no. 3, a 30/50 EPSC was cast on a PVC foil and finished with a 2 cm layer of self-levelling screed. The model was used to determine the possible influence of slip membrane laid under the EPSC. The last sample, a 10 cm layer of 30/50 EPSC cast over a reinforced concrete slab. was made in order to determine the possible shrinkage. The specimen was left uncured and uncovered, untypically to standard practices. The samples are shown in Fig. 8 and Fig. 9.

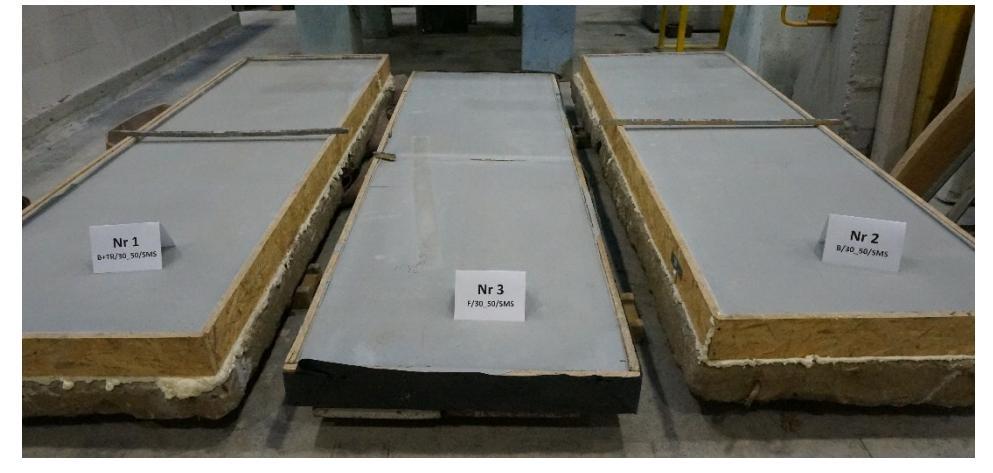
Fig. 8. Samples no. 1, 2 and 3.

The visual evaluation of the samples was being conducted for over 2 months. The observations lasted over 2,5 times longer than the time in which the cracks occurred in analyzed floor. After 49 days first three samples did not exhibit any signs of cracking. The last sample exhibited small shrinkage cracks. Local width of the crack reached between  $0.1\div0.5$  mm. The cracks on the surface of the EPSC occurred after two weeks due to lack of curing. The cracks are shown in Fig. 10.

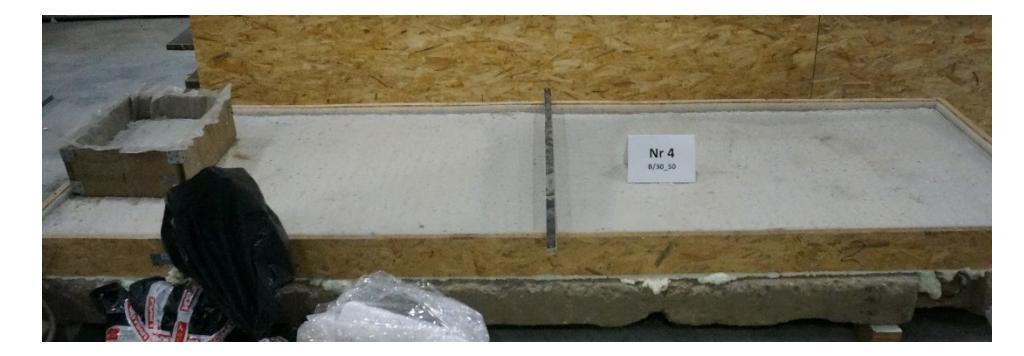
Fig. 9. Sample no. 4.

Comparative tests have shown that it is possible to make a self-levelling screed for the designed floor. Lack of curing resulted in the occurrence of cracks in the EPS concrete.

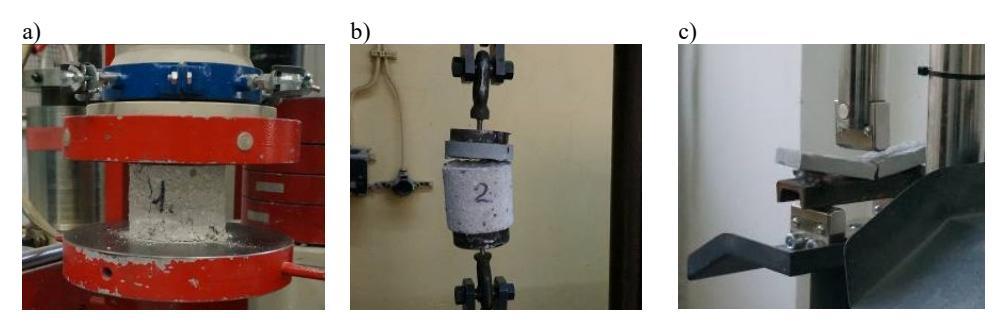
Conducted tests have determined that the materials used (p. 4.1) in the comparative laboratory tests meet the manufacturers recommendations in terms of compressive and flexural strength. Core samples from the damaged floor in majority also exhibited required

compressive and tensile strength. A single sample exhibited significantly lower flexural strength, while the other did not meet the tensile strength requirements.

**Fig. 12.** Laboratory tests: a) compressive strength test of the EPS concrete, b) tensile strength test of the EPSC+screed samples, c) flexural strength test of the screed.
