Diagnosics and protection methods a residential building in connection with the reconstruction of a road located in its immediate neighborhood - case study

Maciej NIEDOSTATKIEWICZ ^{1*}

¹ *Department of Engineering Structures, Faculty of Civil and Environmental Engineering,
Gdansk University of Technology, Gdansk, Poland*

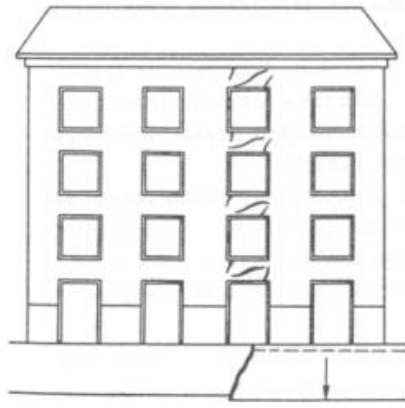
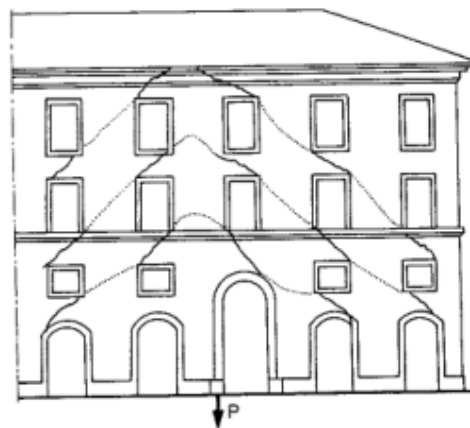
Fig. 5: The mechanism of damage to external walls caused by uneven settlement according to: a) Mitzel A., Stachurski W., Suwalski J.: Failures of concrete and masonry structures, *Arkady Publishing House*, Warsaw 1973, b) Masłowski E., Spiżewska D.: Strengthening of building structures, *Arkady Publishing House*, Warsaw 2000

Scratches and cracks were visible on the front (northern) elevation (Fig. 4). Scratches were also visible on the garden (southern) elevation. The morphology of the above damage, especially that visible on the unplastered brick wall, i.e. on the front elevation, indicated that they were the result of uneven settlement of the building as a consequence of its partial basement. A similar picture of damage can be found in the literature on the subject (Fig. 5): in the case of the building in question, the analogy to the examples from the literature is that, similarly to Fig. 5, damage to the wall is visible, i.e. its cracks above the window arches that are tilted to the right, in the basement part (L) and to the left in the part without a basement (R). The inclination of the cracks is consistent in terms of direction
