## DYNAMIC STATE ASSESSMENT OF THE WATER TURBINE WITH THE POWER OF 600 kW

Grzegorz ŻYWICA, Paweł BAGIŃSKI, Łukasz BREŃKACZ

Institute of Fluid-Flow Machinery, Polish Academy of Sciences  
80-231 Gdansk, Fiszerka 14 str., [gzywica@imp.gda.pl](mailto:gzywica@imp.gda.pl)

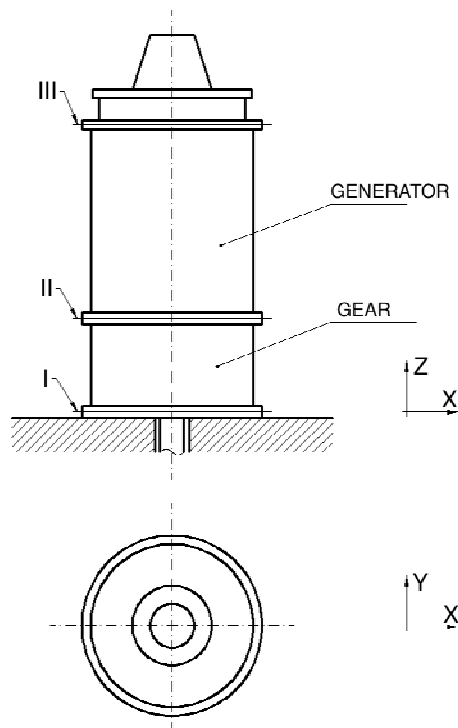
The measurements were carried out in three measurement nodes, and each of them was measured in three directions consistent with adopted axes (Fig. 3). This represented a total of nine measurement locations (points). Measurement nodes were located within the upper bearing of the turbine shaft (I) and the lower (II) and the upper (III) bearing of the generator's shaft. Closed machine housings prevented a direct measurement of vibrations on the bearings, and therefore according to the standards, the measurement points were located on steel flanges connected to the bearing support housings. Due to the construction of turbine set, it was

Fig. 3. Scheme of the turbine set with the coordinate system
