# Integrated Application of GPR and Ultrasonic Testing in the Diagnostics of a Historical Floor

**Abstract:** The paper presents the results of integrated ground penetrating radar (GPR) and ultrasonic testing (UT) measurements conducted on a historical floor in St. Nicholas' Church, Gdańsk, Poland. The described inspection was the first stage of the technical state assessment of the building. The aim of the study was the detection of underfloor air gaps, which were observed in a few trial pits. The condition of the ground under the floor was determined by localizing other inclusions such as rubble, human remains, brick walls and pipes. To identify the phenomenon of electromagnetic and ultrasonic wave propagation within the air gap, laboratory tests were conducted on physical models consisting of two concrete slabs stacked on top of each other and gradually moved apart to simulate a slot of varying thickness. The conducted research was supported by the numerical models of electromagnetic wave propagation. The obtained results showed that the integration of the GPR and UT methods provided an effective imaging of the floor and the area under it. Ultrasonic testing was proved to be a

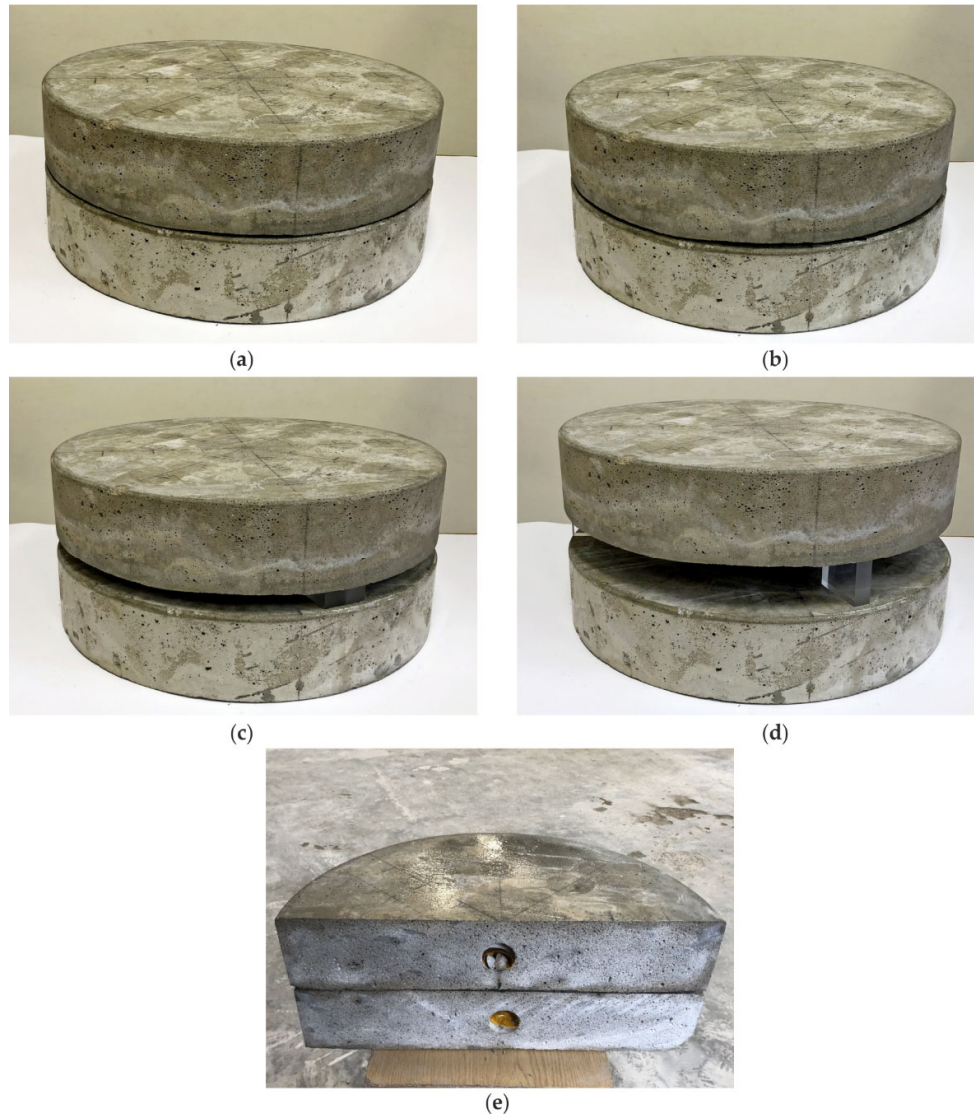
**Figure 4.** Circular concrete slabs with air gaps of different thickness: (a) 1 mm; (b) 4 mm; (c) 20 mm; (d) 50 mm; and (e) upper plate after cutting.

Additional investigations were conducted at the laboratory, on two circular concrete slabs. The slabs had a diameter of 49 cm and a thickness of 10 cm. One of the slabs had a table tennis ball with a diameter of 40 mm embedded in its center, at the half height of the slab. During the tests, the slabs were stacked on top of each other and gradually moved apart to simulate air gaps of varying thickness: 1, 4, 20 and 50 mm (see Figure 4).

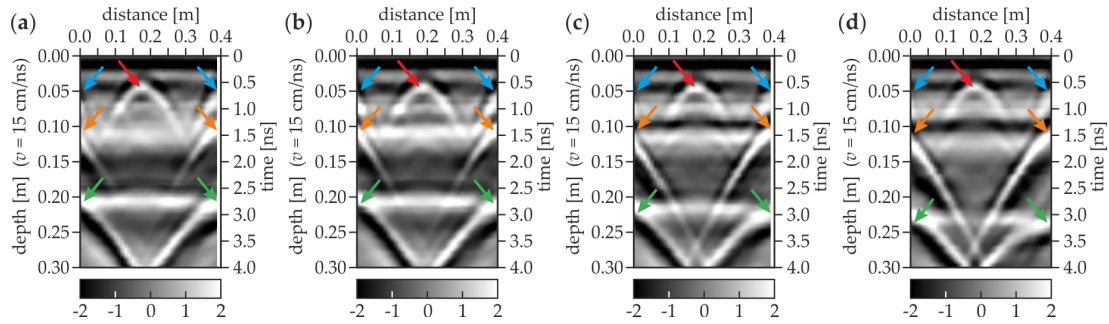
**Figure 11.** Experimental GPR B-scans for concrete slabs with air gap of thicknesses (a) 1 mm (trace D-1); (b) 4 mm (trace D-2); (c) 20 mm (trace D-3); and (d) 50 mm (trace D-4).

The results for the concrete slabs were first discussed as an initial step towards a more detailed analysis of the floor. Figure 11 shows the experimental GPR B-scans for the concrete slabs with different thicknesses of the air gap. The scan length was approximately 0.4 m. The depth axis was determined with the assumption that the electromagnetic wave velocity was equal to 15 cm/ns (based on the “depth to known reflector method” [45]). For the air gap thickness equal to 1 mm (Figure 11a), the half hyperbolas were clearly detected at the depth of 0.1 (orange arrows) and 0.2 m (green arrows), representing the reflections from the bottom faces of the upper and the lower slabs, respectively. This observation indicated the proper assumption of the electromagnetic wave velocity in the analyzed elements. The bottom faces of both slabs were visible as the lines with an intensity different from the adjacent part of the B-scan. The position of the reflection from the upper slab did not change, whereas the lower slab appeared deeper when increasing the air gap thickness (compare Figure 11a–d). For the air gaps with the thicknesses of 4, 20 and 50 mm, the position of the bottom plate was detected at about 20.5, 22 and 24 cm depths, respectively. This change showed the increase in the distance between both slabs and indicated a high compatibility of the obtained numerical results with the real thicknesses of the gaps. The identified gaps thicknesses were slightly different from the actual ones because the depth axis in Figure 11 was calculated for the velocity of the electromagnetic wave in concrete (15 cm/ns). In addition, the line at the depth of 0.1 m transformed into two separate lines, which indicated the opening of the air gap. It should also be mentioned that the line representing the bottom face of the lower slab became less pronounced for the greater distances between the slabs. This remark allowed concluding that the larger the air gap was, the harder it was to detect elements below it. Moreover, other half hyperbolas (denoted by blue arrows) were present at the depth of about 0.05 m, indicating a technological break during the concreting of the upper slab (visible in all B-scans, see Figure 11a–d). The upper slab was prepared in two stages unlike the lower one, in which no additional perturbations could be seen. A full hyperbola was observed in the center of each B-scan at the depth of about 0.05 m (marked by the red arrow), revealing the presence of the table tennis ball, which was placed in the upper slab between both stages of concreting.

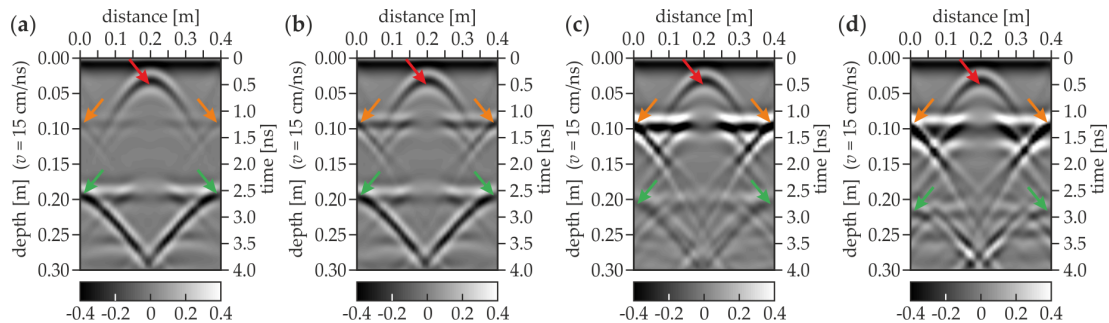
**Figure 12.** Numerical GPR B-scans for concrete slabs with air gap of thicknesses (a) 1 mm (model #2.1); (b) 4 mm (model #2.2); (c) 20 mm (model #2.3); and (d) 50 mm (model #2.4).

The numerical GPR B-scans corresponding with the above-described experimental results are presented in Figure 12. The half hyperbolas marked by the orange and green arrows clearly show the bottom faces of the upper and the lower slabs, respectively. The line denoting the bottom face of the lower slab became less noticeable and appeared deeper when increasing the distance between both slabs (cf. Figure 12a–d). For air gaps with thicknesses of 4, 20 and 50 mm, the position of the bottom plate is detected at about 19, 21 and 22 cm depths, respectively. The opening of the air gap was observed as the shift of the reflection from the bottom face of the lower slab occurred and also by the gradual separation of the single line into two lines. The hyperbola revealing the presence of the table tennis ball (red arrow) was clearly visible at the depth of 0.05 m. However, the technological break was not detectable (it was not modelled). The high agreement of the experimental and numerical results allowed concluding that the modelling of electromagnetic wave propagation was correct. The possibility of detecting air gaps and concentrated inclusions was confirmed.

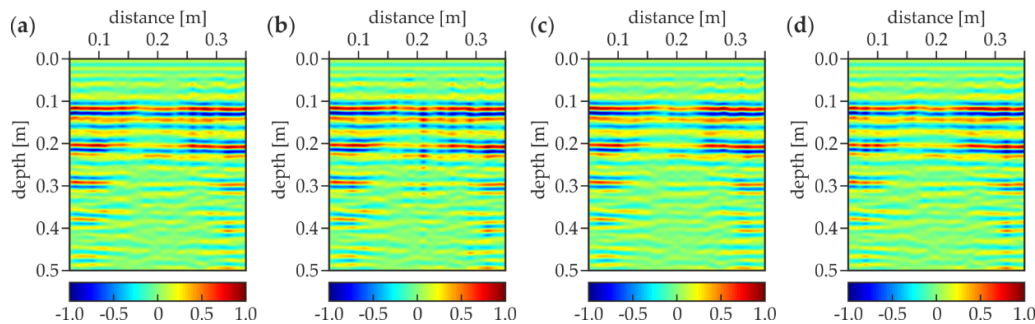
**Figure 13.** Ultrasonic B-scans for concrete slabs with air gap of thicknesses (a) 1 mm (trace D-1); (b) 4 mm (trace D-2); (c) 20 mm (trace D-3); and (d) 50 mm (trace D-4).

The UT B-scans for the analyzed slabs are presented in Figure 13. The ultrasonic pressure wave velocity determined before the main tests was equal to 2055 m/s. The scan length was reduced to 0.3 m due to the dimensions of the used UT antenna. There were no noticeable differences between all scans (Figure 13a–d), thus it could be concluded that the thickness of the air gap did not affect the results obtained. The lines at the depth of about 0.1 m representing the reflections from the bottom face of the upper slab were seen in all B-scans. Moreover, these lines were repeated regularly along the depth axis with the step of about 0.1 m (the slab thickness). Ultrasonic waves did not penetrate into the lower slab, they were fully reflected from the bottom face of the upper slab. The deeper lines were only the multiple reflections from the faces of the upper slab. The intensity of these lines decreased with the depth because of the damping of the ultrasonic waves. It is worth noting that the deeper lines appeared only near the edges of the slab. The presence of the boundaries strengthened the reflections, thus the signals were damped slower at the sides compared with the center of the slab. An important observation is that the table tennis ball was not observed at all. The reason might be the limitation of the used UT antenna. The Pundit PL-200PE instruction states that inclusions with

a diameter of at least 30 mm should be detected, however, this condition deals with cylindrical elements. Being a relatively small spherical (concentrated) inclusion, the ball was not possible to be detected, despite the fact that its diameter was greater than minimum. To sum up, the air voids could be successfully detected using the UT technique, but without estimating the thickness. On the other hand, the content of the element below the air gap could not be imaged because the ultrasonic waves were entirely reflected from the air gap. Additionally, small concentrated inclusions could not be detected.

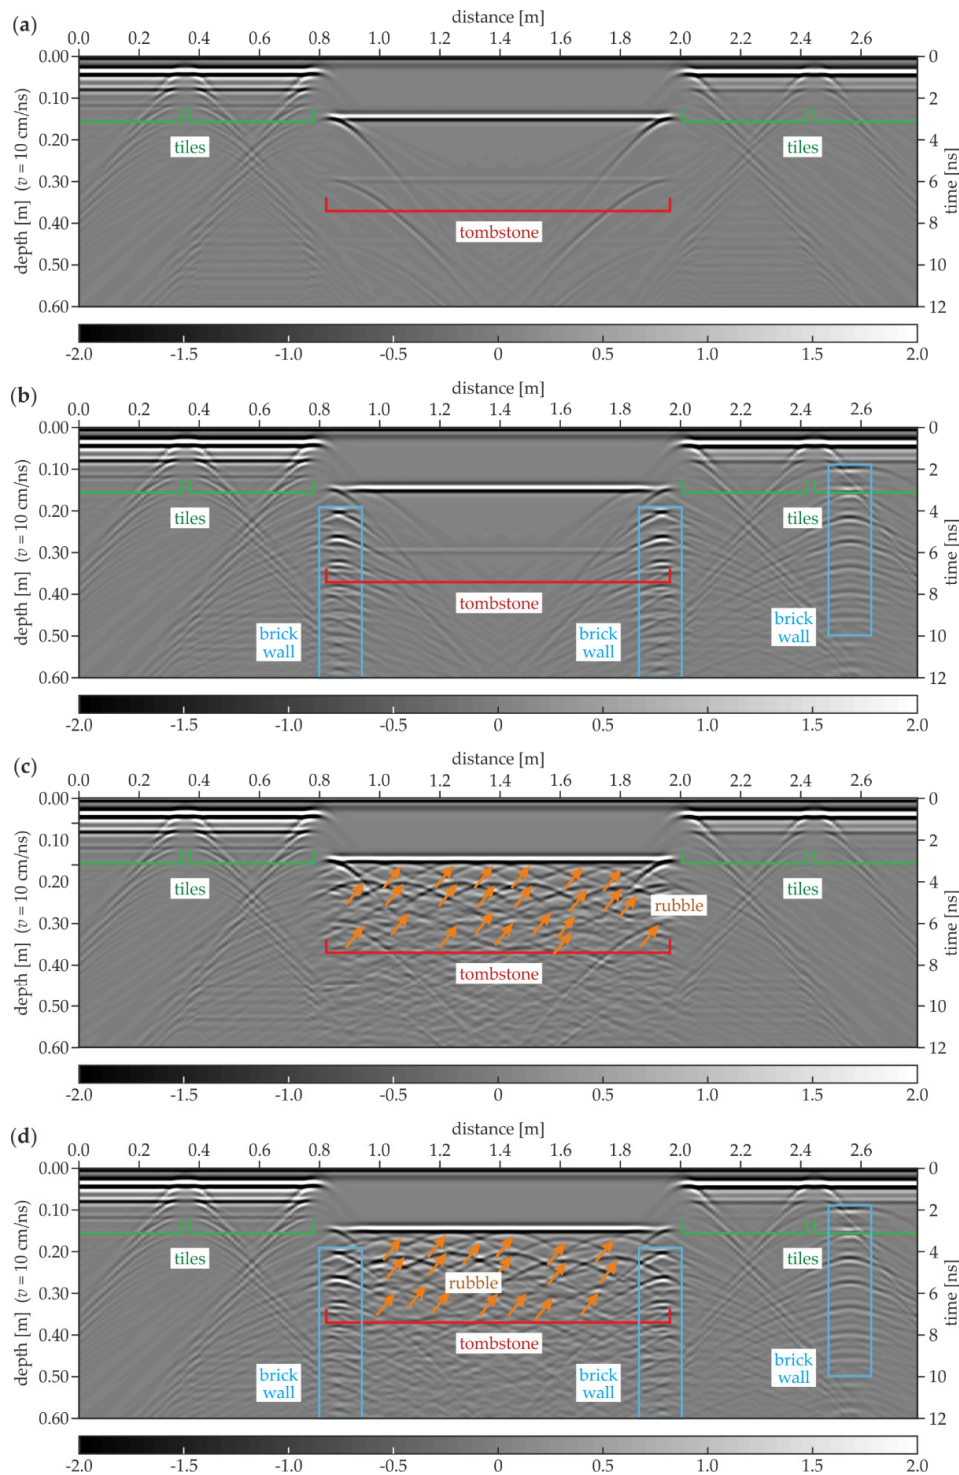
**Figure 14.** Numerical GPR B-scans for the floor: (a) model #1.1; (b) model #1.2; (c) model #1.3; (d) model #1.4.

Figure 14 shows the GPR B-scans acquired in the numerical models of the considered floor. Taking into account the complexity of the analyzed medium, the electromagnetic wave velocity was set as constant and equal to 10 cm/ns. The strategy applied did not take into account the heterogeneity factor. Therefore, the results were only approximations of the real subsurface geometry. However, this fact did not disable the proper interpretation of the results. In the model #1.1 (Figure 14a), the positions of the stone tiles were clearly identified based on the line patterns denoting the reflections from the vertical joints between tiles. The half hyperbolas at the ends of the tombstone were visible in the center of the scan. The lower faces of the tiles and the tombstone were located at the depths of 0.04 and 0.15 m, respectively. Some additional reflections with a lower intensity were observed below, indicating the further wave reflections from the analyzed elements (e.g., at the depth of 0.08 m below the tiles and 0.3 m below the tombstone). The difference between the tiles laid with and without the air gap was small, i.e., additional reflections below the tiles located above the air gap were insignificantly stronger. This observation might lead to the hypothesis that the detection of the small air gaps based on the GPR scanning could be problematic. For the model #1.2 (Figure 14b), the conclusions from the identification of the tombstone and the tiles were the same as for model #1.1. However, additional hyperbola patterns appeared, being the reflections from all singular bricks of the walls located below the edges of the tombstone. It is worth noting that the intensity of the hyperbolas decreased with the depth, which is a common relation observed for electromagnetic waves. Similarly, another brick wall was visible at the distance of 2.55 m. It is interesting to note that the walls seemed to be located at different depths. This apparent observation was the result of the assumption that the electromagnetic wave velocity was constant. The wave needed more time to travel through the tombstone (to reach the edge walls) compared with the stone tiles and the sand (above the additional wall). In the model #1.3 (Figure 14c), the additional hyperbolas were observed below the tombstone, proving the presence of the rubble. The great amount of the inclusions made the interpretation of the scan more complicated. It is also worth noting that the deeper hyperbolas had a much lower intensity, thus the identification of inclusions located deeper was straitened. The interpretation of the reflections below the tombstone was far more difficult when considering the simultaneous presence of the rubble and the brick walls (model #1.4, Figure 14d). The superimposition of the hyperbolas denoting the rubble and the singular bricks made them undistinguishable. Therefore, it was not possible to state whether a certain hyperbola denoted the

brick or any different kind of inclusion. To sum up, the results obtained from the numerical calculations gave some information about the possibilities and limitations of GPR scanning. The location of the tombstone and the tiles could be determined. The rubble below the tombstone was detectable as well as the brick walls; however, when these elements appeared together, the interpretation was complicated. What is essential is that the air gaps were difficult for the identification.
