# Renovation works in buildings in the area of former defensive fortifications

Maciej NIEDOSTATKIEWICZ<sup>\*1</sup>, Tomasz MAJEWSKI<sup>2</sup>, Adam BARYŁKA

## Abstract

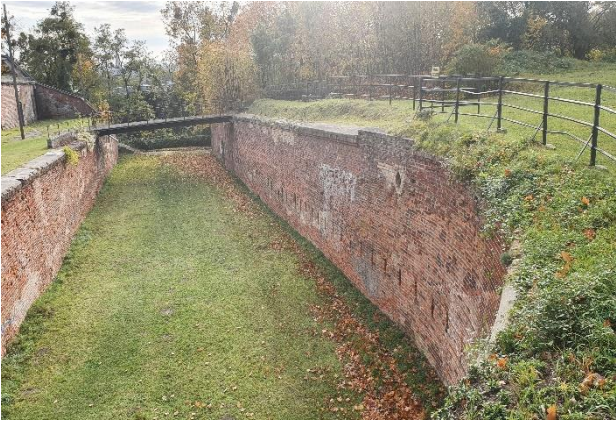
A general view of the defensive rampart to which the Complex of Buildings covered by the study adjoins is shown in Photo. 1. Former office rooms (A) were created by using a part of the historical wall and aligning it with the completion of the defensive rampart. The extension of the wall are the rooms of the former service apartment (B), part of which is the historic buildings of the Southern Guardhouse. The former service apartment (B) was added to the front wall and the gable wall of the former office premises (A) in the later period, as evidenced by the lack of a full masonry bond at the junction of the walls and a different type of brick from which the wall was made (Photo 2). Utility rooms (C) perpendicularly adjoin the body of the former service apartment (B) (Photo 3). The wall on the back side of the former office rooms (A) was built with faults, probably with the use of brick reinforcements of the escarpment (Photo 4).

**Photo. 1:** Widok ogólny szańca obronnego przylegającego do Zespołu Budynków

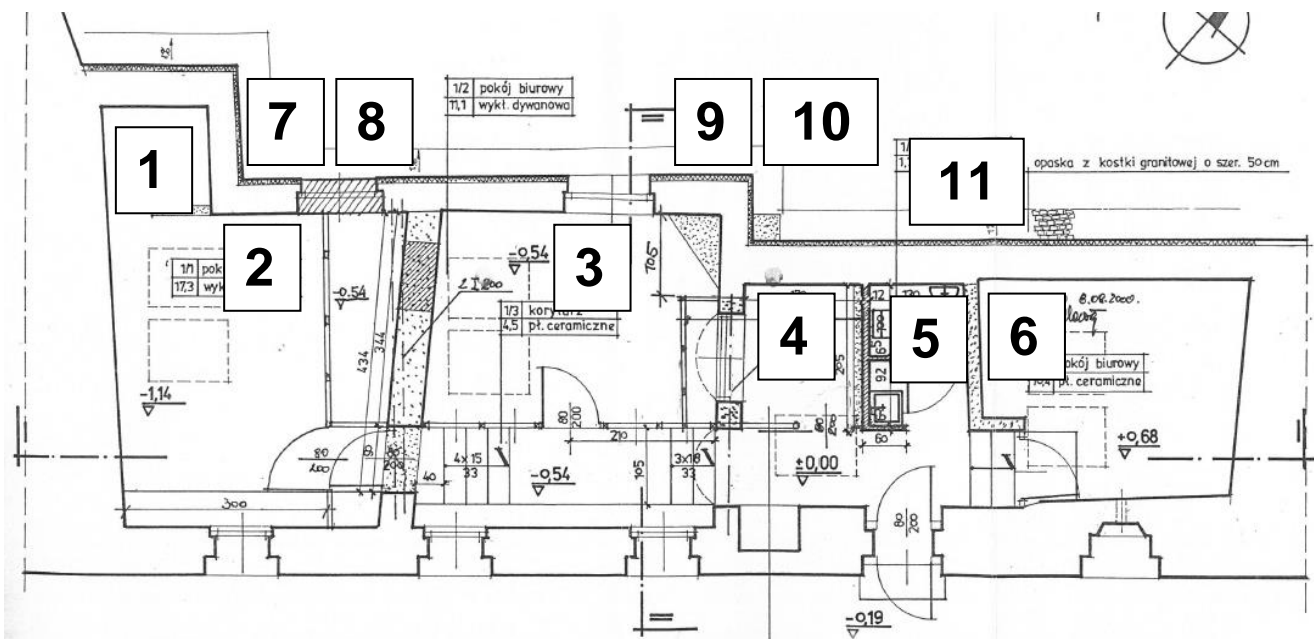
In order to estimate the method of constructing the wall from the side of the slope in the area of the former office premises (A), excavations were made, both from the outside and the inside of the building (Fig. 2). Thanks to the excavations made, it was checked whether the historical, brick reinforcements of the escarpment were used during the construction of the rear wall. Based on the excavations made, it was found:

Fig. 2: Location of opencasts in the external wall (on the slope side) of the former office rooms (A): 1, 2, 3 ... - number of the opencast
