Research paper

Settlement of a historic building due to seepage-induced soil deformation

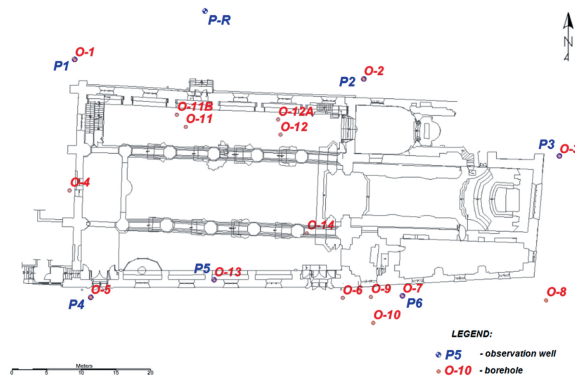
Fig. 4. Location of subsoil test boreholes and groundwater level observation piezometers [40]

Extensive diagnostics [39–43], typical for historic buildings situated within a dense urban development, which covered the Basilica and its adjacent area, involved also detailed soil testing and the installation of piezometers for observing water levels in the subsoil. Locations of test boreholes and implemented piezometers are shown in Fig. 4.
