## Studies of the mechanism of metal dusting of 10CrMo9-10 steel after 10 years of operation in the semi-regenerative catalytic reformer

The purpose of this paper is to present a metal dusting mechanism for 10CrMo9-10 steel operated for 10 years in the semi-regenerative catalytic reformer.

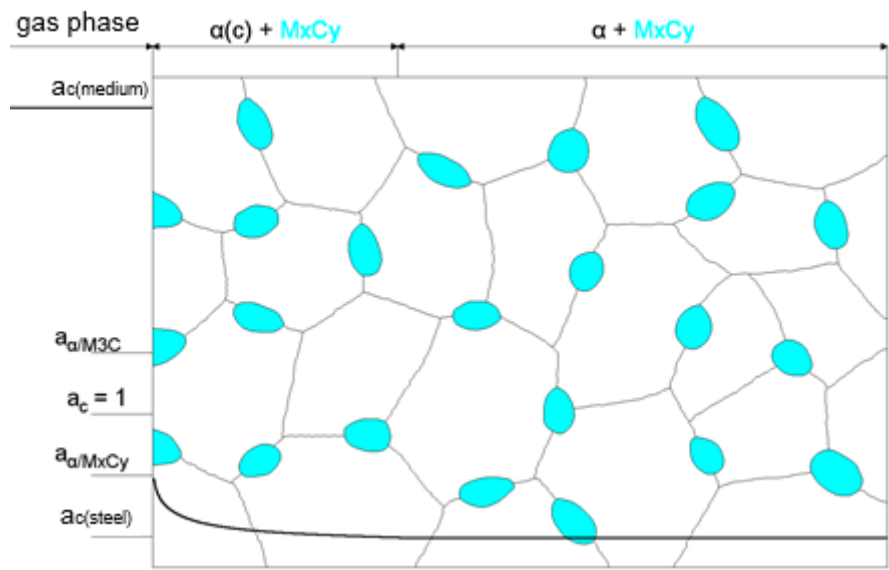
1. 10CrMo9-10 steel in the initial state i.e. after normalizing and high tempering, has a microstructure composed of ferrite  $\alpha$  and alloy carbide  $M_xC_y$  ( $M_2C$ ,  $M_6C$ ,  $M_7C_3$ ). As a result of thermal decomposition of hydrocarbons in the gaseous phase, the free carbon atoms create, which leads to increased carbon activity  $a_c$  at this phase. Free carbon atoms are adsorbed on the surface of the metallic phase, then they are absorbed and diffuse into the steel. The carbon activity in the surface layer of steel increases and ferrite alloy supersaturated by carbon  $\alpha$  (C) is formed, as schematically shown in Fig. 9.

Fig. 9. Stage I - increase the carbon activity in the surface layer and the creation of ferrite alloy supersaturated by carbon (color: online only)

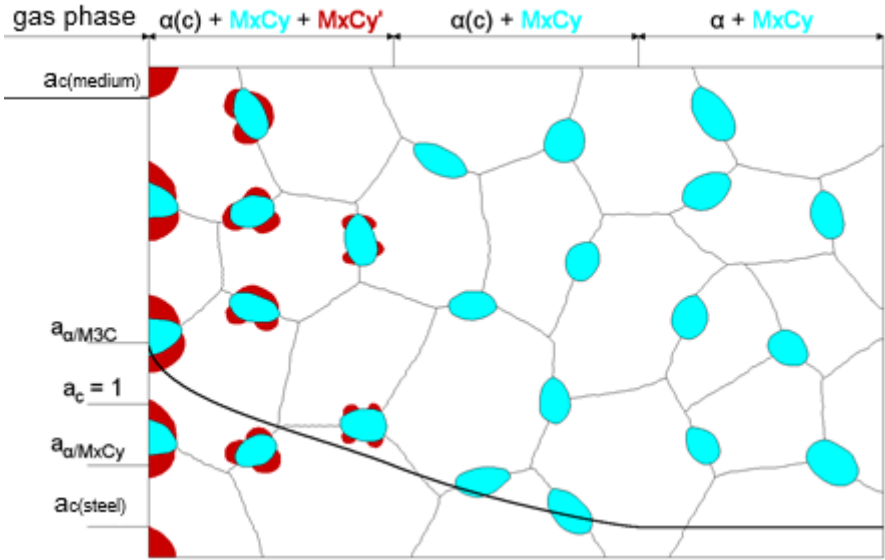
2. The increase in carbon activity greater than the activity of the equilibrium of  $MxCy$  carbide formation ( $a_{\alpha(c)}/MxCy$ ) causes that at  $\alpha$ /primary carbides  $MxCy$  interfaces, new carbides  $MxCy'$  evolve and grow, which leads to an increase in the particle size of carbide. The content of alloying elements - chromium and molybdenum in the ferrite decreases, resulting in their presence in the newly established carbides is dropping, and type of formed precipitates changes (see Fig. 10).

Fig. 10. Stage II - nucleation and growth of new carbide  $MxCy'$  at ferrite/primary carbides  $MxCy$  interfaces (color: online only)
