# Assessment of Technical Conditions in Adapting a Historic Warehouse's Space Functionality

The aim of the paper is to present the results of the analysis of the technical condition of a historic Warehouse building located in the former shipyard area in connection with the planned construction in the place of the existing location of the production hall warehouse building.

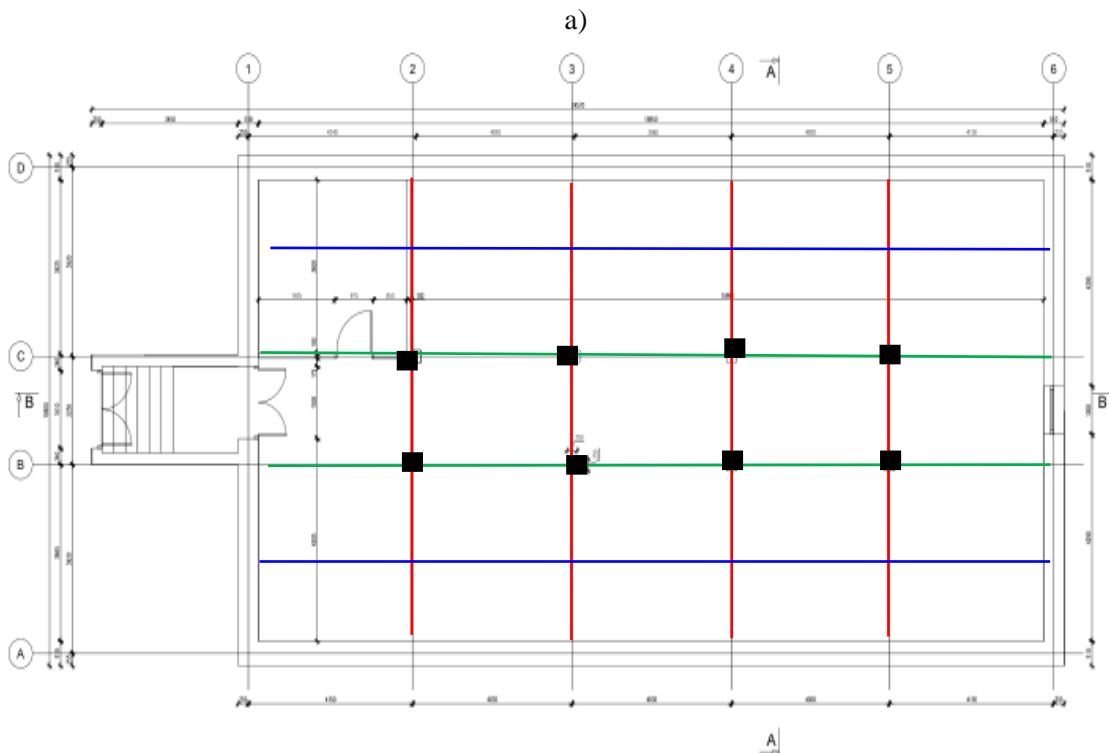
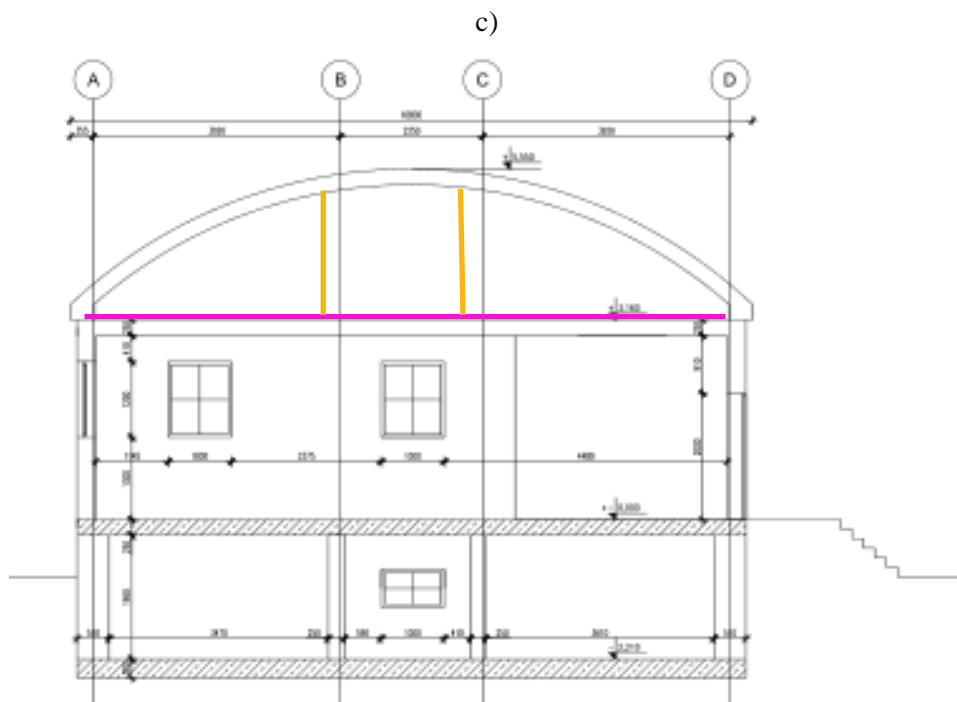
**Fig. 1.** Warehouse building: projections: a) basement floors, b) ground floor, cross-sections: c) transverse, d) longitudinal (*based on inventory*) continued
