# Assessment of Wooden Beams from Historical Buildings Using Ultrasonic Transmission Tomography

The main goal of this study was non-destructive evaluation of wooden elements using ultrasonic waves. The inspection was carried out on wooden beams from a historical object. Elastic wave signals were processed by ultrasonic transmission tomography to obtain imaging of the internal structure of tested elements without disturbing their state and integrity. The focus was on the influence of wood anisotropy on the propagation of ultrasonic waves. A novel method of determining the position of the cross-section pith was proposed. The study presented that the proposed imaging approach was capable to assess the technical condition of historic wooden beams by determining the degree of wood damage and the location of discontinuities, scratches or fibrosis in the tested cross-section.

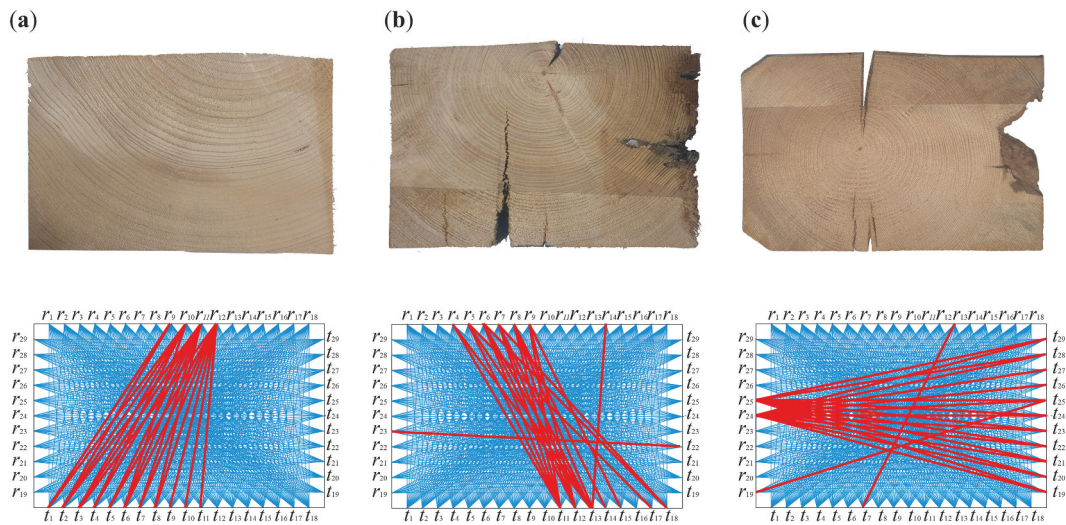
Figure 11. Rays of performed measurements with the 5% fastest waves marked in red.

maps. In general, the wood pith may be within or outside the cross-sectional area for which the measurements are made. In the proposed approach, it was based on 5% of the fastest paths among the collected measurement data. These paths, marked in red in Figure 11, were selected in order to determine the location of the pith for each of the beams. If the fastest paths appear between a pair of opposite edges, it is an indication that the pith lies outside the examined area.

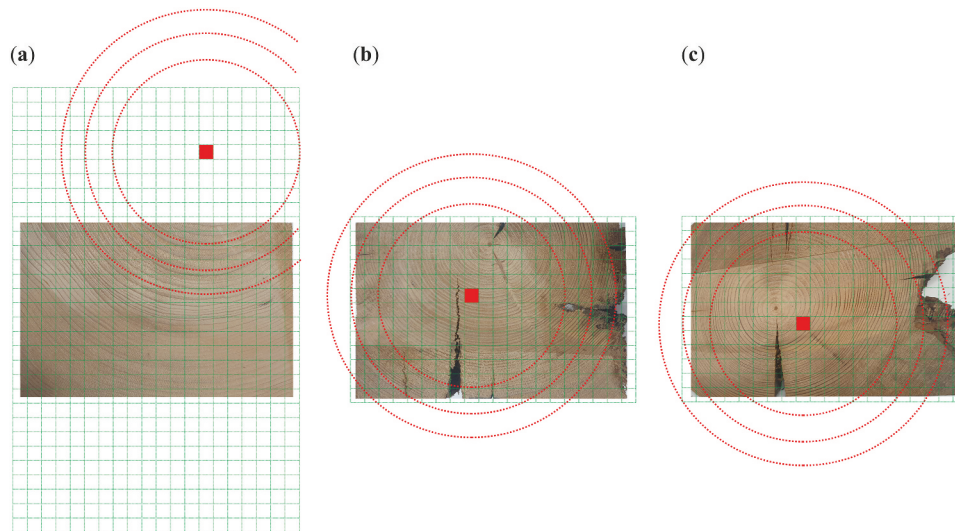
**Figure 12.** Determining the location of the pith from beams #1-#3.

The wood pith was searched independently for each pixel into which the element was divided. In the case of the element for which the pith was expected to be outside, the pixel grid was enlarged along the edge from where the fastest rays propagated. The pixel grid was therefore enlarged 3 times for element #1 (Figure 12a). In beams #2 and #3 the pixel grids remained unchanged (Figure 12b-c). For each of the pixels, the closest path from each transmitter  $t_1-t_{29}$  and each receiver  $s_1-s_{29}$  was selected. Thus, 58 rays were assigned to each pixel. The pixel for which the sum of the velocities of these rays was the highest indicated the positions of the pith. Selected pixels are shown in red in Figure 12. In beam #1, it coincides with the actual location of the pith. In beams #2 and #3, it is slightly shifted due to the failures in the beams affecting the course of the rays.

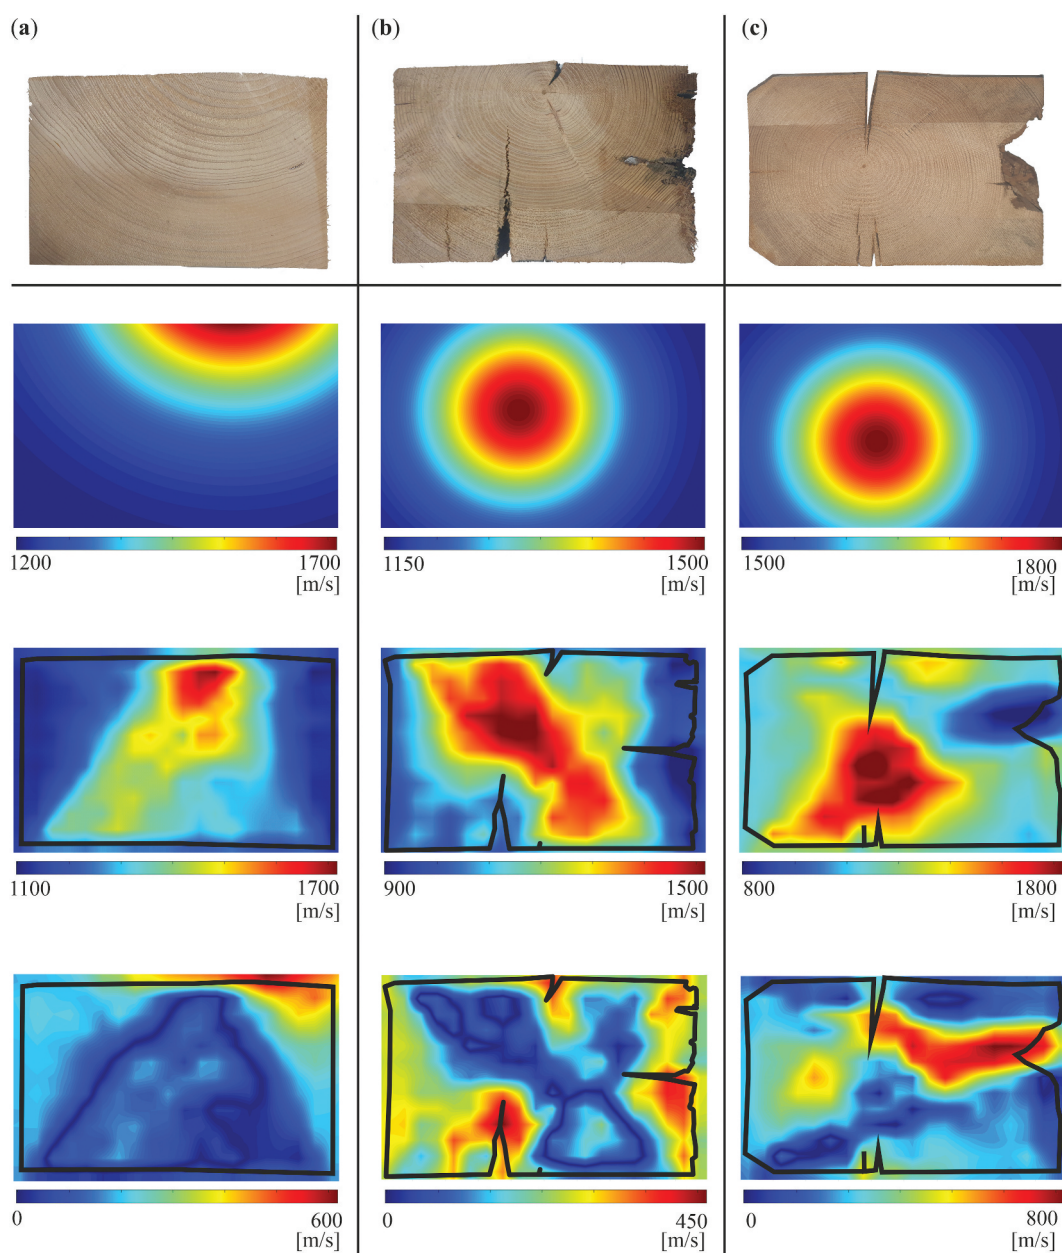
**Figure 13.** Ultrasound tomography maps: cross-sections (first row), idealized models, taking into account the location of the pith (second row), initial tomographic maps from Figures 8–10 (third row), the difference between the idealized maps and the initial maps (fourth row).

Idealized maps of wave propagation velocity in the wooden element were created after determining the pith location (Figure 13, second row). The highest speed was identified at the designated pith and was equal to the maximum value in the preliminary topographic map (Figures 8–10). It was different for

each of the three samples and was 1637 m/s, 1442.3 and 1842.5 m/s respectively for samples # 1- # 3. The velocity decreased circularly and uniformly for each direction of the outer edges of the beams. The third row in Figure 13 summarizes the initial tomographic maps. The final result is the maps shown in the fourth row. They are the difference between idealized and initial maps. Due to the subtraction of the idealized model indicating the location of the pith, only places showing a decrease in wave
