Causes of damage and methods of repairing floor made on polystyrene concrete

Lukasz Drobiec^{1,*} and *Pawel Piotrkowski*²

Abstract. The paper describes damages, tests and repair of the floor made on existing ceiling and expanded polystyrene concrete underlay. The floor was built on a reinforced concrete ceiling with an area of about 1050 m². Significant damage in the form of cracks, detachments and unevenness was found in the floor. In order to determine the causes of damage, in situ tests and laboratory tests were carried out. It was found that the damage was caused by numerous performance errors. A test repair of the damage (4.7x6.0 m) was carried out, and then the repair method was applied on the entire floor surface.

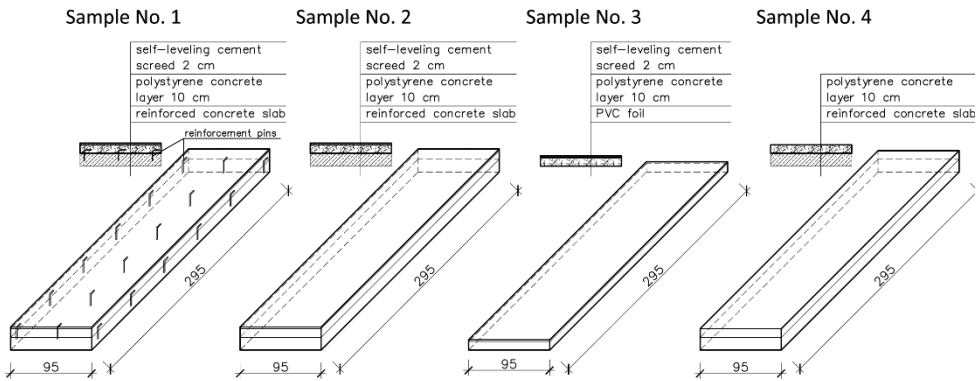
In order to determine the possible interaction between individual layers of the floor, four test specimen were prepared. Three of them were made on a 95x295 cm reinforced concrete slab, the last one on a PVC foil (Fig. 7). The first sample was reinforced with steel 12 mm pins, with 10 cm of a 30/50 EPSC overlay and 2 cm of self-leveling screed. The model reflected the existing floor. Sample no. 2, was identical to the first one with exclusion of reinforcement pins which were not installed. The model, in comparison to the first one, was used to determine the effect of the pins. In sample no. 3, a 30/50 EPSC was cast on a PVC foil and finished with a 2 cm layer of self-levelling screed. The model was used to determine the possible influence of slip membrane laid under the EPSC. The last sample, a 10 cm layer of 30/50 EPSC cast over a reinforced concrete slab. was made in order to determine the possible shrinkage. The specimen was left uncured and uncovered, untypically to standard practices. The samples are shown in Fig. 8 and Fig. 9.

Fig. 7. Comparative test samples.

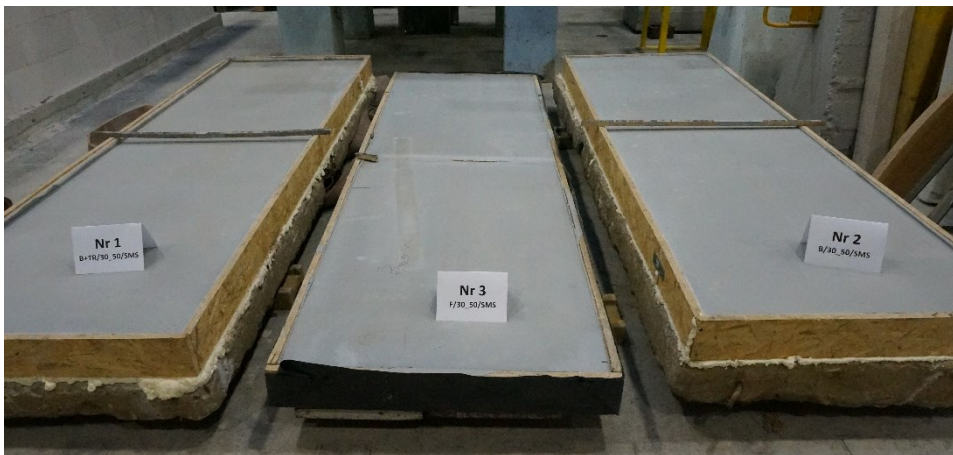
Fig. 8. Samples no. 1, 2 and 3.

The visual evaluation of the samples was being conducted for over 2 months. The observations lasted over 2,5 times longer than the time in which the cracks occurred in analyzed floor. After 49 days first three samples did not exhibit any signs of cracking. The last sample exhibited small shrinkage cracks. Local width of the crack reached between $0.1 \div 0.5$ mm. The cracks on the surface of the EPSC occurred after two weeks due to lack of curing. The cracks are shown in Fig. 10.
