COMPREHENSIVE MONITORING OF CHANGES IN THE GEOMETRIC STRUCTURE OF A HISTORIC BUILDING THE "SALA BHP" IN GDAŃSK

Jacek SZTUBECKI¹, Maciej NIEDOSTATKIEWICZ², Maria MRÓWCZYŃSKA³,
Tomasz MAJEWSKI⁴

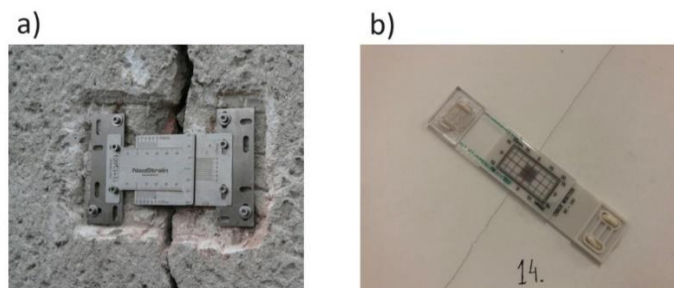
Fig. 12. View of the installed crackmeters: a) inside the facility, b) outside the facility

The crackmeters were installed on the building's structural elements (walls) and finishing elements at various heights (floors). The measurements made it possible to assess changes in the opening width of monitored scratches and cracks (building geometry) in different seasons of the year and the impact of these changes on the technical condition of the monitored building. An example view of the installed crackmeters is shown in Fig. 12.

It was found that changes in the width of monitored cracks located on the walls of the building's facade are caused by changes in atmospheric conditions: ambient temperature, humidity, and sunlight. Significant changes in the readings of the S10 crack gauge means that the crack above the lintel is active, and therefore it is recommended to check the lintel's stress and propose ways to strengthen it.
