Diagnostics and protection methods a residential building in connection with the reconstruction of a road located in its immediate neighborhood - case study

Maciej NIEDOSTATKIEWICZ ^{1*}

¹ *Department of Engineering Structures, Faculty of Civil and Environmental Engineering,
Gdansk University of Technology, Gdansk, Poland*

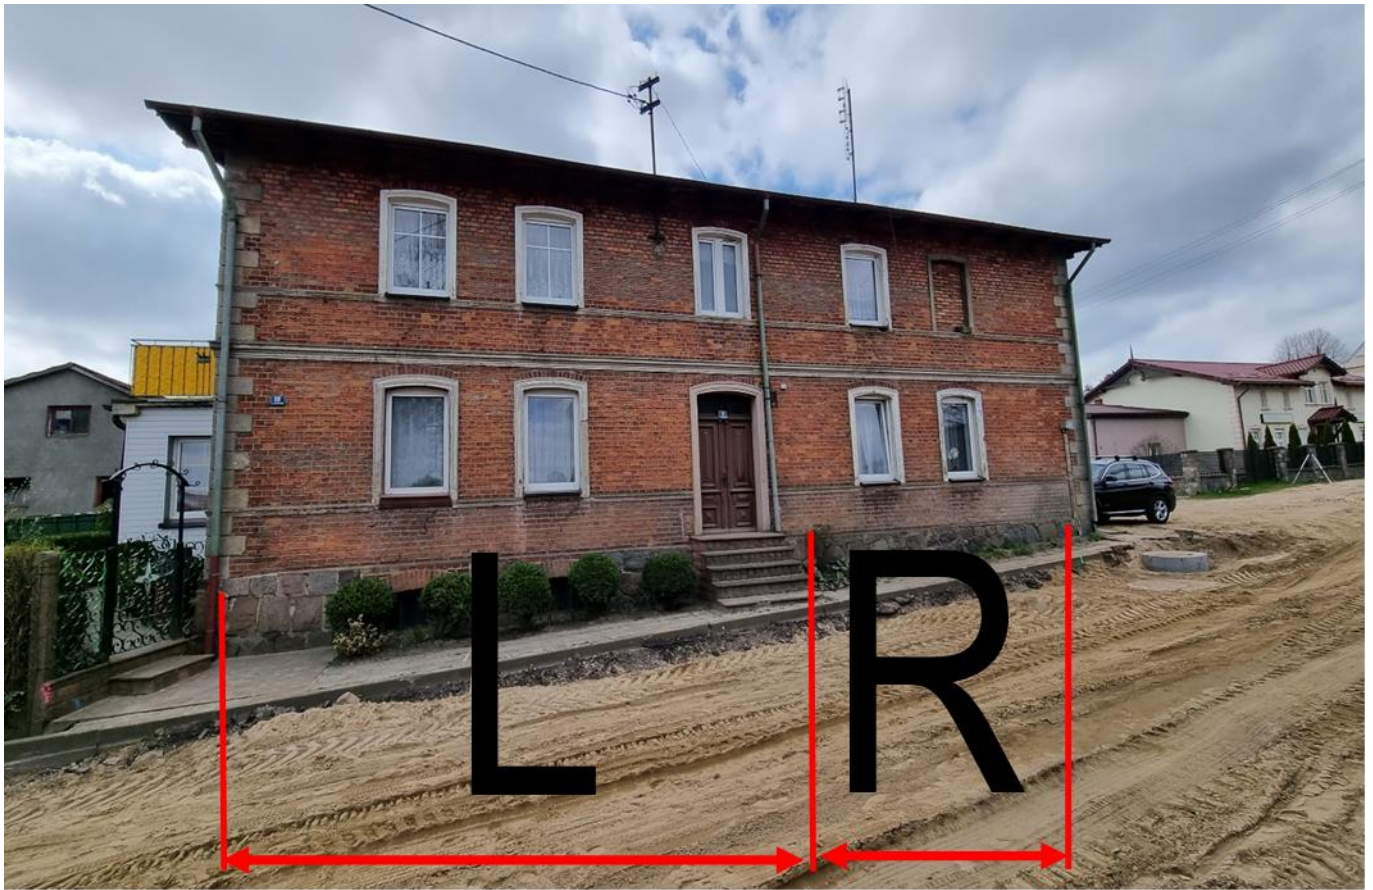
Fig. 1: Basement diagram of a residential building:
 (L): basement part, right side (R): part without basement, left side

Fig. 1 shows a view of the front elevation of a residential building. The part with a basement, including the width of the basement staircase, will be referred to later in the article as the left side (L), while the part without a basement will be referred to as the right side (R).

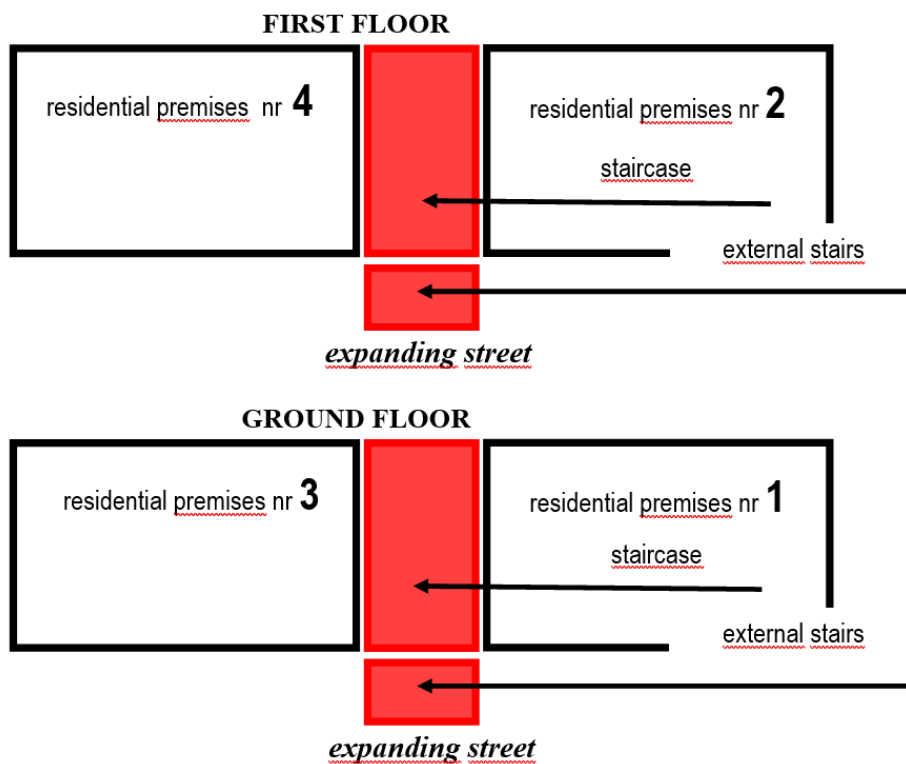
Fig. 2: Functional and utility layout diagram of a residential building
