DYNAMIC STATE ASSESSMENT OF THE WATER TURBINE WITH THE POWER OF 600 kW

Grzegorz ŻYWICA, Paweł BAGIŃSKI, Łukasz BREŃKACZ

Institute of Fluid-Flow Machinery, Polish Academy of Sciences
80-231 Gdansk, Fiszerka 14 str., gzywica@imp.gda.pl

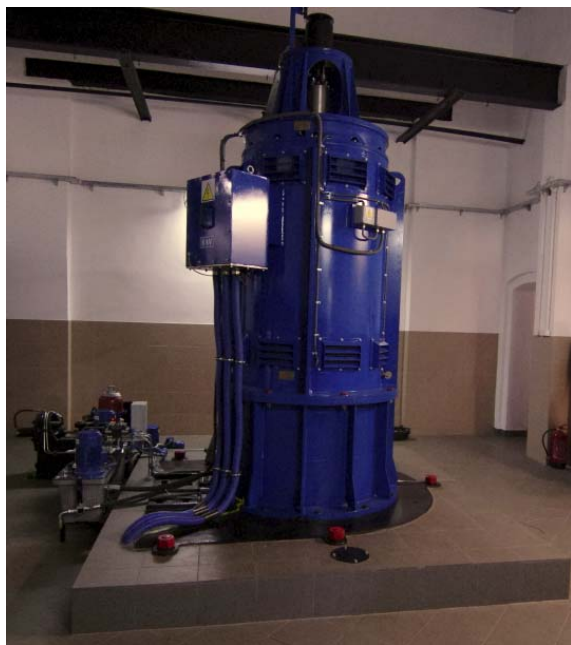
Fig. 2. Tested turbine set in a technical room located in the hydroelectric power plant

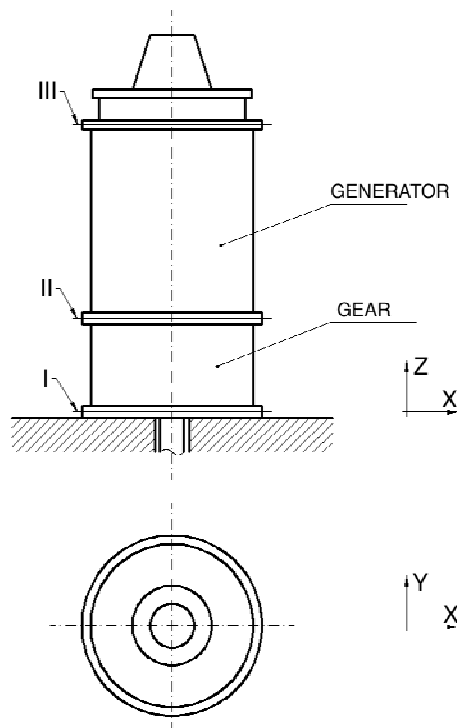
The measurements were carried out in three measurement nodes, and each of them was measured in three directions consistent with adopted axes (Fig. 3). This represented a total of nine measurement locations (points). Measurement nodes were located within the upper bearing of the turbine shaft (I) and the lower (II) and the upper (III) bearing of the generator's shaft. Closed machine housings prevented a direct measurement of vibrations on the bearings, and therefore according to the standards, the measurement points were located on steel flanges connected to the bearing support housings. Due to the construction of turbine set, it was

impossible to perform measurements within the lower bearing of the turbine shaft.

Fig. 3. Scheme of the turbine set with the coordinate system
