Monitoring of a historic sacral building on an example Basilica St. Nicholas in Gdańsk

Abstract

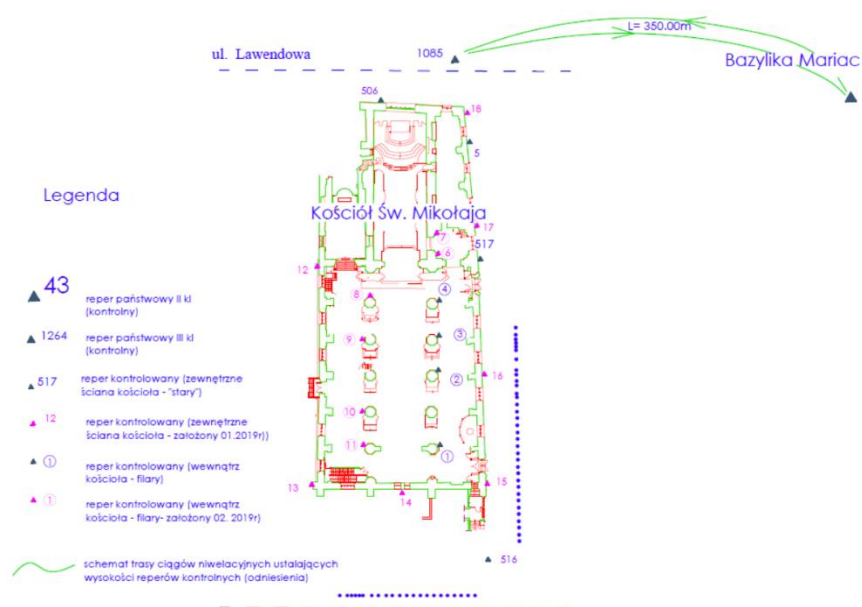
Fig. 2. Location of geodetic benchmarks and measurement sequence in the Basilica of St. St. Nicholas in Gdańsk [30]

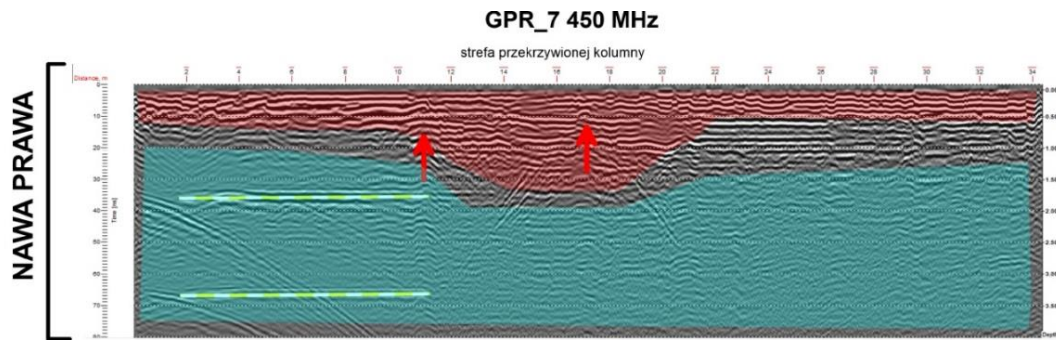
Fig. 5. Selected 450 MHz georadar echogram in the area of the southern aisle of the Basilica of St. St. Mikołaja in Gdańsk based on measurements using GPR [31]

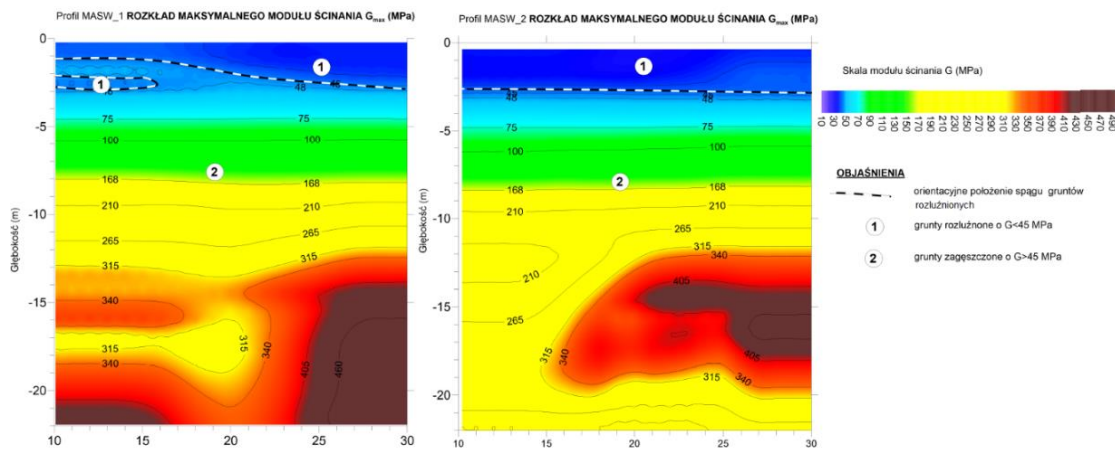
Fig.. 6. Distributions of the G_{max} shear modulus values in the axes of the southern aisle (left figure) and the northern aisle (right figure) of the Basilica of St. St. Mikołaja in Gdańsk based on measurements using multi-channel surface wave analysis (MASW) [31]

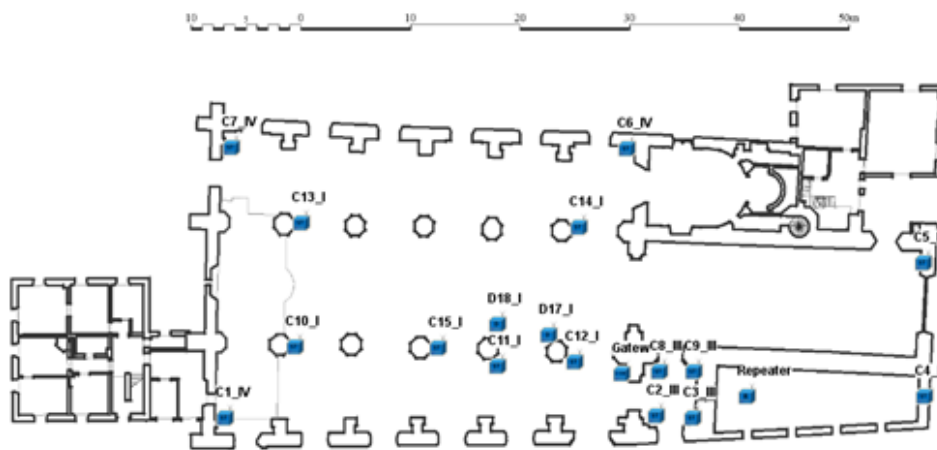
Fig. 7. Floor plan of the Basilica of St. St. Mikołaja in Gdańsk with the location of measuring

sensors marked (*own elaboration*) [50]

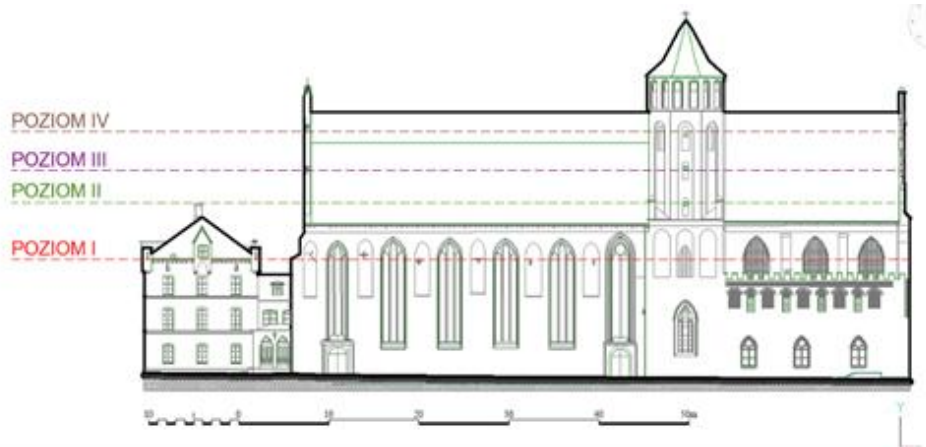
Fig. 8. Vertical (longitudinal) section through the Basilica of St. St. Mikołaja in Gdańsk with marked levels of measuring sensors placement (*own elaboration*) [50]
