Monitoring of a historic sacral building on an example Basilica St. Nicholas in Gdańsk

Tomasz MAJEWSKI^{*1}, Maciej NIEDOSTATKIEWICZ²

Abstract

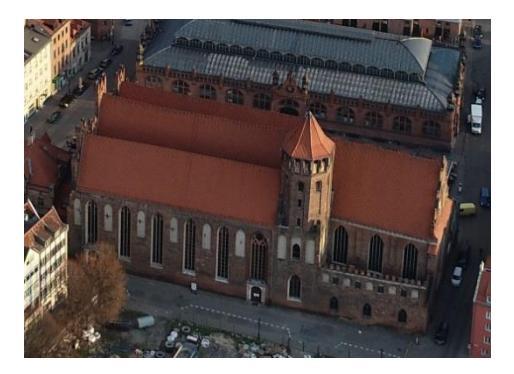
In the initial stage of the recognition, a visual inspection of the condition of the Basilica's structural elements was made (Photo 1 and Fig. 1), photographic and drawing documentation of the faults and damages was prepared [24]. Photo 2 and Photo 3 show the photos of the cracked arch between the pillars of the southern aisle and representative damage to the vault rib for the southern aisle. Based on the information collected, it was decided to immediately temporarily support the damaged vaults of the south aisle with temporary supporting scaffolding. The scaffolding was to be placed on the historic floor of the church, which was deformed and locally collapsed. For this reason, local covers were made to check the condition of the subfloor under the floor, in which voids and cavities were found. Preliminary tests of the entire floor in the Basilica were carried out using the GPR ground-penetrating radar [25]. Based on the results obtained, a decision was made to temporarily dismantle the floor within the southern aisle for the duration of the scaffolding operation. Before dismantling the floor, a detailed conservation inventory was made. After dismantling the floor, scaffolding was erected to protect the vaults of the southern aisle (Photo 4).

Photo 1. Basilica of St. St. Nicholas in Gdańsk: view (photo by T. Majewski)

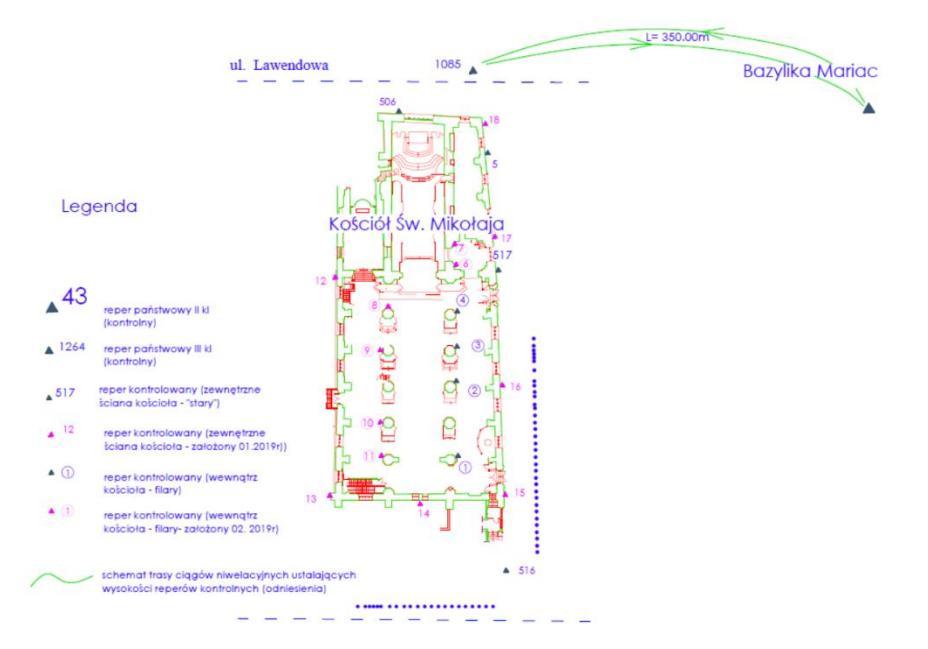
Before the failure, the walls and pillars of the Basilica were fitted with traditional mandrel benchmarks whose position was controlled at irregular intervals. After the failure, new benchmarks and geodetic charts were installed on the walls and pillars of the building, which were tied to the functioning measurement network [30]. Fig. 2 shows the location of measurement points and measurement lines led to benchmarks of the national geodetic network. Measurements are carried out in variable periods, before the implementation of the automatic measurement system, geodetic measurements were made every two weeks, and after the implementation of the system, the frequency of readings has changed - measurements are made every 6 months.

Fig. 2. Location of geodetic benchmarks and measurement sequence in the Basilica of St. St. Nicholas in Gdańsk [30]

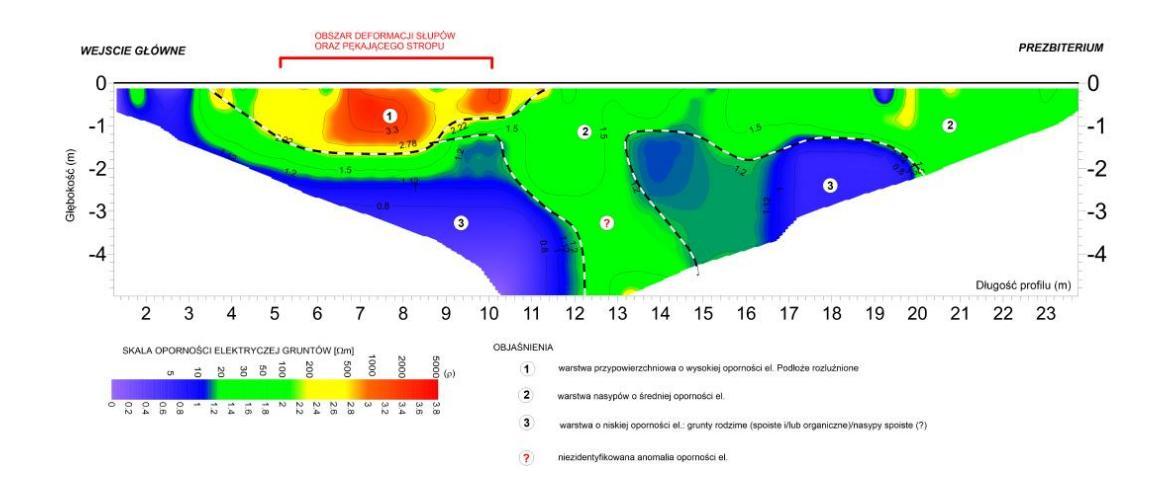
Basic and extended geotechnical surveys of the ground under the building and in its immediate vicinity were also performed. Basic research included geotechnical drilling and probing [33]÷[36] and installation of piezometers, advanced geophysical methods were used for extended research: electroresistance tomography (ERT) [37]÷[39], georadar (GRP) [40]÷[43] and multi-channel surface wave analysis (MASW) [44]÷[45]. Selected results of the above-mentioned studies are presented in Fig. 4, Fig. 5 and Fig. 6, as well as described in [24]÷[25], [31], [46]÷[49].

Fig. 4. Electrofusion profile made along the southern aisle of the Basilica of St. St. Mikołaja in Gdańsk based on measurements using electroresistance tomography (ERT) [31]

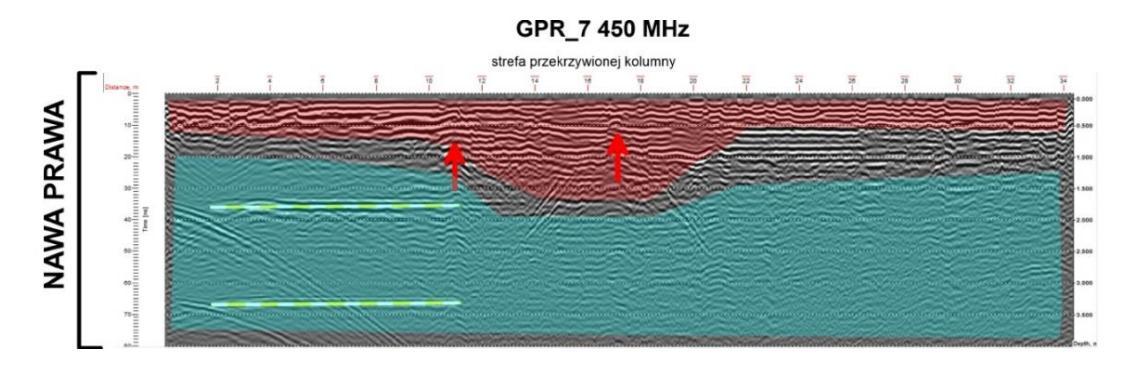
Fig. 5. Selected 450 MHz georadar echogram in the area of the southern aisle of the Basilica of St. St. Mikołaja in Gdańsk based on measurements using GPR [31]

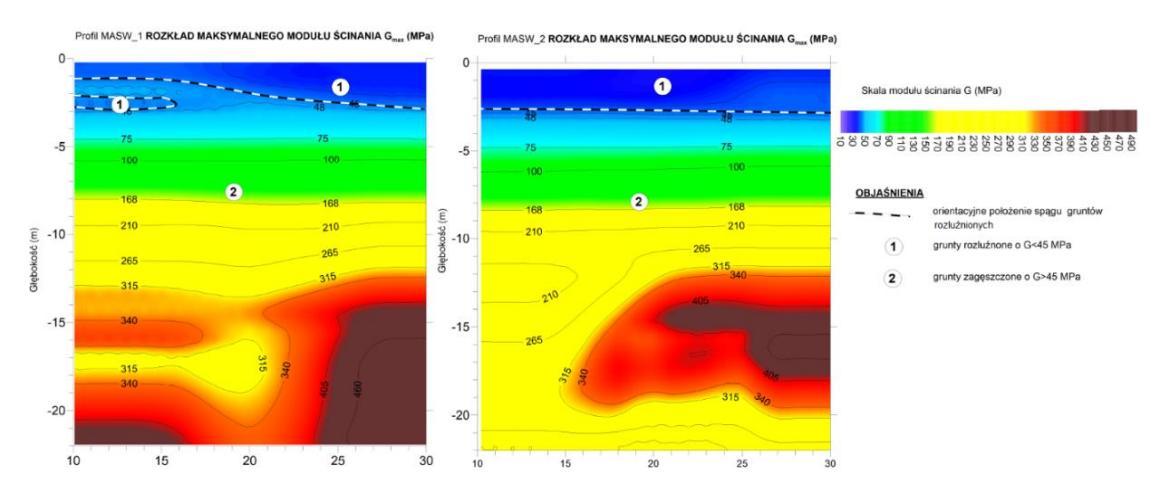
Fig.. 6. Distributions of the *Gmax* shear modulus values in the axes of the southern aisle (left figure) and the northern aisle (right figure) of the Basilica of St. St. Mikołaja in Gdańsk based on measurements using multi-channel surface wave analysis (MASW) [31]

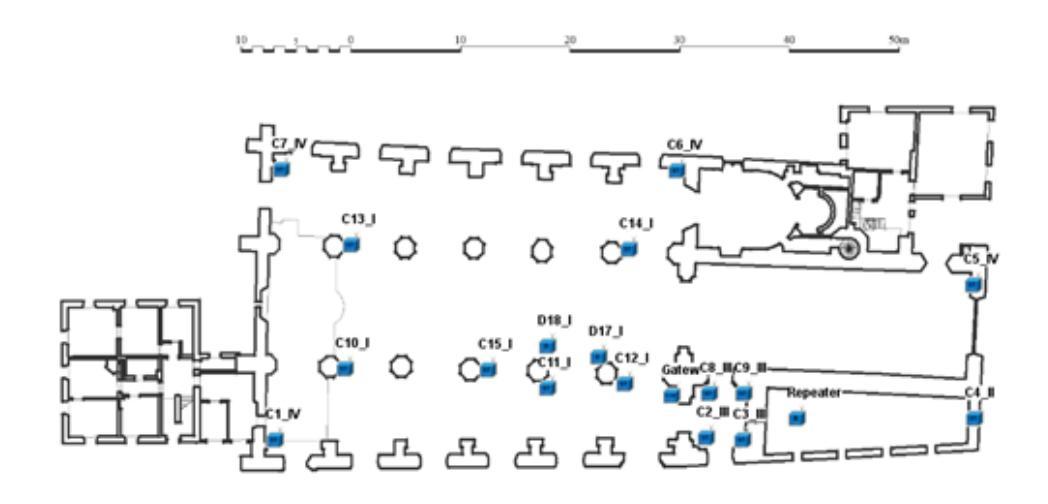
Simultaneously with the works protecting the building structure from collapsing, the *Measurement system* [50] was developed, the aim of which was to automatically measure the deformations (displacements and deflections) of building structural elements selected for ongoing and continuous monitoring. The measurement system was developed in cooperation with and on the basis of devices provided by Leica Geosystems. On the walls and pillars of the building, radio sensors of displacement (D) or inclination (C) based on a wi-fi network have been installed. All sensors included in the system are equipped with an ambient temperature measurement module. Access to the results is possible remotely via the website. The sensors are battery-powered, which makes them resistant to interference and power failures. Fig. 7 and Fig. 8 show the location of the mounted sensors on the projection and cross-section of the Basilica building.

Fig. 7. Floor plan of the Basilica of St. St. Mikołaja in Gdańsk with the location of measuring

sensors marked (own elaboration) [50]

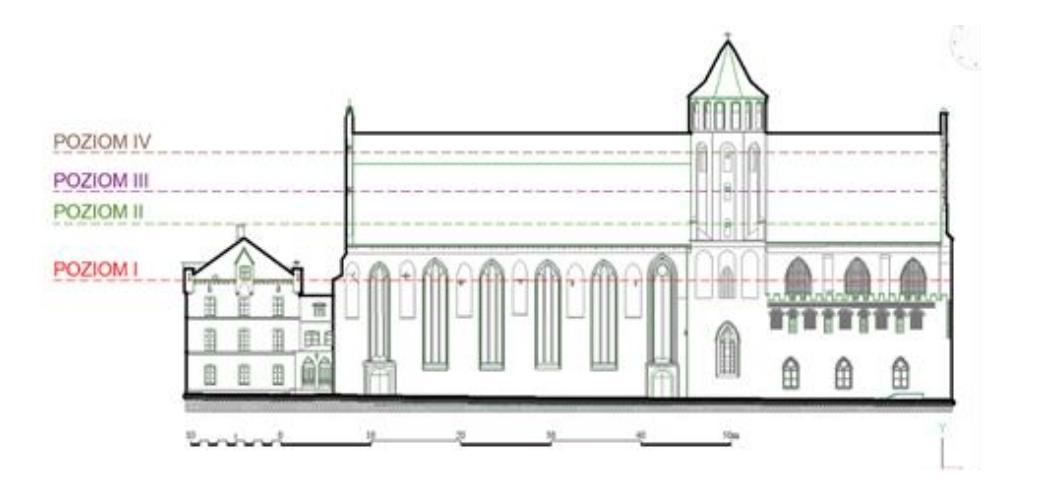
Fig. 8. Vertical (longitudinal) section through the Basilica of St. St. Mikołaja in Gdańsk with marked levels of measuring sensors placement (*own elaboration*) [50]
