## **On the current state of dovetail wall-corner joints in wooden Greek Catholic churches in Polish Subcarpathia with structural and sensitivity analyses**

# On the current state of dovetail wall-corner joints in wooden Greek Catholic Churches in Polish Subcarpathia with structural and sensitivity analyses

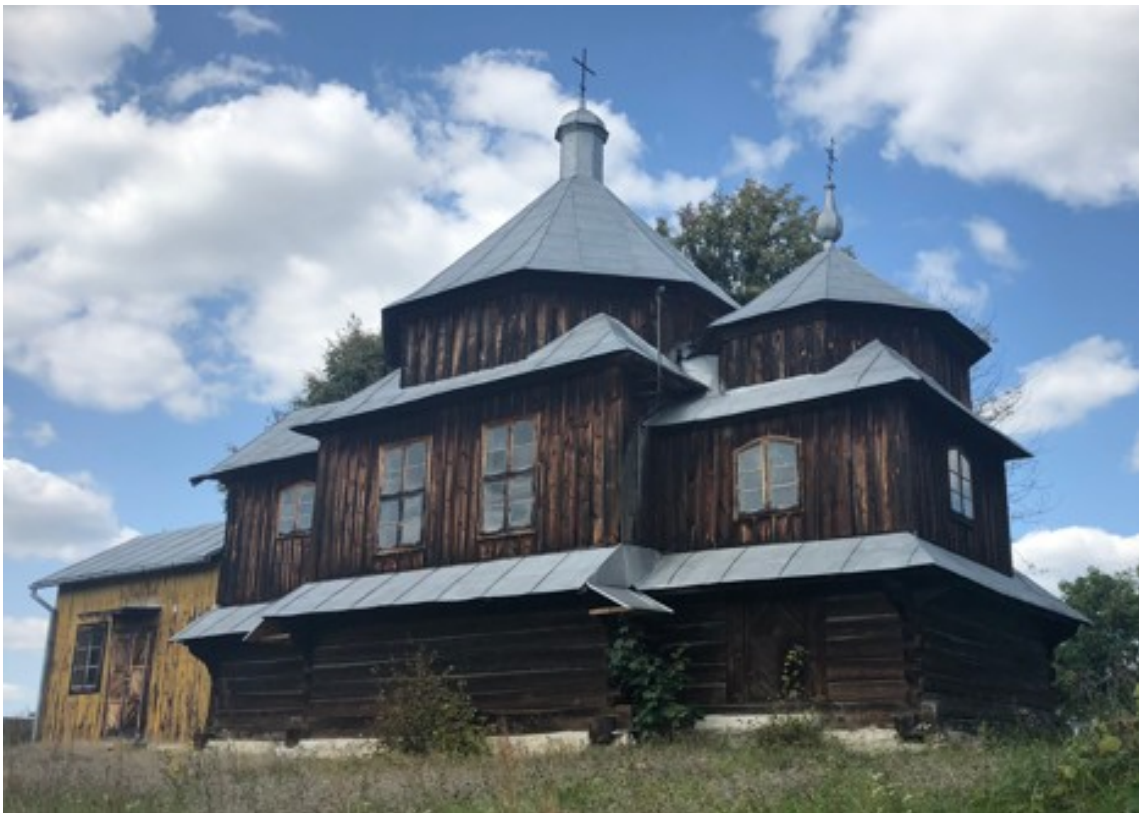
Figure 3. The church in Chotylub.

The church is located in the village centre, on a hill by the local road. It is surrounded by rural buildings. The church foundations are made of crushed stone and lime mortar. Dovetail log walls are made of fir wood and have no wood siding so the log construction is visible inside and outside the church. The construction of the roof is of the rafter-collar type and the roof is covered with galvanized steel sheets. The church is longitudinal in plan with the entrance through the vestibule (Figure 8). The church is tripartite and consists of the women's section, the nave and the sanctuary with the sacristy. The dominant feature of the church is the dome situated above the nave and topped with an iron cross (Zawaleń 1997).

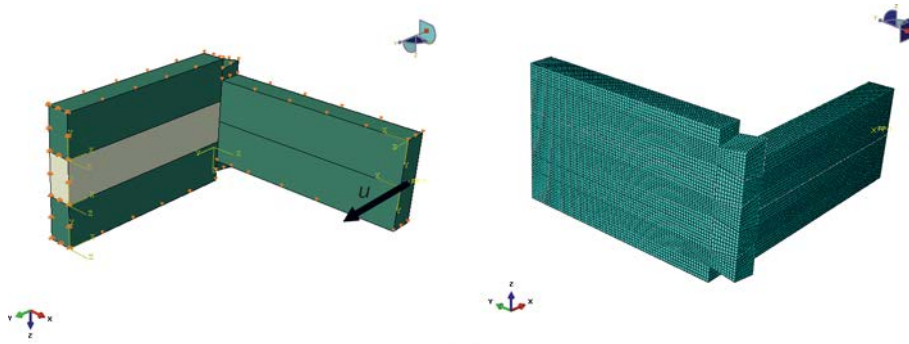
This motivated the authors to perform a study of the influence of a change in the material properties of joint members on the mechanical behaviour of dovetail corner joints. Numerical models of dovetail corner joints containing 5 logs (Figure 12) representing the joints observed in the churches were defined by means of the finite element method. This methodology is used in assessments of the state of historic structures for timber buildings (see e.g., (Armesto et al. 2009)) as well as masonry ones

forming one side of the joint were fixed. This means that in the numerical model all three degrees of freedom of each node of the logs cross-sections were fixed while the other two logs were displaced along the  $y$ -direction by  $u_y = 5$  cm in the global system of coordinates of the model (the local  $z$ -direction, see Figure 12) resulting in a change of the corner angle. The applied displacement is greater than that observed in the churches investigated but in this way the trend in the mechanical behaviour is highlighted. The bottom surfaces of most bottom logs and the top surfaces of most top logs were fixed in the global  $z$ -direction (vertical) as shown in Figure 12 to reflect the effect of the foundations and the rest of the wall.

Figure 12. Dovetail log joint model for FEM analysis, boundary conditions and finite element mesh.

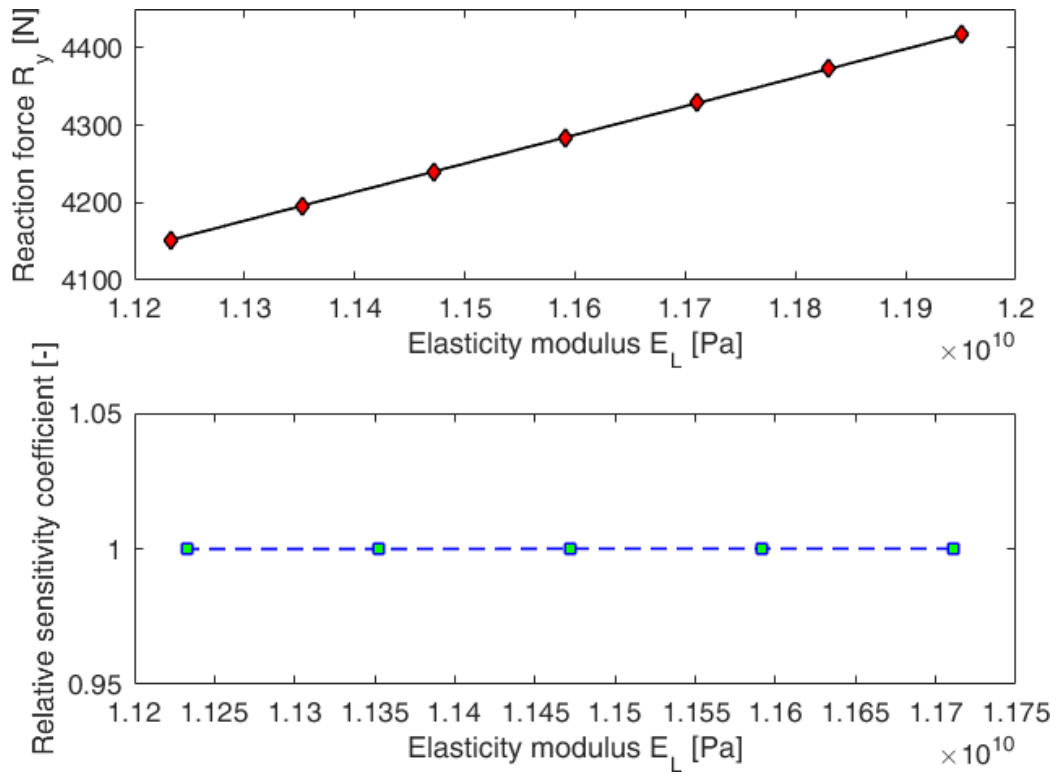
Two types of joint were considered in the study. First it was assumed that the joint is made of dry wood. In this case the Young's modulus does not differ much between old and new wood according to laboratory tests (internal report of Grant No. 2015/17/B/ST8/03260). The Young's modulus in the analysis varies from 11.233 GPa to 11.95 GPa. In the case of a parametric change of the material properties of the whole joint, the change of the reaction force is almost linear so the sensitivity is represented by a constant function (Figure 15). Here it will be represented by the relative sensitivity coefficient which is close to 1. In the second variant, the joint was built of old, damp wood but one of the five logs had been replaced with a new one. The elasticity moduli of

Figure 15. Sensitivity of reaction force due to variation of the modulus of elasticity in dovetail joint where all five logs have the same variable stiffness.

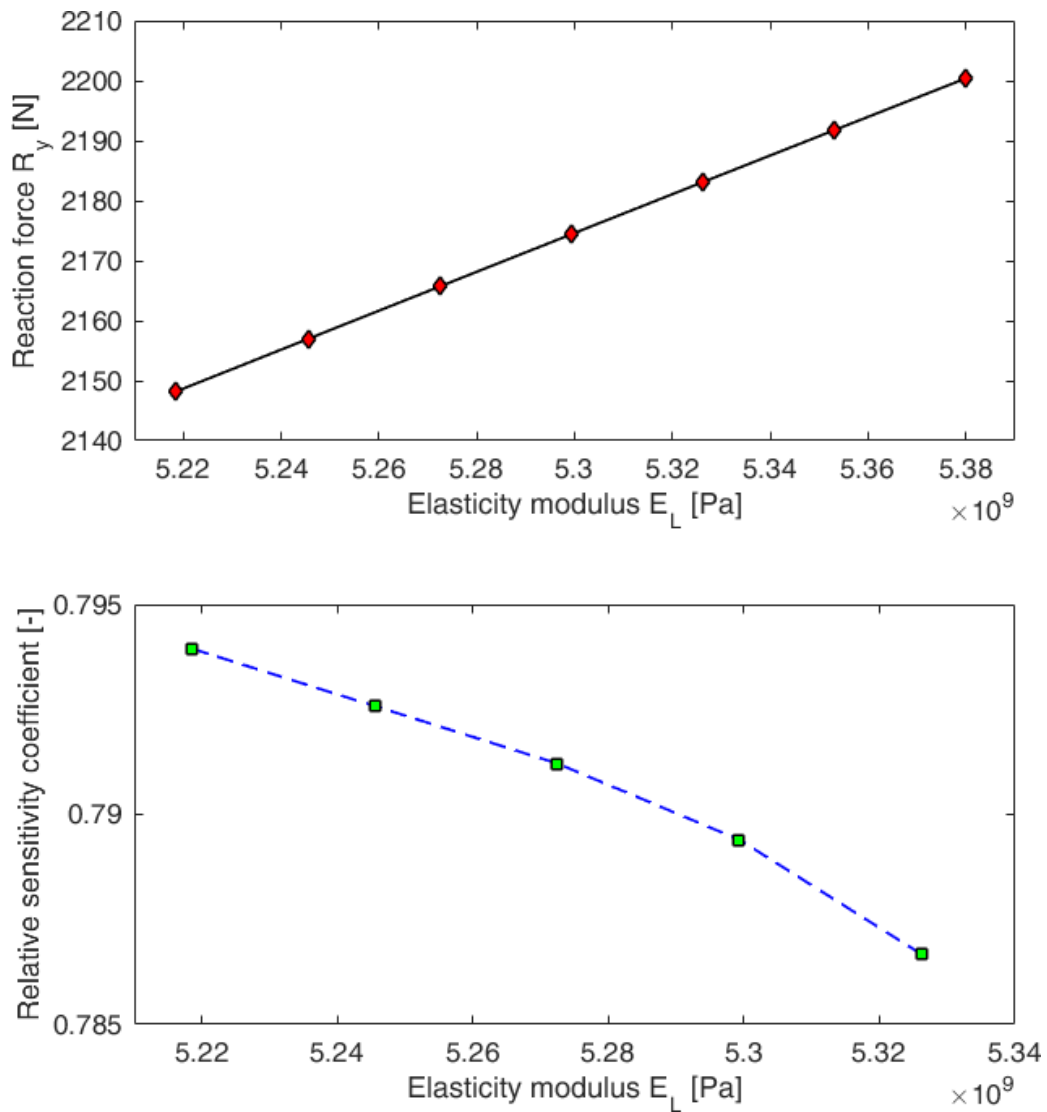
the old logs (5.38 GPa) and the new ones (11.95 GPa) in the same joint then differ significantly. In this variant some variations was assumed of the Young's modulus of the old wood, since the material properties in this case may not be easy to identify. The range of  $E_L$  in the analysis is 5.218 GPa to 5.514 GPa. In this case the sensitivity of the reaction force  $R_y$  due to the change of the stiffness of the old wood is nonlinear, and the value of the relative sensitivity coefficient changes with the change of  $E_L$  as shown in Figure 16. It increases as the stiffness of the old wood decreases. It therefore also grows with the difference between the two Young's moduli.

Figure 16. Sensitivity of reaction force due to variation of the modulus of elasticity in four logs of dovetail joint while one log is new and its stiffness is known and does not vary.
