On the current state of dovetail wall-corner joints in wooden Greek Catholic churches in Polish Subcarpathia with structural and sensitivity analyses

On the current state of dovetail wall-corner joints in wooden Greek Catholic Churches in Polish Subcarpathia with structural and sensitivity analyses

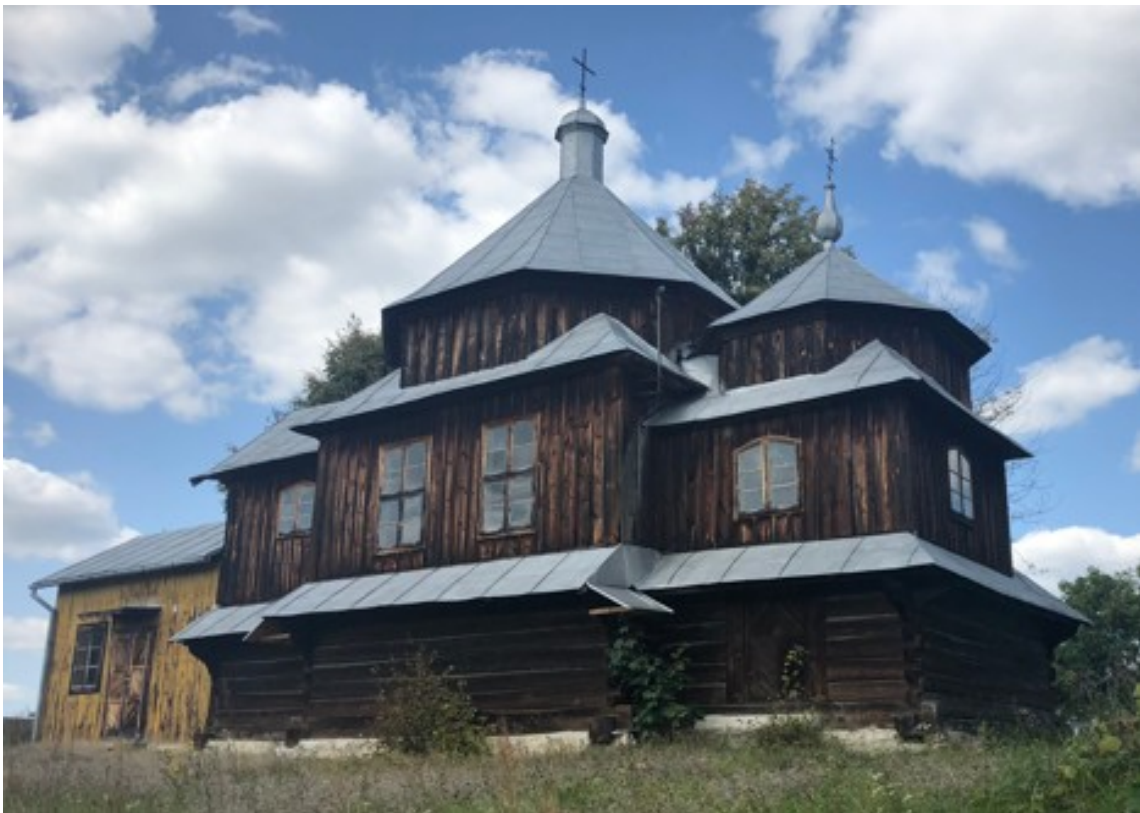
The church is located in the village centre, on a hill by the local road. It is surrounded by rural buildings. The church foundations are made of crushed stone and lime mortar. Dovetail log walls are made of fir wood and have no wood siding so the log construction is visible inside and outside the church. The construction of the roof is of the rafter-collar type and the roof is covered with galvanized steel sheets. The church is longitudinal in plan with the entrance through the vestibule (Figure 8). The church is tripartite and consists of the women's section, the nave and the sanctuary with the sacristy. The dominant feature of the church is the dome situated above the nave and topped with an iron cross (Zawaleń 1997).

Figure 3. The church in Chotylub.

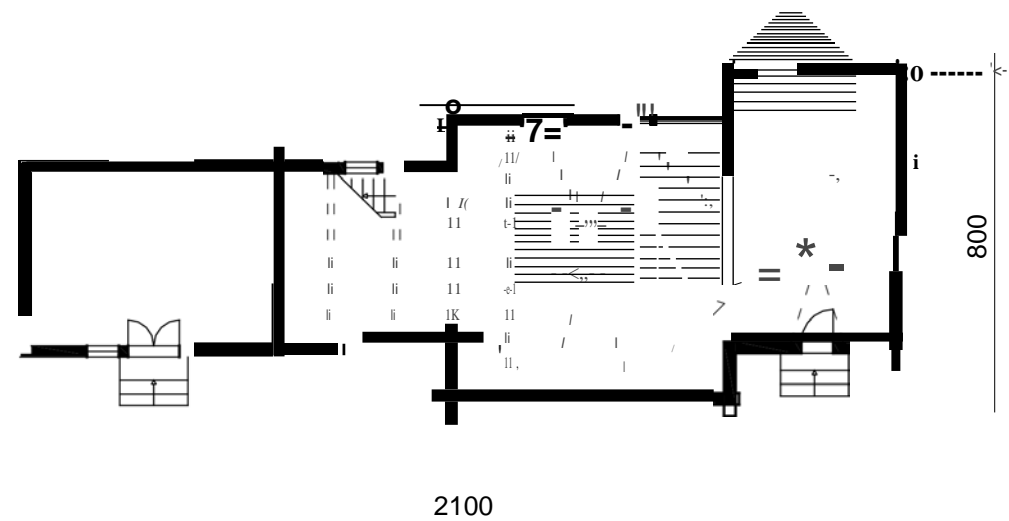
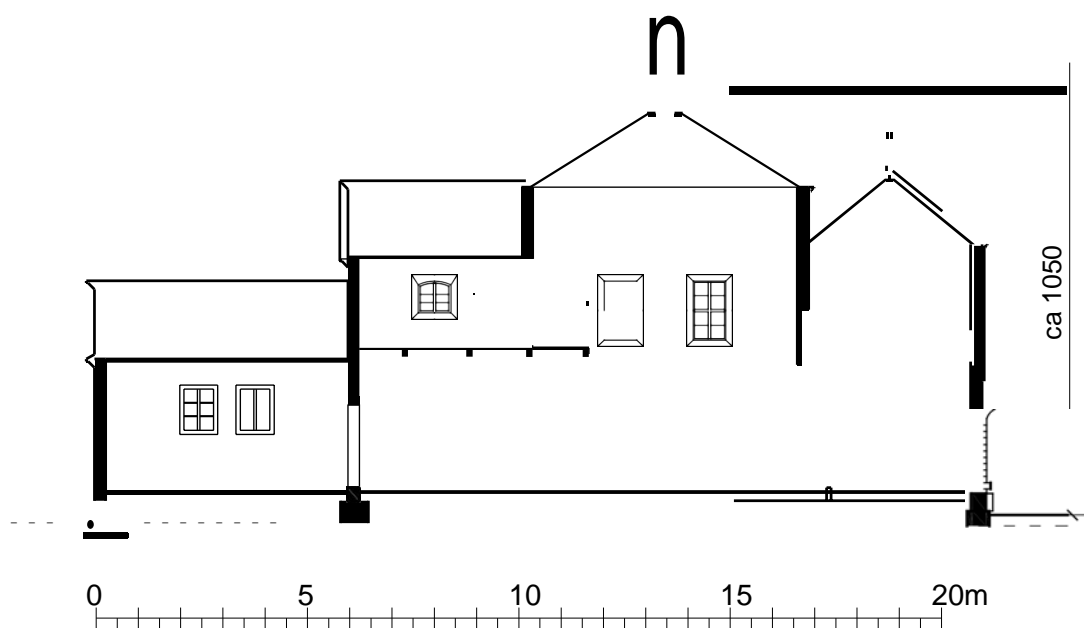
CHOTYLUB

Figure 8. Longitudinal cross-section and plan of the church in Chotylub.

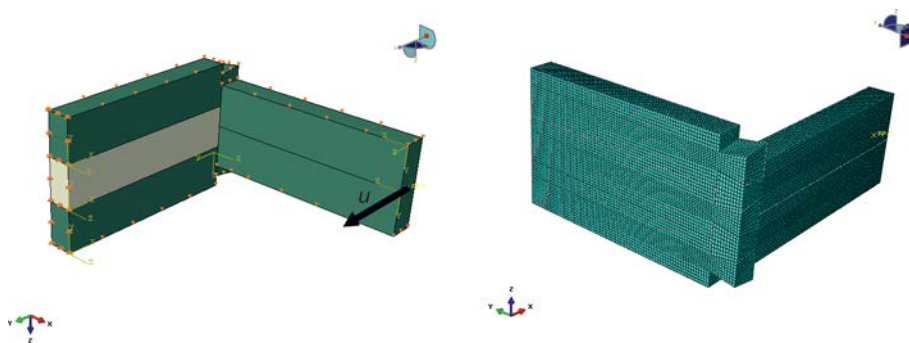
forming one side of the joint were fixed. This means that in the numerical model all three degrees of freedom of each node of the logs cross-sections were fixed while the other two logs were displaced along the y -direction by $u_y = 5$ cm in the global system of coordinates of the model (the local z -direction, see Figure 12) resulting in a change of the corner angle. The applied displacement is greater than that observed in the churches investigated but in this way the trend in the mechanical behaviour is highlighted. The bottom surfaces of most bottom logs and the top surfaces of most top logs were fixed in the global z -direction (vertical) as shown in Figure 12 to reflect the effect of the foundations and the rest of the wall.

Figure 12. Dovetail log joint model for FEM analysis, boundary conditions and finite element mesh.
