Problem of Clogging in Drainage Systems in the Examples of the Żur and Podgaje Dams

Witold Sterpejkowicz-Wersocki

Gdańsk University of Technology, Faculty of Civil and Environmental Engineering,
ul. G. Narutowicza 11/12, 80-233 Gdańsk, Poland, e-mail: wste@pg.gda.pl

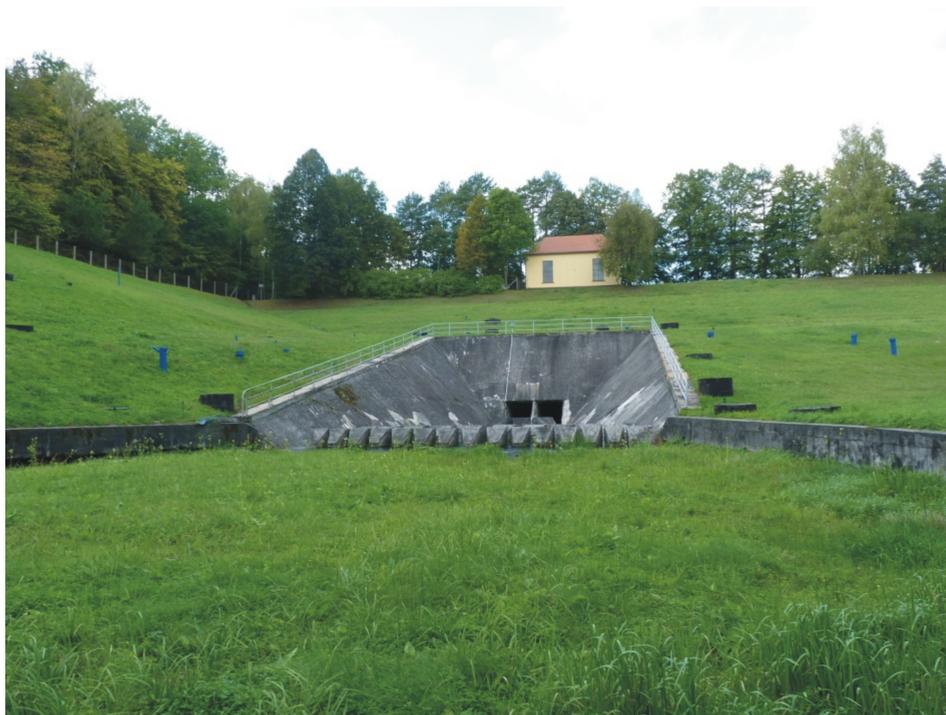
The earth dam in Żur was built in 1928–1930 (Fig. 1). It dams up the Wda (Black Water) river to the elevation of 67.5 m above sea level. The length of the dam at the crown is 175 m, crown elevation 70.0 m a.s.l., base elevation about 52.0 m a.s.l. It is an earth dam sealed with an internal clay core.

The main technical problem that occurs during the lifetime of the earth dam are filtration phenomena, in particular the rising of the phreatic line, caused by the clogging of the drainage system.

Fig. 1. General view of the Zur earth dam and the bottom outlet

In the mid 1970s, a decision was made to build a new drainage system, as the rock toe filter had been clogged, and it was pointless to renovate the filtration capacity

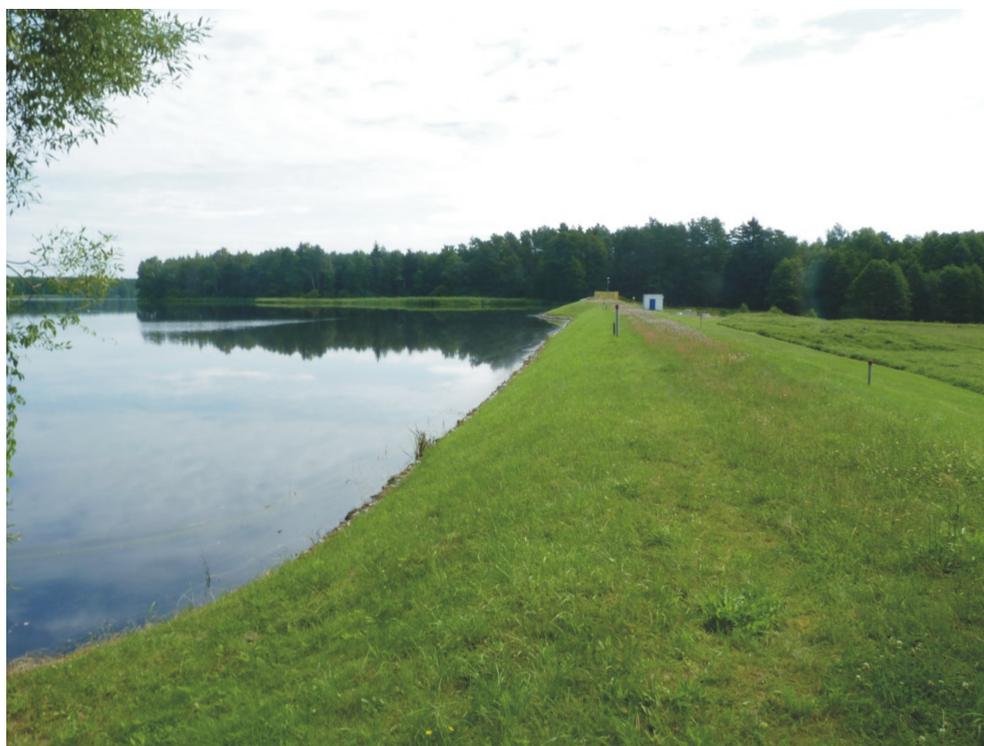
Fig. 2. General view of the Podgaje earth dam

This earth dam is also afflicted with cyclical drainage dysfunctions caused by clogging with iron compounds. Its present drainage system was constructed in 1991. It consists of ceramic drainage pipes, a sand filter, and a geotextile.

During operation, a slow but steady increase in pressure filtration can be observed. Inside wells and drainage pipes, clogging is caused by iron oxide in the form of fer-
