# Renovation works in buildings in the area of former defensive fortifications

Maciej NIEDOSTATKIEWICZ<sup>\*1</sup>, Tomasz MAJEWSKI<sup>2</sup>, Adam BARYŁKA

<sup>1</sup> Department of Engineering Structures, Faculty of Civil and Environmental Engineering, Gdańsk University of Technology, Gdańsk, Poland

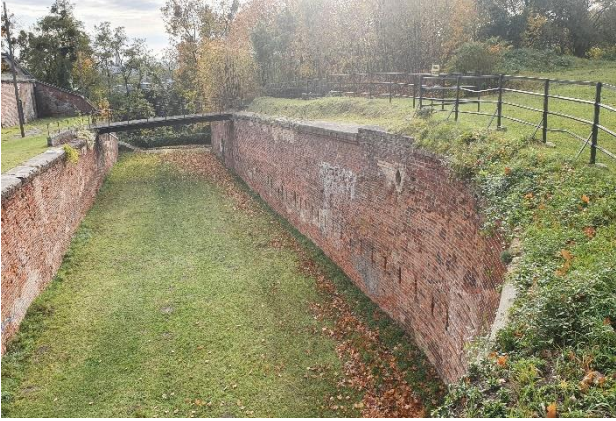
A general view of the defensive rampart to which the Complex of Buildings covered by the study adjoins is shown in Photo. 1. Former office rooms (A) were created by using a part of the historical wall and aligning it with the completion of the defensive rampart. The extension of the wall are the rooms of the former service apartment (B), part of which is the historic buildings of the Southern Guardhouse. The former service apartment (B) was added to the front wall and the gable wall of the former office premises (A) in the later period, as evidenced by the lack of a full masonry bond at the junction of the walls and a different type of brick from which the wall was made (Photo 2). Utility rooms (C) perpendicularly adjoin the body of the former service apartment (B) (Photo 3). The wall on the back side of the former office rooms (A) was built with faults, probably with the use of brick reinforcements of the escarpment (Photo 4).

**Photo. 1:** Widok ogólny szańca obronnego przylegającego do Zespołu Budynków

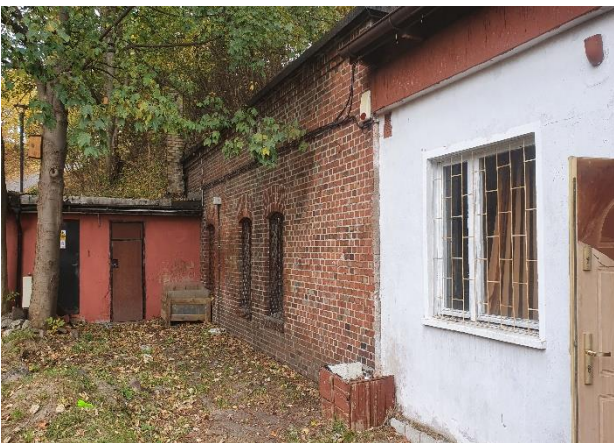
**Photo. 3:** Utility rooms (C) adjacent to the former service apartment (B)
