# Revitalizing the Sacral Complex of the Parish of the Sacred Heart of Jesus in Gdynia: A Comprehensive Restoration Project in Alignment with Monument Conservator's Guidelines and Technical Prerequisites

Maciej NIEDOSTATKIEWICZ<sup>\*1</sup>, Jacek BRAMORSKI<sup>2,3</sup>

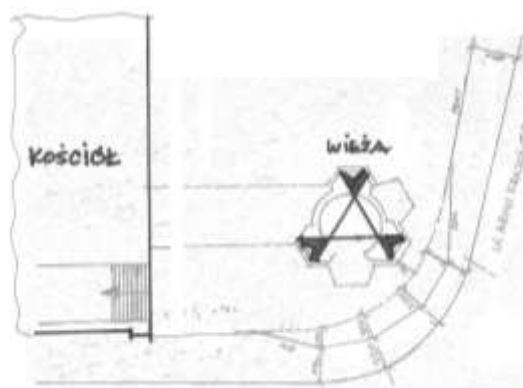
**Fig. 3.** The bell tower of the Church of the SHoJ in Gdynia - cross section

Church bell tower SHoJ was implemented on the basis of socially developed project documentation (Photo 1). The author of the architectural design was MSc Eng. Arch. Julian Demczuk, while the author of the structural design was MSc Eng. Henryk Płociński. The function of the structural design verifier was performed by MSc Eng. Władysław Buczkowski. The spatial, openwork structure of the tower was designed and made as reinforced concrete, monolithic, made of concrete class  $R_w=170$  atm., reinforced with ribbed steel bars A-III class 34GS (structural reinforcement) and smooth bars made of A-0 steel, St0 mark (stirrups). In cross-section, the tower has the shape of an equilateral triangle, in the corners of which there are reinforced concrete, monolithic columns with a V-shaped cross-section (pole designation: A, B, C) (Fig.3).

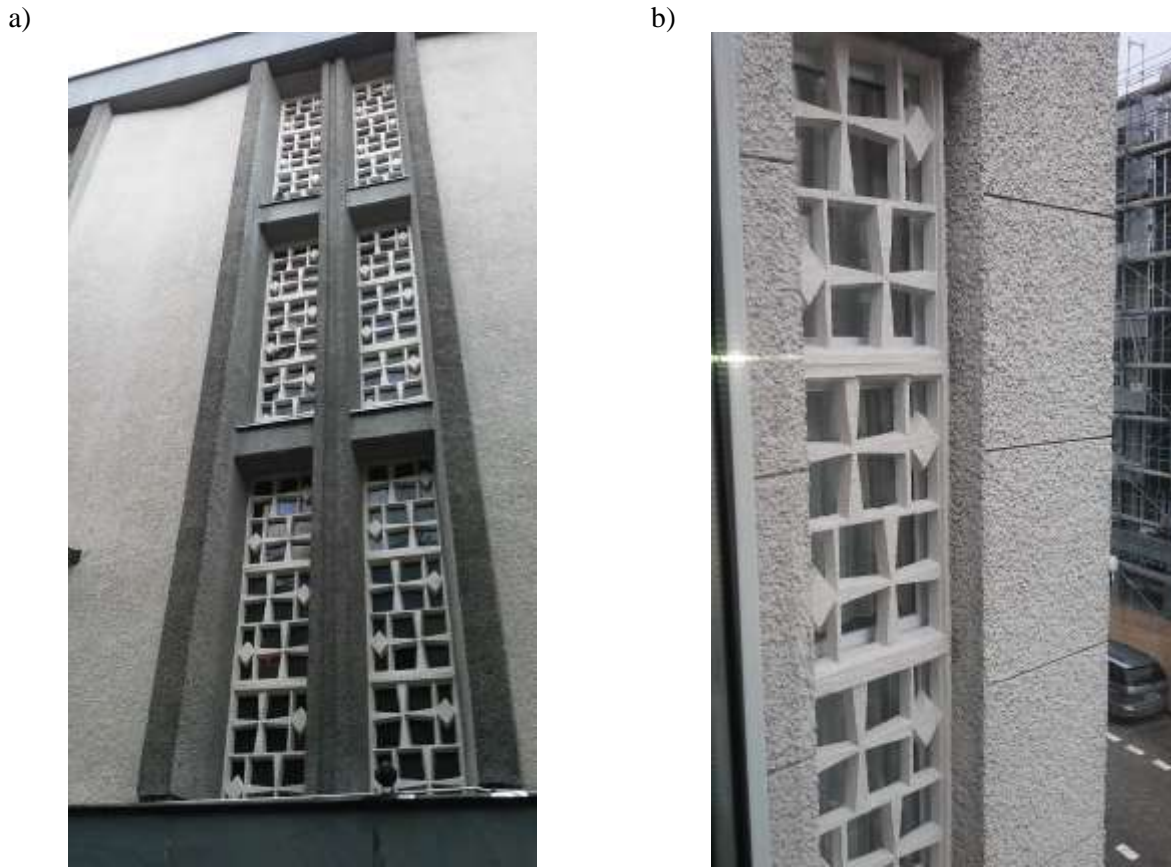
**Photo 18:** The condition of the facade from the south (along Armii Krajowej Street) after cleaning: a) view of the facade plaster, b) concrete window frames after revitalization (name of the street as of 2023) (photo by Jacek Bramorski)

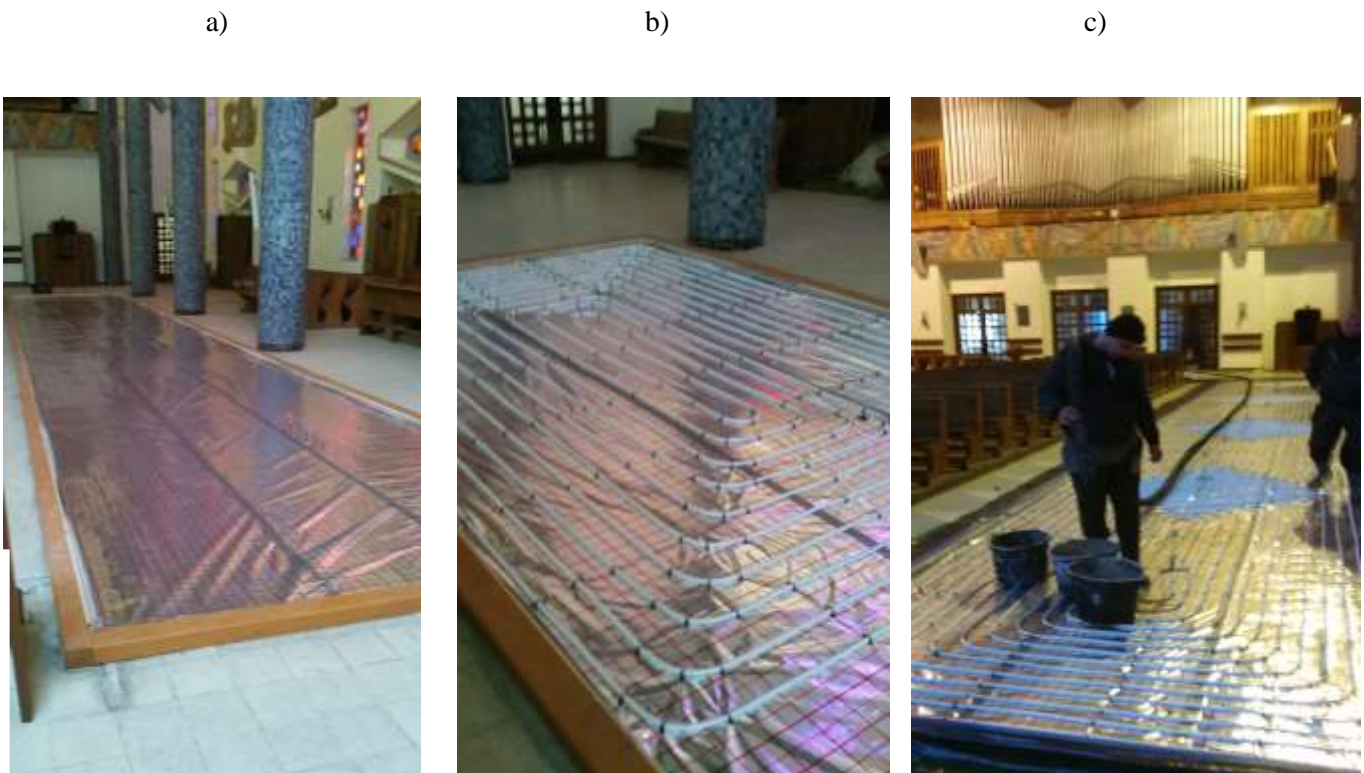
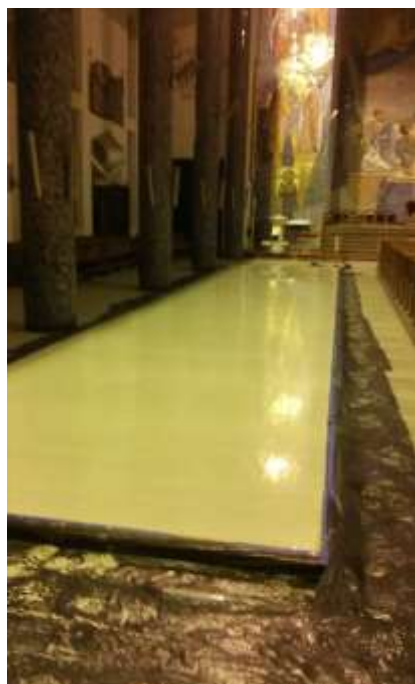
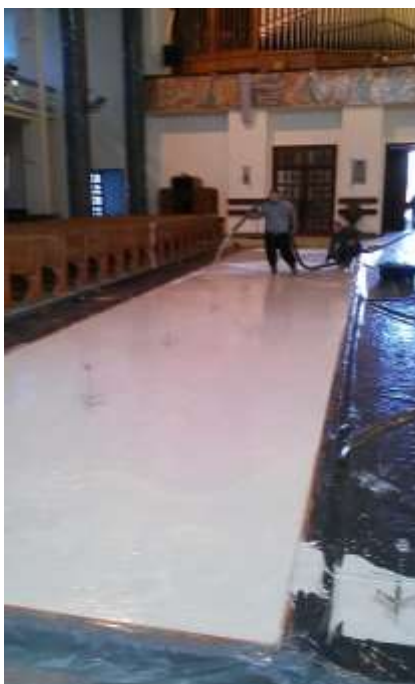
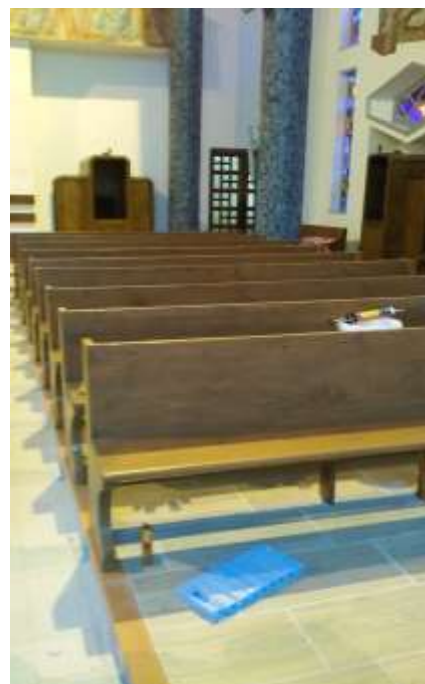
**Photo 19:** Installation of underfloor heating in the Church of the SHoJ in Gdynia in the rooms of the so-called of the upper church: a), b), c), d), e), f) stages of work (photo by Jacek Bramorski)

Underfloor heating has been installed in the so-called upper church. Loops with a heating medium were arranged under three rows of benches - the installation of underfloor heating did not require changing the arrangement of the benches, functioning in the so-called the upper church in an unchanged form until it is made available to the faithful. The implementation of the water-type underfloor heating was carried out on the basis of a design study - an executive design. During the works related to the installation of underfloor heating, special attention was paid to the fact that the thickness of the layers of thermal insulation material and the concrete screed was selected in such a way as to protect the heating installation against the possibility of heat loss (thickness of the thermal insulation material) and the possibility of damage to the heating loops (thickness of the concrete screed (anhydrite) ), on the other hand, so that the installation of underfloor heating does not make it necessary to rebuild (raise) the existing platforms under the benches. The heating center was installed on the level of the upper church. The individual stages of work related to the installation of underfloor heating in the so-called the upper church is shown in Photo 19.
