Research paper

Settlement of a historic building due to seepage-induced soil deformation

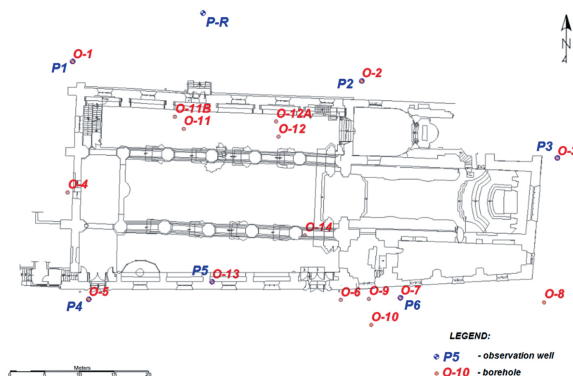
Fig. 4. Location of subsoil test boreholes and groundwater level observation piezometers [40]

Extensive diagnostics [39–43], typical for historic buildings situated within a dense urban development, which covered the Basilica and its adjacent area, involved also detailed soil testing and the installation of piezometers for observing water levels in the subsoil. Locations of test boreholes and implemented piezometers are shown in Fig. 4.

The piezometers were located around the temple with cyclical observations conducted. The measured water table levels are listed in Table 2.
