# Thermal failure of a second rotor stage in heavy duty gas turbine

Daniel Sławiński<sup>(1)</sup>, Paweł Ziółkowski<sup>(2)</sup>, Janusz Badur<sup>(1)</sup>

<sup>(1)</sup> Institute of Fluid-Flow Machinery, Polish Academy of Sciences, Fiszerza 14, 80-231, Gdańsk, Poland

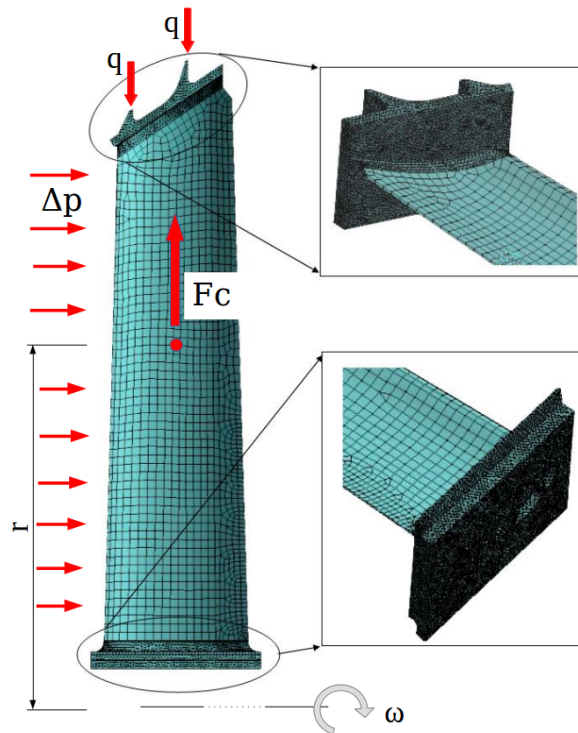
22 To perform the numerical simulation, we executed a 3D blade model for the blade prior to the  
23 failure. In the model (Fig.5) the exact shape of the upper bandage and a small portion of the  
24 blade foot are reproduced to determine the causes of the crack at the base of the profile. The  
25 geometry of internal flow channels for cooling the blade was also mapped.

1  
2 Figure 5 Model of a blade before destruction after its discretization with a mesh of  
3 finite elements and marked boundary conditions.
