# Typology, current state and non-destructive testing of timber roof trusses of historic churches in the West Vistula Delta, Poland

## Abstract

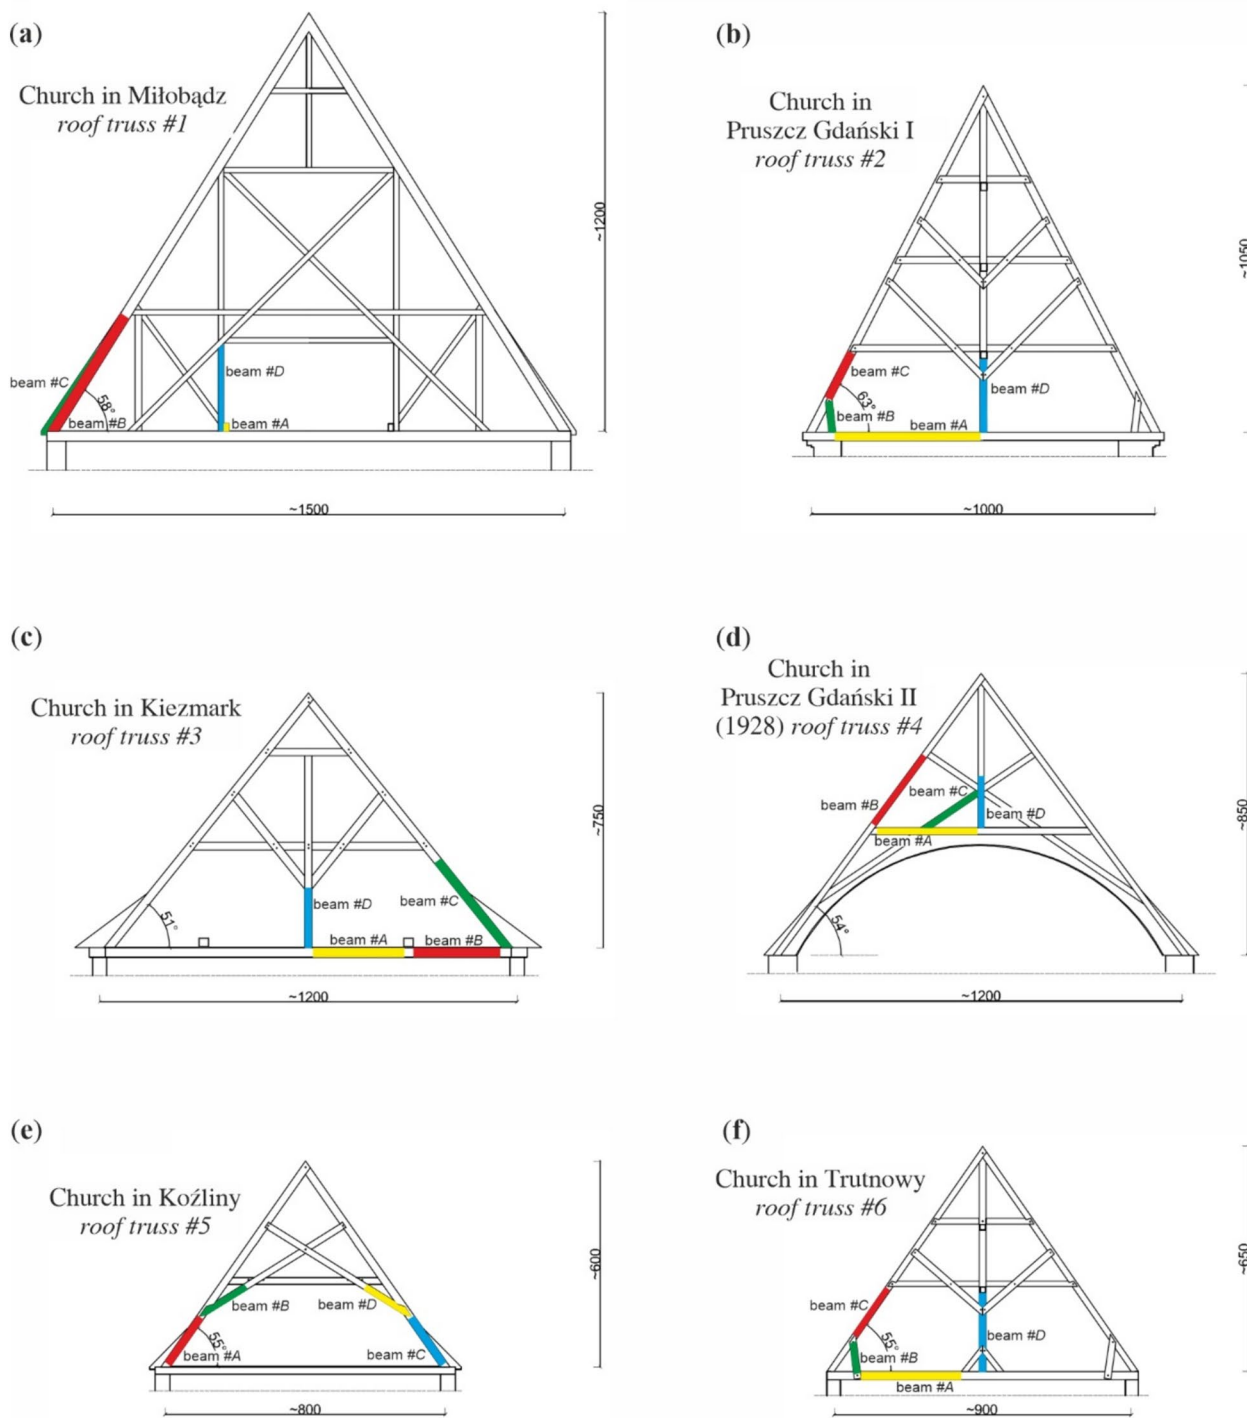
**Fig. 4** Geometry and girders of the roof trusses with the indication of the measured timber elements, churches in: **a** Miłobądz (#1) **b** Pruszcz Gdański I (#2) **c** Kiezmark (#3) **d** Pruszcz Gdański II (#4) **e** Koźliny (#5) **f** Trutnowy (#6)

The analysis shows that the most common type of roof truss in the historic churches located in Żuławy is the king post truss (Figs. 4, 5b, c, f). In church #5 (Fig. 5e) there is a collar beam truss with struts, in church #4

(Fig. 5d) there is a scissor truss. In the church #1 (Fig. 5a) there is an attic truss shaped similar to that of the previous structure, that one from before the war damage.

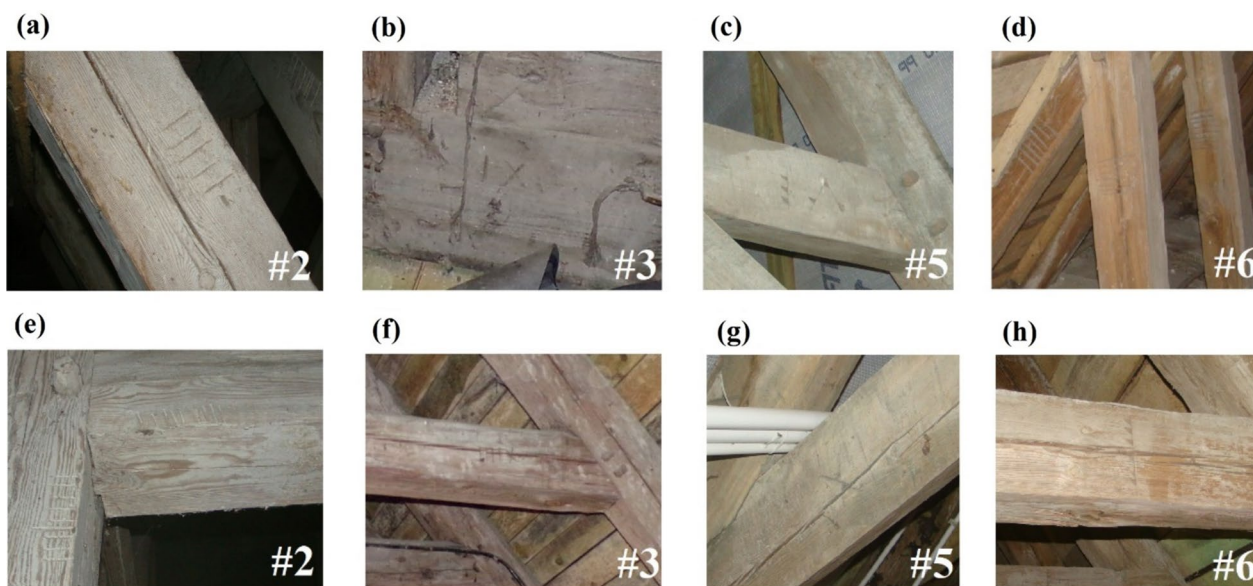
**Fig. 7** Carpenters' marks on roof trusses: **a** and **e** Pruszcz Gdański I (#2), **b** and **f** Kiezmark (#3), **c** and **g** Koźliny (#5), **d** and **h** Trutnowy (#6)

(Fig. 2). The state of conservation of the trusses is good, the roofing is waterproof and the gravity ventilation of the attics is intact (Table 1). Only the roof trusses built before the twentieth century (churches #2, #3, #5, #6) have carpentry marks (Fig. 7).
