# B. Trybuś<sup>1</sup>, J. M. Olive<sup>2</sup>, N. Lenoir<sup>3</sup>, A. Zieliński<sup>1</sup>\*

# X-RAY COMPUTER TOMOGRAPHY STUDY OF DEGRADATION OF THE ZIRCALOY-2 TUBES OXIDIZED AT HIGH TEMPERATURES

Keywords: zirconium, oxide layers, high temperature, X-ray tomography, cracking, nodular corrosion

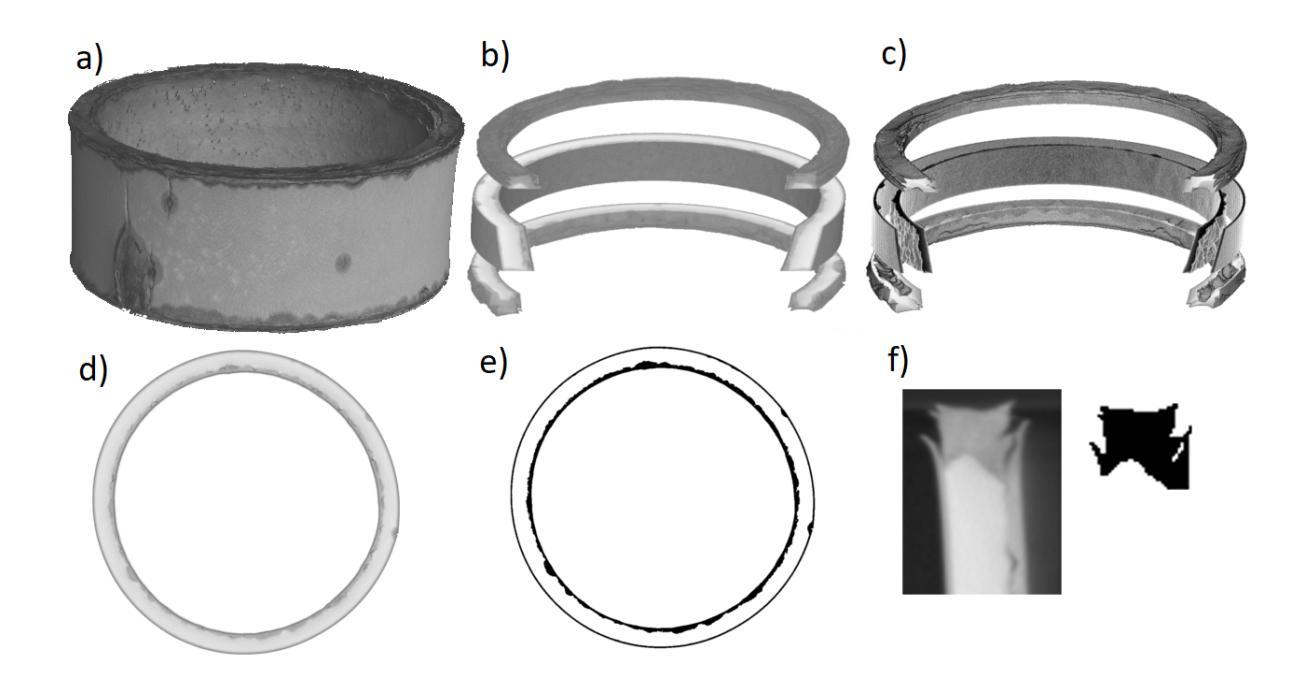
**Fig. 1.** a) X-ray tomography made the 3D view of sample oxidized at 1373 K and cooled in air, b) separated zones of an oxidized metal, c) separated zones of an oxide layer, d) view of the single slice of the transverse cross-section of the tube; **e)** binary image of the transverse cross-section of the tube, outer and inner oxide layers can be recognized, f) longitudinal cross-section of the tube and its binary image, the oxide layer at the top edge can be seen.

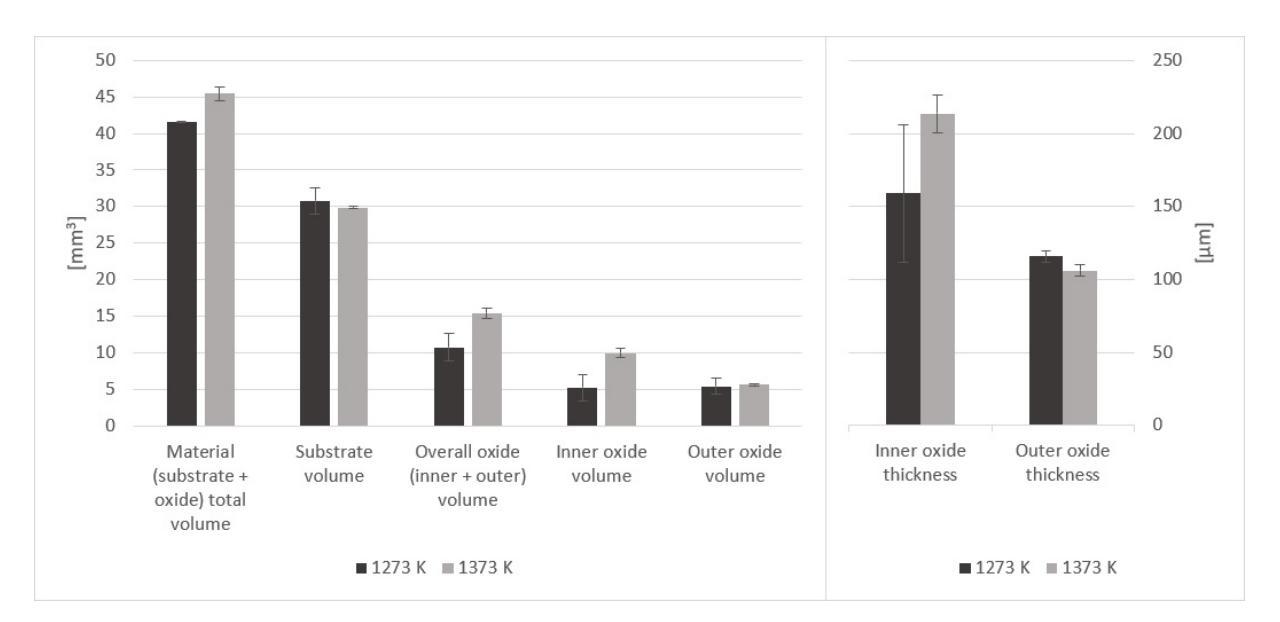
Relationships between the volumes and thickness of the oxide layers, and oxidation temperature and a place of oxidation (oxides grown on the internal or external surface of the tube, called later inner and outer oxides) are presented in Fig. 2. The increasing temperature resulted in an increasing oxide volume and thickness. Both surfaces revealed similar thickness of oxide layer after oxidation at lower temperature, and higher on internal surface after oxidation at 1373 K.

Fig. 2. Relation of the oxide layer volume and thickness on oxidation temperature and oxide layer placement (outside or inside the tube)

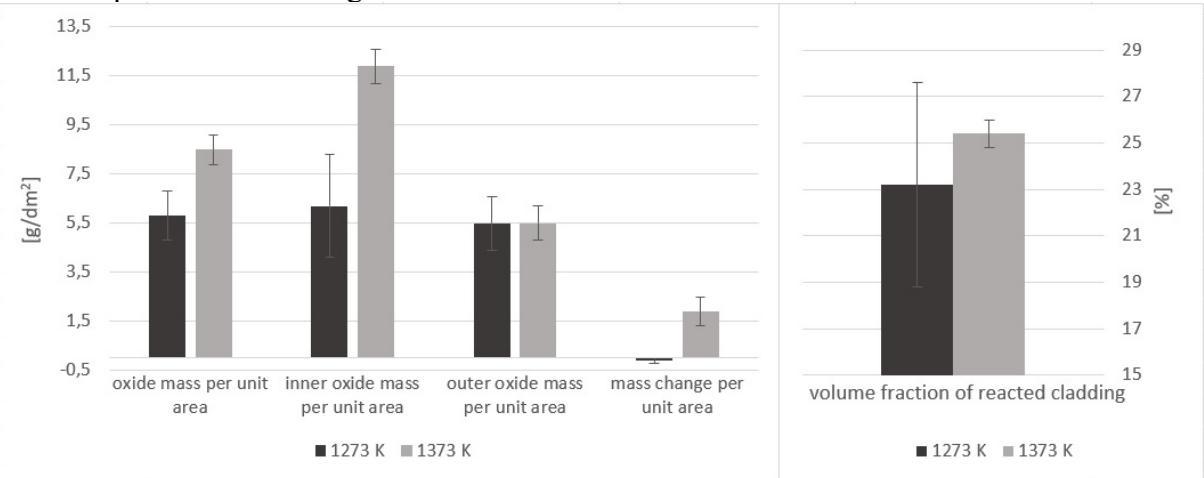
Based on the estimated number and volume of cracks in the oxide layer, the volume of oxide layer was arbitrarily reduced for each temperature and the place of layer, internal or external, e.g. about 20% for specimens oxidized at 1273 K. Figure 4 presents a change in mass per unit area in the middle section of the oxidized tube in comparison to the non-oxidized sample. The presented values were calculated based on the previously measured volumes of the middle section and volumes of oxide, and densities of the substrate alloy and the zirconium dioxide. The volume of reacted zirconium cladding determines previously oxidized part of the cladding.

Fig. 4. Oxide mass per unit area and volume fraction of reacted cladding obtained at different oxidation

The weight gains are consistent with the reference values for oxidation temperature of 1273 K, but after oxidation at 1373 K, they are slightly lower than reported so far [4,5,25]. This discrepancy is negligible and may be attributed to the specimen's geometry, different microstructure, difference between flat and curved surfaces, different environment (air instead of steam) and, in consequence, different oxide growth. The higher inner oxide thickness
