Analysis of the Ways to Identify Rail Running Surface Defects by Means of Vibration Signals

Summary

The article discusses a preliminary concept of a method enabling the identification of chosen rail running surface defects, such as squats, spalling, and running surface defects, by analysing the parameters of vibration signals. It features a description of the methodology of the conducted tests, the scope thereof, and the selection of the measurement points with specific defect types. The article covers selected results of vibration tests, the results of analyses of recorded signals for defective track sections and those for control track sections. The presented measurement results have been obtained for the technical–operating conditions occurring on railway line no. 213 Reda – Hel and line no. 131 Chorzów Batory – Tczew. The preliminary test results and conclusions included in the article show that it is reasonable to pursue further research into the phenomena involving the utilisation of vibroacoustics in rail performance diagnostics.

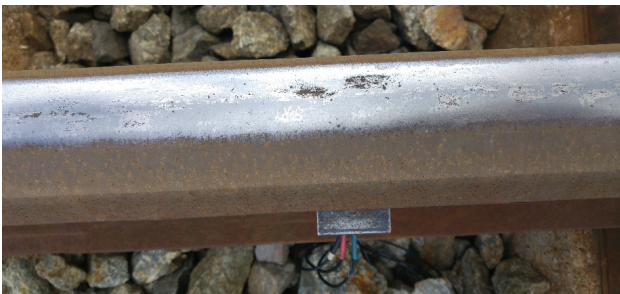
Fig. 2. Spalling defect on railway line no. 213 Reda – Hel [authors' own work]

The next defect is spalling, defect no. 2252 and no. 2251, single and multiple spalling in accordance with PLK's Catalogue of Rail Defects (Fig. 2). Spalling involves the damage of rail running surfaces resulting entirely from the standard use and operation of rails, found commonly on track sections where trains brake violently or where heavy freight trains are accelerated to operational speed. Spalling occurs most often before home signals as well as before level crossings and turnouts.

Spalling occurs symmetrically on both isolated rail sections and is identified by means of visual inspection. Recommended measures to be taken are observation, grinding, replacement or immediate replacement of the rail [3, 7].

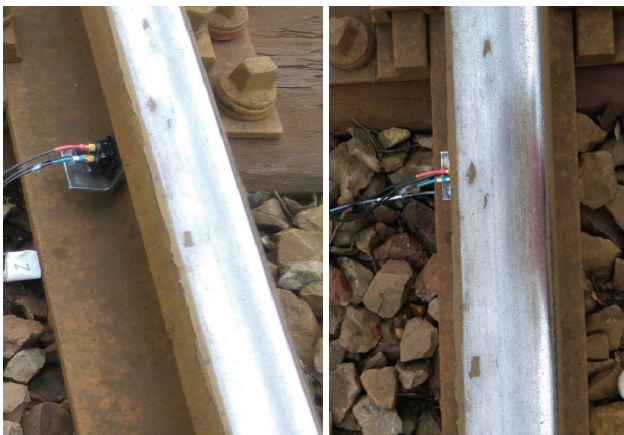
Fig. 3. Defect 221 – damage of the running surface on railway line no. 213 Reda – Hel [authors' own work]

The last of the analysed defects is the rail running surface defect no. 221 in accordance with PLK's Catalogue of Rail Defects (Fig. 3). Defect no. 221 appears only on the railhead during the standard use and operation of the track. It is damage with a metallurgical origin. Its most common manifestations include shelling of the running surface or groove-shaped cracks.

Damage 221 is identified most often by means of visual inspection. Depending on the degree of defect development, the recommendation is to inspect the rail visually on a continual basis, grind it or re-surface it [3].
