## APPLICATION OF GUIDED WAVE PROPAGATION IN DIAGNOSTICS OF STEEL BRIDGE COMPONENTS

M. RUCKA<sup>1</sup>, B. ZIMA<sup>2</sup>, R. KĘDRA<sup>3</sup>

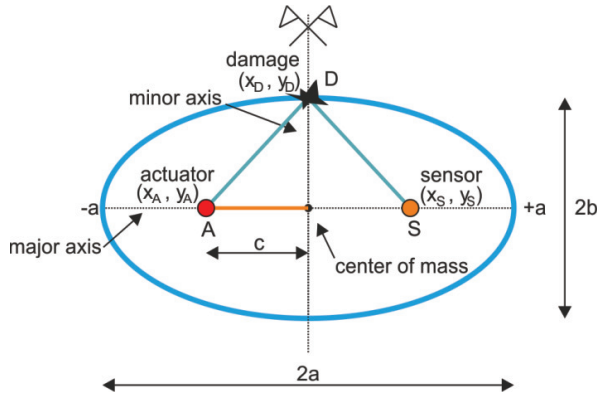
Fig. 7. Geometrical relationship between location of actuator (excitation point), sensor (registration point) and damage

It can be noticed that the distance is equal to the sum of position vectors in the ellipse which presents all possible damage locations in a plate (Figure 7). Because from a single signal only one value of the time-of-flight can be extracted, one solution in the form of the ellipse can be plotted. To obtain accurate position of damage, at least three ellipses must intersect with each other. A simple scheme of the procedure of determining the location of damage for configuration of three sensors and one actuator is presented in Figure 8.
