Aleksander Piwek*

Chapel at St. Joseph's Church in Gdańsk

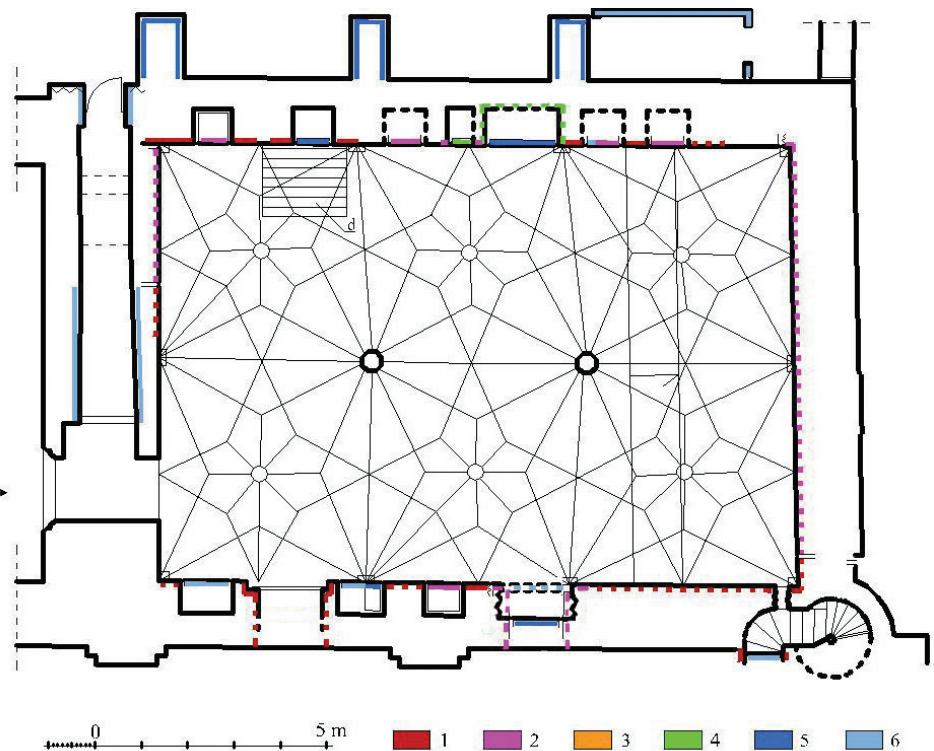
Fig. 2. Stratification of the walls of the chapel at St. Joseph's Church in Gdańsk on the ground floor (below the windows) and in the basement.

The letter "d" indicates the extent of the wooden trapdoor, different from the stone floor of the chapel.

The architectural analysis of the external surfaces of the walls brought some information about the history of the building, but much more was obtained by carrying out work in the interior of the chapel (Figs. 2, 3). The scope of the research undertaken was limited mainly to areas where the original plaster had not survived. In addition to fragmentary modern and younger painting decorations, conservators found medieval (consecration crosses) decorations on them. The original function of the described interior was therefore sacred, located within the present chapel space.

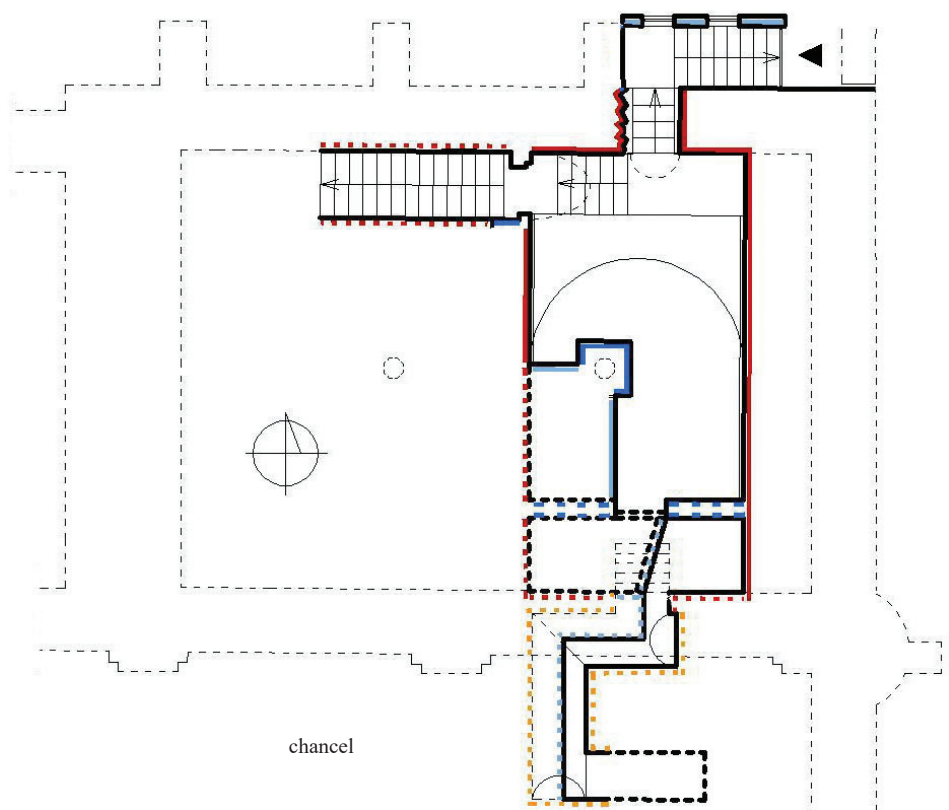
Fig. 3. View of the surface of the internal walls of the chapel at St. Joseph's Church in Gdańsk with marked traces of reconstructions: a) northern, b) southern, c) western (elaborated by A. Piwek)

An architectural analysis carried out on the inner side of the north wall revealed a considerable number of vertical grooves, connected to each other by segmental arches (Fig. 3a). The parts thus separated were found to be masonry of seven recesses. Three types were found among them. The first belonged to the first, second, fifth, sixth and seventh recesses (counting from the east wall) (Fig. 4a). They were 88–91 cm wide and 75–78 cm deep. The caps of the arches reached a height of 210–220 cm, while the edges of the base were 90 cm high (from the floor level). In recess five, the side walls (at the height of the fifth layer of bricks from its base) have a groove made up of two sloping walls. This is a remnant of a shelf. The recesses mentioned are original and date from the Middle Ages. They have been bricked up

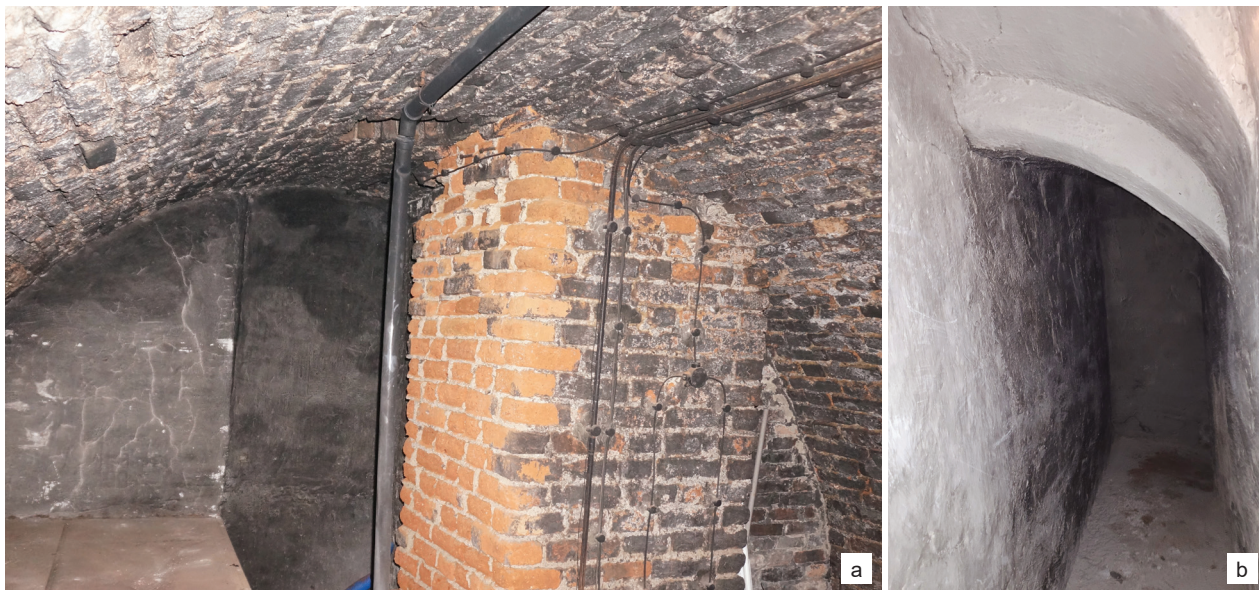
Fig. 6. Underground parts connected with the chapel at St. Joseph's Church in Gdańsk:
 a) a view of the interior of the crypt under the eastern part of the chapel towards the south,
 b) a fragment of the present corridor connecting the former crypt with the chancel (photo by A. Piwek)

of the brick covering were half covered by a bricked-up wall narrowing the passageway to 48–60 cm (Fig. 6b). It was probably made in the 20th century.
