# Comparison of Surface Quality and Tool-Life of Glulam Window Elements after Planing

### Original scientific paper • Izvorni znanstveni rad

**Key words:** planing process, pine wood, window frame, surface quality, 2D/3D surface texture

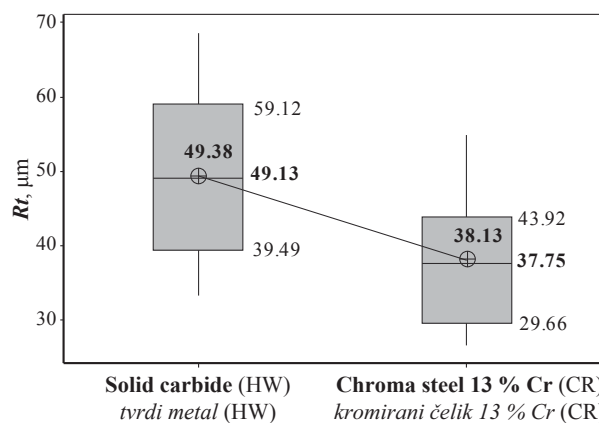
a) b)  
**Figure 6** The mean value and value dispersion of total height  $Rt$  (a) and maximum height  $Rz$  (b) of the profile vs. selected types of blade material (the box plot presents: the mean, median, interquartile range box and data range)  
**Slika 6.** Srednja vrijednost i rasipanje podataka: a) o ukupnoj visini  $Rt$  i b) o maksimalnoj visini  $Rz$  profila obrađene površine pri obradi dvama različitim noževima (na grafu su prikazane srednje vrijednosti, medijani, interkvartilni raspon i raspon podataka)

ond area (HW) and it was about 25 % greater than the maximum value for CR blade (Sample #6 second area). In both cases, the range of  $Rt$  parameter was significant and amounted to 33.31 – 68.54  $\mu\text{m}$  (HW) and 26.74 – 54.97  $\mu\text{m}$  (CR). Generally, mean and median were about 30 % greater for HW blade (Fig. 6). Similar situation occurred for maximum height of the profile ( $Rz$ ).

However, the inter-quartile range was 8.92  $\mu\text{m}$  (HW) and 7.66  $\mu\text{m}$  (CR), respectively, whereas these ranges were twice as high as parameter  $R_t$ . This indicates a greater concentration of results around the median, which is related to the method of determining this parameter based on a sampling length and not on an evaluation length as in the case of  $R_t$ .

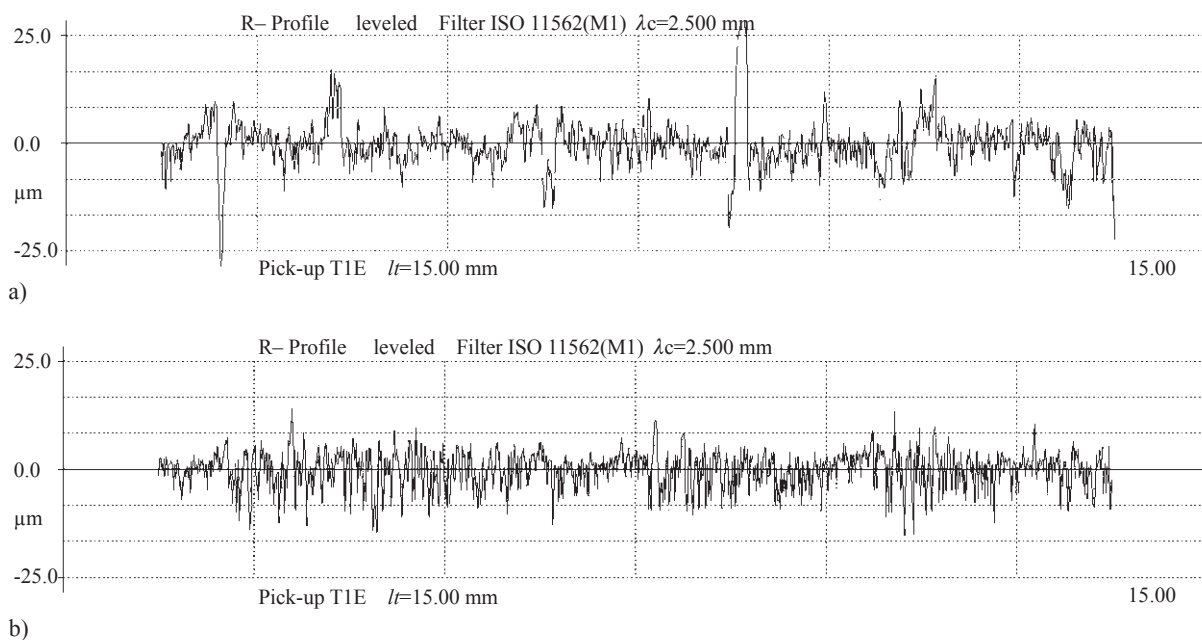
**Figure 7** R-profiles of Sample #2 machined with HW blades (a) and Sample #5 planed with CR blades (b)  
**Slika 7.** a) R-profil uzorka #2 obrađenoga nožem od tvrdog metala, b) R-profil uzorka #5 obrađenoga nožem od kromiranog čelika

Therefore, both minimum and maximum heights are characterised by particular maximum height of the profile ( $R_z$ ) in the range of 20 – 45 % for HW blade, and 12-45 % for CR blade, which is smaller than corresponding values of profile total height ( $R_t$ ). The maximum difference of 45 % is presented by the example of the profile of Sample #2 second area (HW) (Fig. 7a). Moreover, the profile for the minimum value of 12 % observed in Sample #5 second area (CR) is pictured in Figure 7b. Scratches, pull-outs and other damages to the machined wooden material could be distinctly ob-
