Article

Damage Development on the Surface of Nickel Coating in the Initial Period of Erosion

Keywords: cavitation erosion; nickel coating; corrosion

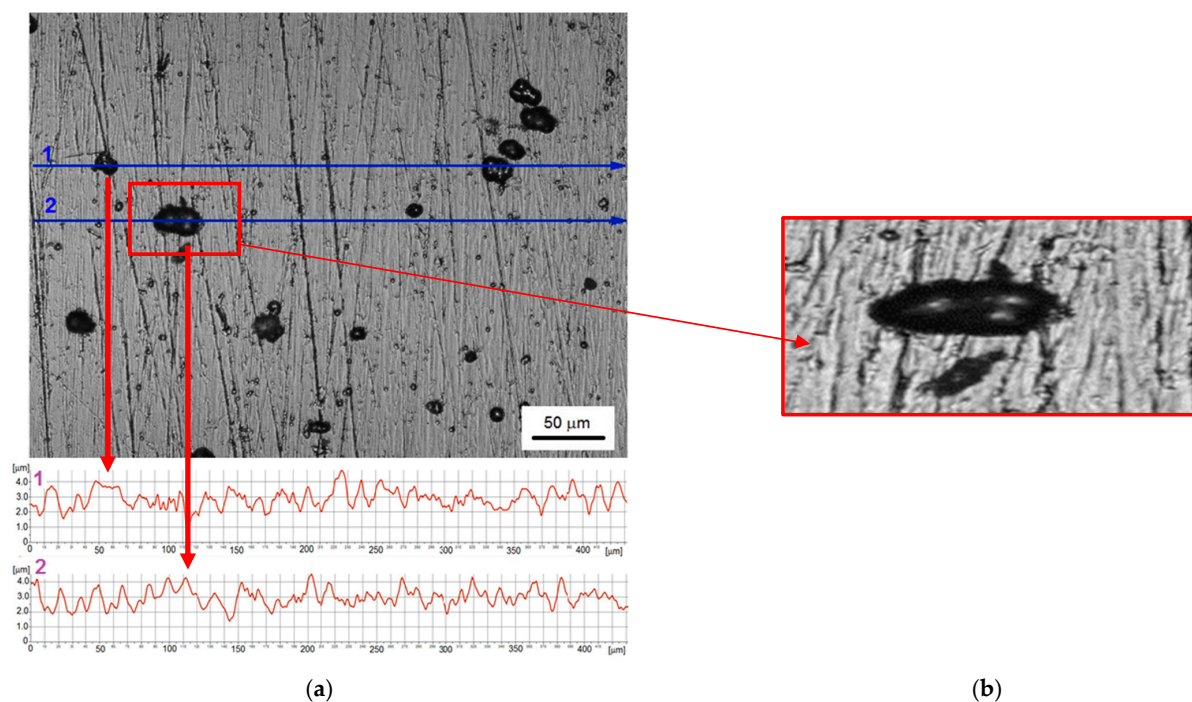
Figure 2. Nickel coating before cavitation erosion tests: (a) surface morphology with roughness profiles along the selected measurement lines; (b) 3D profile of a surface defect.

The Ni coating investigated in the presented studies is shown in Figure 2. The microscopic observation revealed the coating reflected the substrate very well and numerous defects with diameters ranging from 2 μm to even 46 μm were formed. The median size of defects was 9.6 μm the standard deviation was 8.7 μm . In addition, the roughness measurements showed that the surface unevenness had a height up to 2.5 μm and the defects were convex. Nevertheless, the coating was applied evenly to the substrate, and the observed unevenness was due to the unevenness of the substrate surface due to the low thickness of the nickel coating (about 10 μm).

The microscopic observations of the coating before cavitation tests showed that the surface irregularities were reflected by the coating due to its small thickness. However, the height of surface unevenness decreased by about 0.8 μm : from $2.63 \pm 0.29 \mu\text{m}$ to about 2 μm . In addition, defects with a wide range of diameters were formed during coating deposition. According to [49], defects in electroless Ni coatings are related to the phosphorus content and coating thickness. Thus, the cause of the numerous and large defects was likely the high content of phosphorus.
