M. Landowski, K. Imielińska

Gdańsk University of Technology, Faculty of Mechanical Engineering, Narutowicza 11/12,
80-233 Gdańsk, Poland
mlandowski@gmail.com

IMPACT BEHAVIOUR OF GLASS FIBRE /EPOXY COMPOSITES WITH NANO-ENHANCED RESIN AFTER WATER EXPOSURE

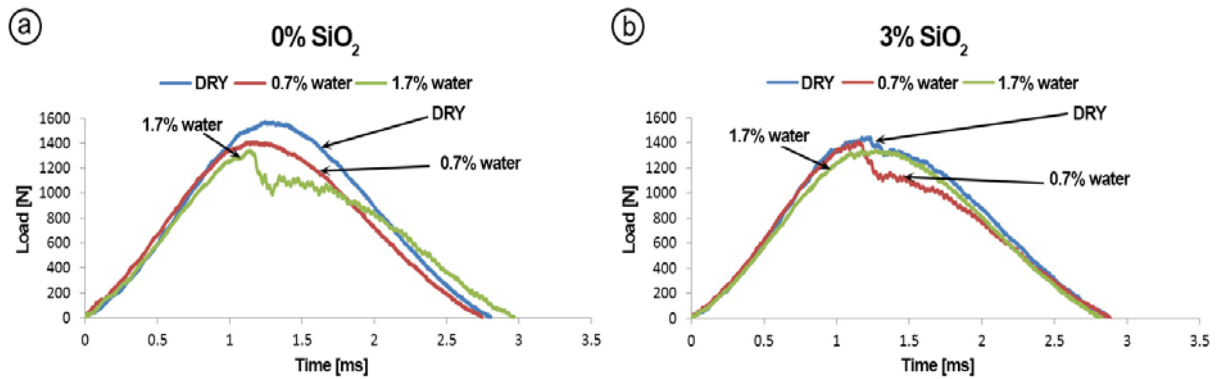
Fig. 1. Impact load-time characteristics for (a) unmodified, (b) 3% nanoparticle modified specimens in dry and wet conditions (with variable water contents). Impact energy 3J

Fig. 1 compares dynamic force –time impact characteristics at 3J impact energy for unmodified specimens (Fig. 1a) and specimens with 3%wt. nanoparticles (Fig. 1b) both in “dry” condition or with 0.7% and 1.7% water absorbed. Smooth curve profile for “dry” and 0.7% water (Fig. 1a) indicates that only minor impact damage resulted in these specimens whereas at higher water contents (1,7%) more severe fibre damage resulted. Addition of 3% SiO₂ (Fig. 1b) changes the failure mode of “wet (1.7% water) specimens compared to the dry (3% SiO₂) and to the unmodified (0% SiO₂). At 3J impact energy, dry (and 0.7% water) 3% SiO₂ modified specimens are subjected to fibre breakage whereas in wet condition (1.7% water) smooth load-time curve is observed which is indicative of minor damage (matrix cracks) and a positive nano-particle effect. Fig 2a illustrates slightly decreased peak impact load for SiO₂ modified specimens. This property remains practically unchanged after water exposure (up to 2% water absorbed). However failure modes are different. Energy absorbed (Fig. 2b) decreased with increased water amount and absence of nanoparticle effect was observed.

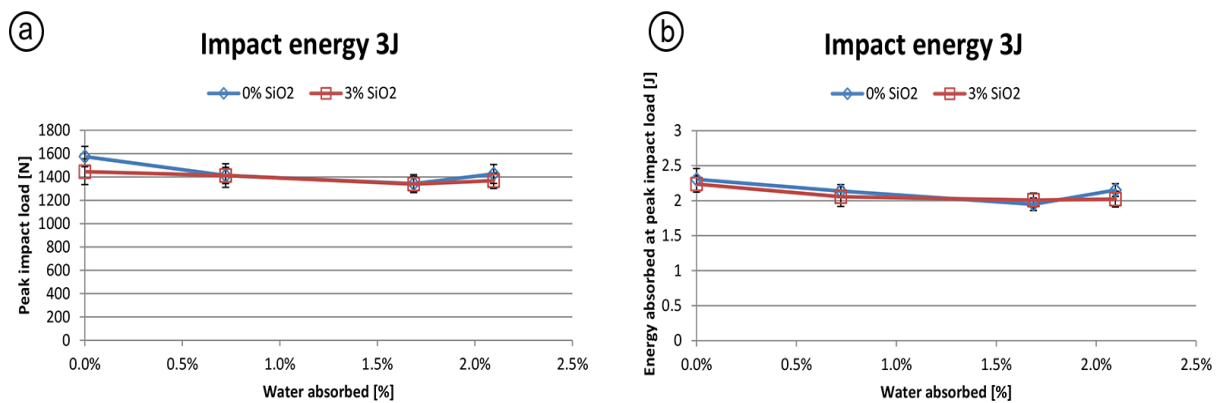
Fig. 2. a) Peak impact load as a function of amount of water absorbed by the specimens with 0% and 3% nanoparticles, b) energy absorbed at peak impact load as a function of amount of water absorbed by the specimens with 0% and 3% nanoparticles. Impact energy 3J

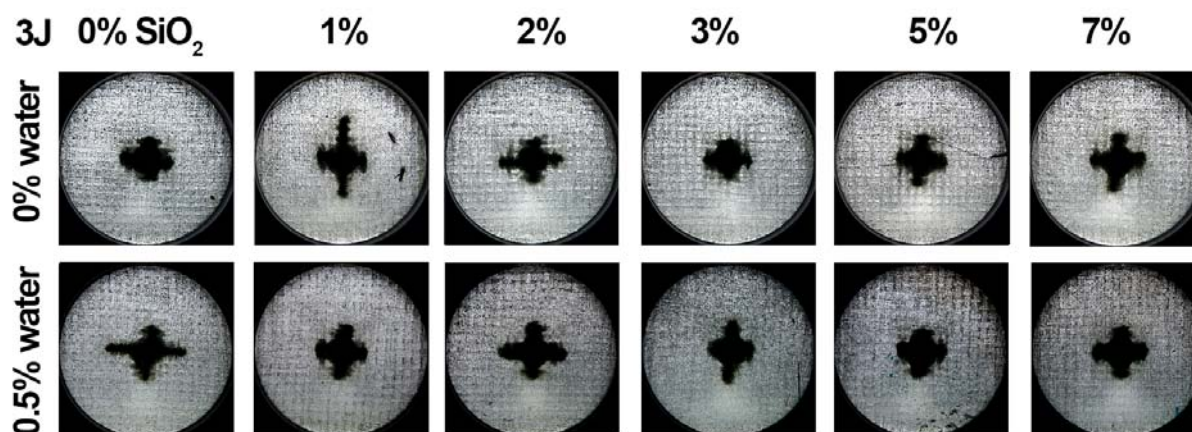
Fig. 3. Impact damage in laminates modified with 1-7% nanoparticles in dry (upper row) and wet (0,5% water absorbed)

Fig. 3 illustrates impact damage in laminates modified with 1-7% nanoparticles in dry (upper row) and wet (0.5% water absorbed). The shape of impacted zone differs slightly due to different failure modes, however impact damage area (Fig. 4) is 10-15% lower for unmodified specimens. The improvement in the behaviour of 3% SiO₂ modified specimens is observed in terms of impact damage area for “wet” (1-2% water absorbed) specimens.

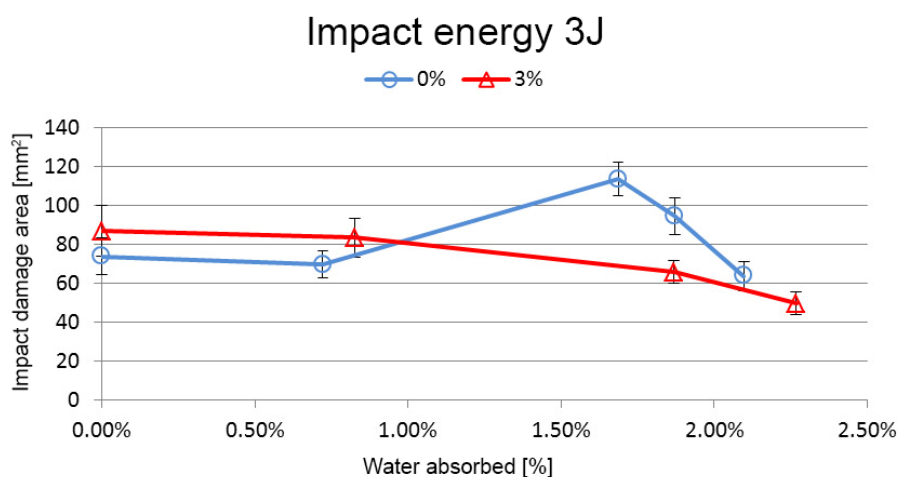
Fig. 4. Impact damage area as a function of percent water absorbed by the specimens with 0% and 3% nanoparticles. Impact energy 3J
