M. Landowski, K. Imielińska

Gdańsk University of Technology, Faculty of Mechanical Engineering, Narutowicza 11/12,
80-233 Gdańsk, Poland
mlandowski@gmail.com

IMPACT BEHAVIOUR OF GLASS FIBRE /EPOXY COMPOSITES WITH NANO-ENHANCED RESIN AFTER WATER EXPOSURE

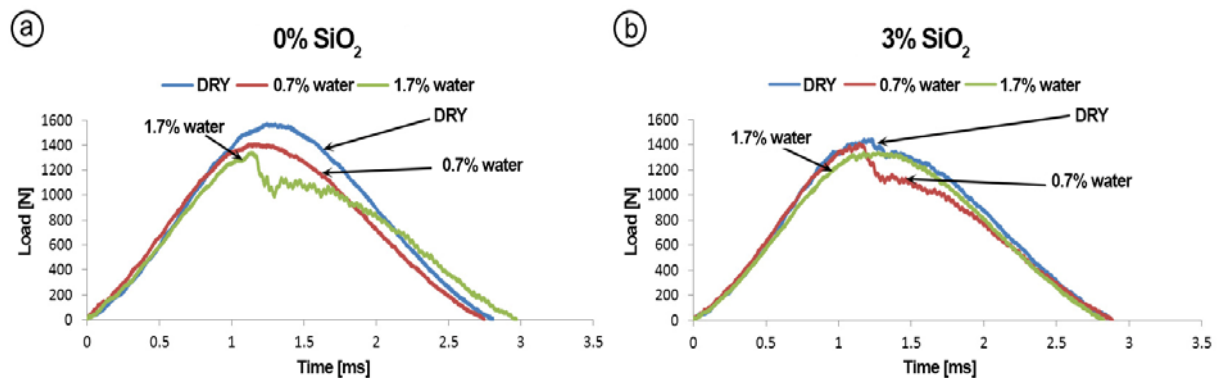
Fig. 1. Impact load-time characteristics for (a) unmodified, (b) 3% nanoparticle modified specimens in dry and wet conditions (with variable water contents). Impact energy 3J

Fig. 1 compares dynamic force –time impact characteristics at 3J impact energy for unmodified specimens (Fig. 1a) and specimens with 3%wt. nanoparticles (Fig. 1b) both in “dry” condition or with 0.7% and 1.7% water absorbed. Smooth curve profile for “dry” and 0.7% water (Fig. 1a) indicates that only minor impact damage resulted in these specimens whereas at higher water contents (1.7%) more severe fibre damage resulted. Addition of 3% SiO₂ (Fig. 1b) changes the failure mode of “wet (1.7% water) specimens compared to the dry (3% SiO₂) and to the unmodified (0% SiO₂). At 3J impact energy, dry (and 0.7% water) 3% SiO₂ modified specimens are subjected to fibre breakage whereas in wet condition (1.7% water) smooth load-time curve is observed which is indicative of minor damage (matrix cracks) and a positive nano-particle effect. Fig 2a illustrates slightly decreased peak impact load for SiO₂ modified specimens. This property remains practically unchanged after water exposure (up to 2% water absorbed). However failure modes are different. Energy absorbed (Fig. 2b) decreased with increased water amount and absence of nanoparticle effect was observed.

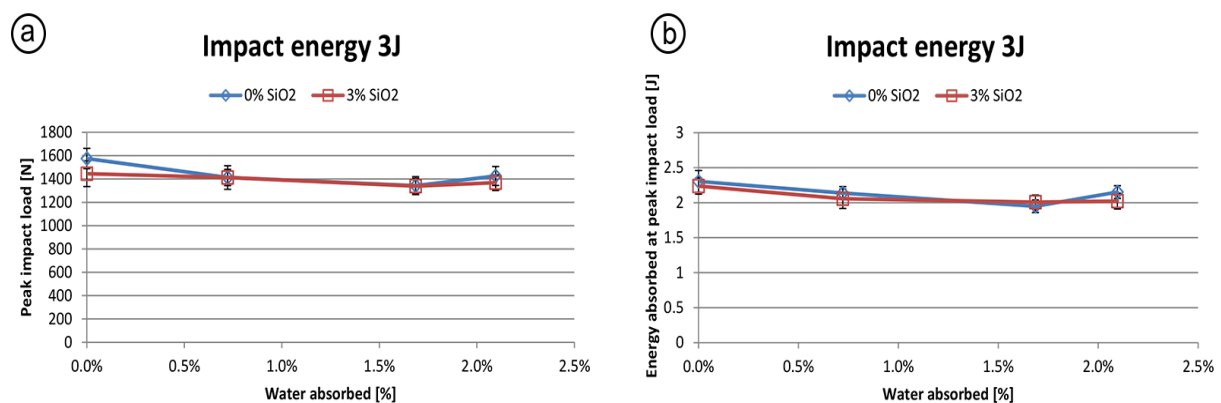
Fig. 2. a) Peak impact load as a function of amount of water absorbed by the specimens with 0% and 3% nanoparticles, b) energy absorbed at peak impact load as a function of amount of water absorbed by the specimens with 0% and 3% nanoparticles. Impact energy 3J

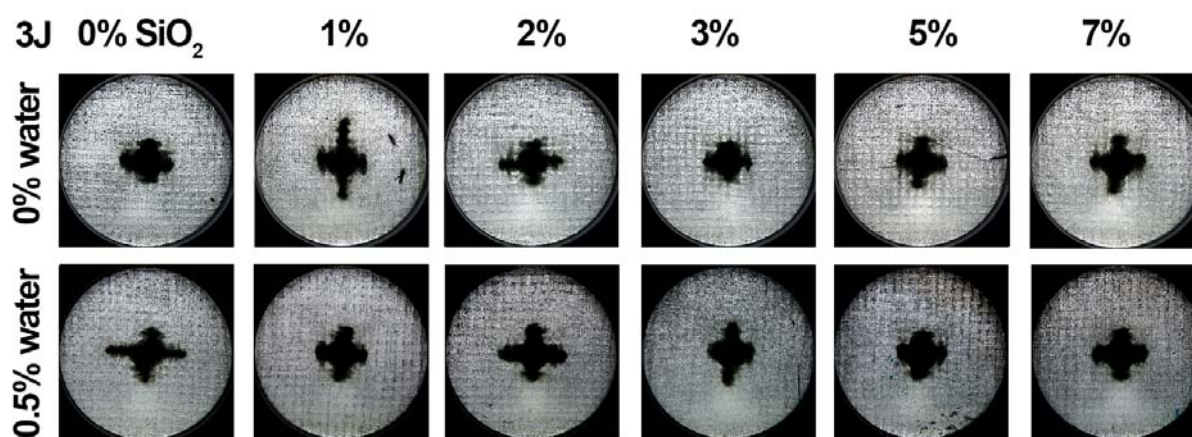
Fig. 3. Impact damage in laminates modified with 1-7% nanoparticles in dry (upper row) and wet (0,5% water absorbed)

Fig. 3 illustrates impact damage in laminates modified with 1-7% nanoparticles in dry (upper row) and wet (0.5% water absorbed). The shape of impacted zone differs slightly due to different failure modes, however impact damage area (Fig. 4) is 10-15% lower for unmodified specimens. The improvement in the behaviour of 3% SiO₂ modified specimens is observed in terms of impact damage area for “wet” (1-2% water absorbed) specimens.

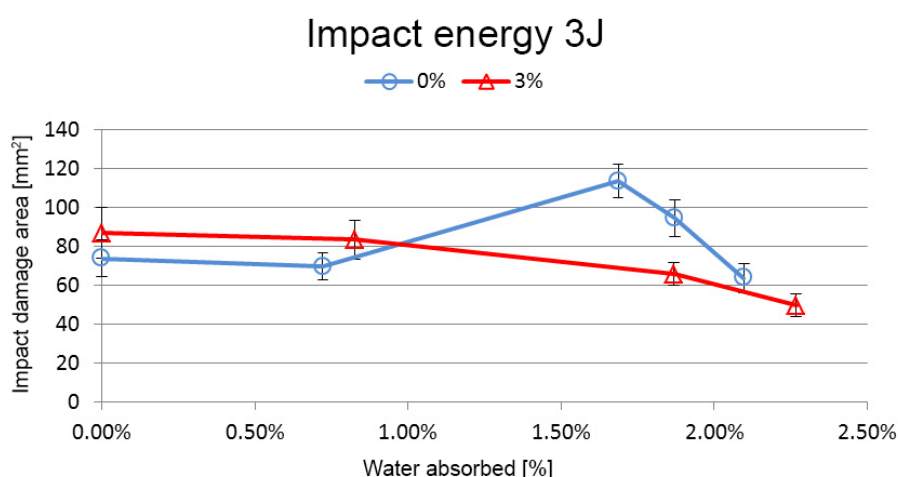
Fig. 4. Impact damage area as a function of percent water absorbed by the specimens with 0% and 3% nanoparticles. Impact energy 3J

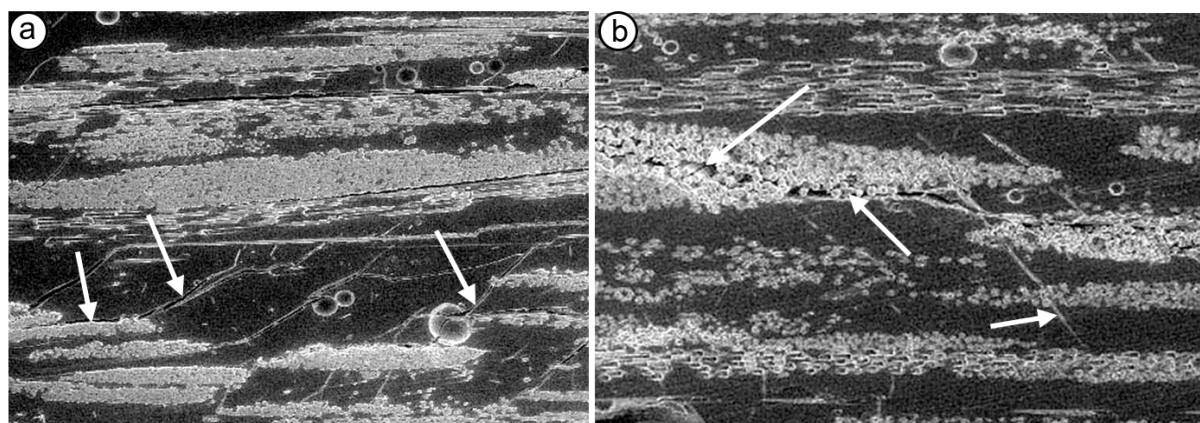
Fig. 5. SEM micrographs of dry (a) and wet (b) (1,7% water absorbed) specimen modified with 3% nano-SiO₂ after 3J impact. Arrows show matrix cracks and debonded fibres

Figs. 5ab illustrate SEM micrographs of dry (a) and wet (1.7% water absorbed) specimen modified with 3% nano-SiO₂ after 3J impact. Typical impact failure modes observed in this illustration are numerous matrix cracks (arrows). Nanoparticles cannot be observed at this magnification (100x). In Fig 5b debonded fibres are demonstrated (arrow) which is the effect of water immersion. This effect was observed in the previous study [7]. It appears that the same effect (debondings) could be observed at nanoparticle /matrix interfaces following water exposure which resulted in the change of failure mode observed for impacted specimens in wet condition. The weakest point in the material with up to ca. 2% water absorbed was the matrix with numerous debonded nanoparticles which prevented fibre fracture at 3J impact energy. The presence of debonded nanoparticles accounts for the less severe failure in water affected specimens.
