Influence of laser processing of the low alloy medium carbon structural steel on the development of the fatigue crack

Marek Szkodo¹, Anna Bień²,

Abstract

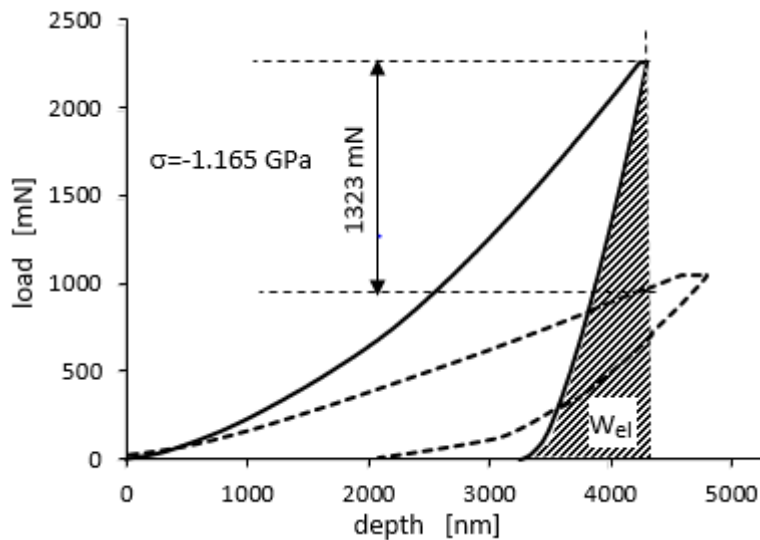
Fig. 10. Load vs. penetrator displacement during hardness measurement in I1 line in the native material in front of the crack tip. Solid line - for material with stress and dashed line – for material after annealing. Calculated compressive stress is 1.165 GPa

loading and unloading when measuring the hardness. If the load required for the penetrator displacement, at the same depth, is greater for the material with residual stress that means that the stress is compressive, as presented in the Fig. 10. If the situation is opposite it means that the stress is tensile, as in Fig 11. Calculated stresses are shown in Fig. 12. The most important for the retention of crack development were stresses along the I1 line in the vicinity of the crack tip. All calculated stresses along the I1 line were compressive stresses. Residual stresses were generally larger along the I1 line than I3 line. They equalize in the vicinity of the P3 path. Residual stress in the native material in front of the crack was 1165 MPa for I1 line (see Fig. 10). Compressive stress was even greater further away from the crack tip. Compressive stress reached a 1688 MPa value in HAZ of P1 path from the side of crack. In contrast, the residual stress in the native material from the side of the tip crack was 723 MPa at a distance of 10 mm from the edge of the fracture. Compressive stresses were smaller the further away from the crack tip, and in the HAZ they have changed the character.

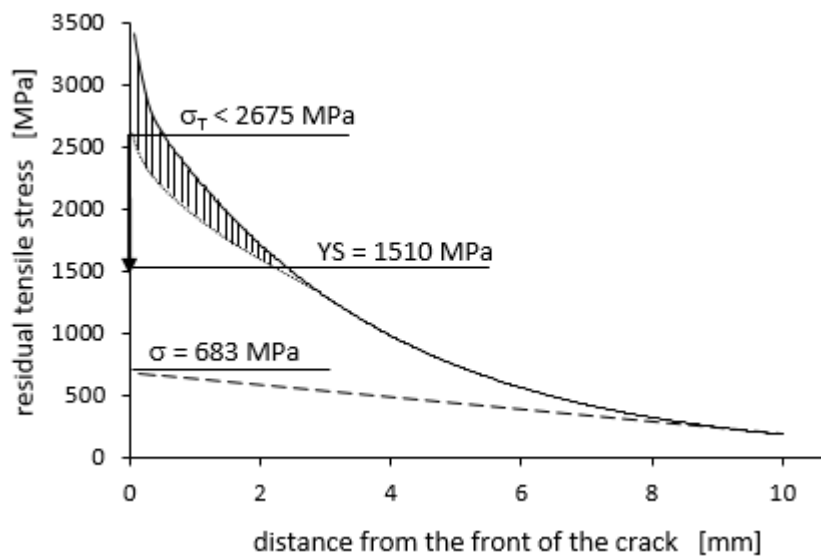
Fig. 14. Stress distribution before tip of the crack in the laser-treated sample during the fatigue test

In Fig. 14, the dashed line shows the change in stress, without taking into account the stress concentration due to the crack. The maximum tensile stress occurs before the face of the crack, and its value is 683 MPa. The occurrence of crack causes stress concentrations that, theoretically, just before its forehead attain very high values (see equation 2). Solid line shows the concentrated stress

distribution in Fig. 14. However, since the crack was not developed during the fatigue test, it can be assumed that just before the crack tip, the stress did not exceed the yield strength of the material. Reduction of the tensile stress before the face of the crack was caused by two factors. The first reason was the presence of the elongated manganese sulfides inclusions in the steel arranged perpendicularly to the direction of developing crack (see Fig. 4). The presence of manganese sulfides caused blunting of blade of the crack, which resulted in a decrease in tensile stress before its face. The phenomenon of blunting of the blade of the crack and related decrease in tensile stress before its face is reflected by the shaded area in Fig. 14. Such an assumption is confirmed by the course of the crack development (see Fig. 3a). As is apparent from Fig. 3a the crack development rate is higher in the first period fatigue test (to about 350,000 cycles). After this first period, the crack development rate decreased. Reduction of the crack development rate was probably caused by blunting of the crack blade due to the occurrence of longitudinal manganese sulfide and other non-metallic inclusions. The second reason causing the stopping of the crack during the fatigue test was the occurrence of the compressive stress ($\sigma_c = 1165$ MPa) in front of its face induced by the laser treatment. The reduction of tensile stress before the front of the crack, due to laser treatment, is illustrated by the arrow in Fig. 14. Both of these factors resulted in a reduction in tensile stress before the face of the crack, below yield strength (YS)
