# Types of Surface Impurities versus the Quality of Brazed Joints

**Abstract:** Brazing is one of the primary joining processes increasingly often applied in industry. Because of their mechanical properties, overlap joints are particularly popular when making brazed structures. The use of brazed joints in structures of critical importance requires that particular attention be paid to joint quality, e.g. by the appropriate cleaning of surfaces to be joined. The article presents results of non-destructive tests of brazed joints made in steel S235JRG2. Surfaces used in the tests were deliberately contaminated to simulate the presence of welding imperfections. Afterwards, the test specimens were subjected to non-destructive (visual and radiographic) tests aimed to determine the effect of surface impurities on the quality of brazed joints.

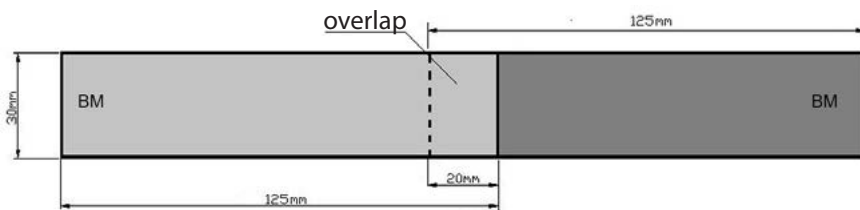
The tests aimed to determine the effect of surface contamination types on the quality of gas (oxy-acetylene) overlay brazed joints. The tests involved the use of 1.5 mm thick sheets (125 × 30 mm) made of steel S235JRG2. The sheets were used to make 10 joints presented schematically in Figure 1. Table 1 presents the chemical composition of the base material.

Fig. 1. Schematic overlay brazed joints, BM – base material

The brazing process was performed using silver brazing metal grade Ag203 (B Ag-44CuZn-675/735) according to PN-EN ISO 17672:2016 (having the form of a wire) and flux 1802 N Atmosin (Castolin), used to dissolve oxides present in the base material. The presence of the flux provided the wetting of elements in the joint by the molten brazing metal and intensified the capillary action in the brazing gap. The flux was used to cover the area referred to as an “overlap” (Fig. 1).

| Spec. no. | Brazing conditions |
|---|---|
| 2 | 50% of the overlap (Fig. 1) covered with flux, 50% covered with grease and flux |

| Spec. no. | Brazing conditions | Conditions of radiographic tests |
|---|--|--|
| 2 | 50% of the overlap (Fig. 1) covered only by flux, 50% covered by grease and flux | Lack of a complete joint, inclusions having a diameter of up to 5mm |

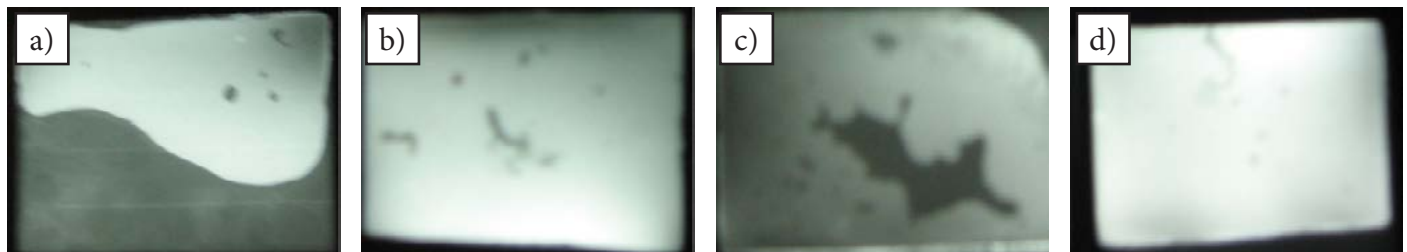
results of the previous tests concerning the effect of impurities during joining processes [15]. Figure 3 presents examples of radiographic test results. Table 3 presents the test results in relation to all of the specimens.

Fig. 3. Radiographic test results; a) specimen 1 – lack of the flux, a complete joint covering approximately 50% of the surface subjected to brazing, inclusions, oval gas cavities, b) specimen 3 – improperly cleaned surface, a longitudinal gas cavity having a length of 5 mm in its central part and oval gas cavities, c) specimen 8 – immersed in water, a gas cavity having a length of 20 mm and a width of up to 7 mm, oval gas cavities, d) specimen 10 – made properly, a longitudinal gas cavity having a length of 3 mm, small inclusions

Pb foil (0.05 mm) made by Kodak. The tests were performed using the following parameters: FFD = 700 mm, U = 130 kV, I = 4,5 mA and an exposure time of 3 minutes. The radiographic tests revealed that the most numerous imperfections were present in the specimens, the surfaces of which were intentionally contaminated with pieces of copper foil. The above-named inclusions precluded the formation of a complete joint and led to the formation of smaller inclusions located nearby. A similar result was observed in relation to specimen no. 9 provided with the flux used in the SAW method. The above-presented results confirmed the
