# Analysis of the Ways to Identify Rail Running Surface Defects by Means of Vibration Signals

The article discusses a preliminary concept of a method enabling the identification of chosen rail running surface defects, such as squats, spalling, and running surface defects, by analysing the parameters of vibration signals. It features a description of the methodology of the conducted tests, the scope thereof, and the selection of the measurement points with specific defect types. The article covers selected results of vibration tests, the results of analyses of recorded signals for defective track sections and those for control track sections. The presented measurement results have been obtained for the technical–operating conditions occurring on railway line no. 213 Reda – Hel and line no. 131 Chorzów Batory – Tczew. The preliminary test results and conclusions included in the article show that it is reasonable to pursue further research into the phenomena involving the utilisation of vibroacoustics in rail performance diagnostics.

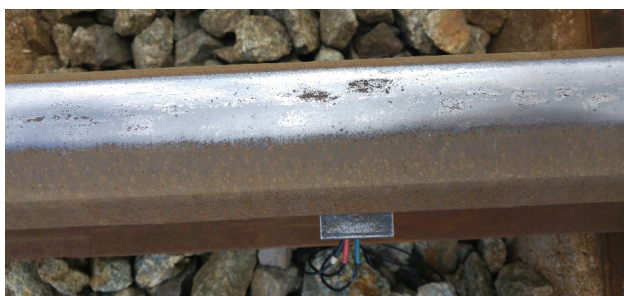
The next defect is spalling, defect no. 2252 and no. 2251, single and multiple spalling in accordance with PLK's Catalogue of Rail Defects (Fig. 2). Spalling involves the damage of rail running surfaces resulting entirely from the standard use and operation of rails, found commonly on track sections where trains brake violently or where heavy freight trains are accelerated to operational speed. Spalling occurs most often before home signals as well as before level crossings and turnouts.

Spalling occurs symmetrically on both isolated rail sections and is identified by means of visual inspection. Recommended measures to be taken are observation, grinding, replacement or immediate replacement of the rail [3, 7].

Fig. 2. Spalling defect on railway line no. 213 Reda – Hel [authors' own work]

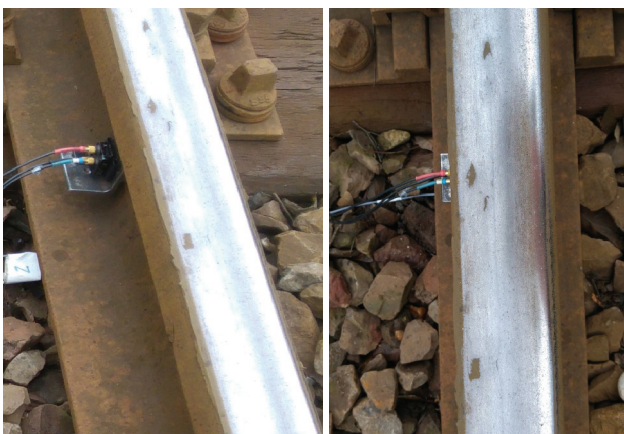
The last of the analysed defects is the rail running surface defect no. 221 in accordance with PLK's Catalogue of Rail Defects (Fig. 3). Defect no. 221 appears only on the railhead during the standard use and operation of the track. It is damage with a metallurgical origin. Its most common manifestations include shelling of the running surface or groove-shaped cracks.

Fig. 3. Defect 221 – damage of the running surface on railway line no. 213 Reda – Hel [authors' own work]

Damage 221 is identified most often by means of visual inspection. Depending on the degree of defect development, the recommendation is to inspect the rail visually on a continual basis, grind it or re-surface it [3].
